# The mass movement response of tectonics phenomena in urban areas, Albania

Y. Muceku

*Institute of Geosciences, Polytechnic University of Tirana, Albania*

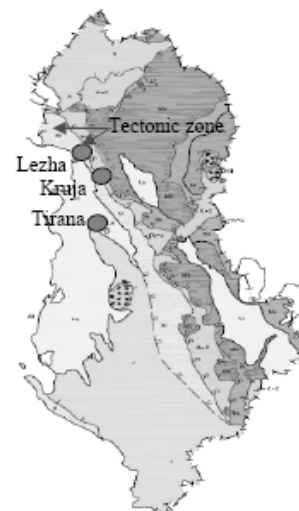
Figure 1. Schematic geological map of Albania

According to geological and tectonics-neotectonics phenomena the eastern part of Lezha and Kruja town take part in Kruja tectonic zone, which include in external area of Alpine folding (Fig.1). It is strongly affected by pre-Pliocene compression

phases. The Kruja tectonic zone has been deformed by folds, reverse faults-thrusts and occasional back thrust, as well as by strike slips from the main Alpine compressive phases which folded the above mentioned tectonic zone. Generally, the structures Kruja tectonic zone extend from NW to SE (Fig.1). It must be emphasized the hilly urban area of Lezha town is situated on intensive tectonic zone (thrust faults), which is formed by movement of Krasta tectonic zone over Kruja tectonic zone (Fig.1, 2.). The eastern part of urban area of Kruja town is built on tectonic zone caused from uplift of the normal thrust of limestone's formations over flysch formations (Fig.1, 3, 5).

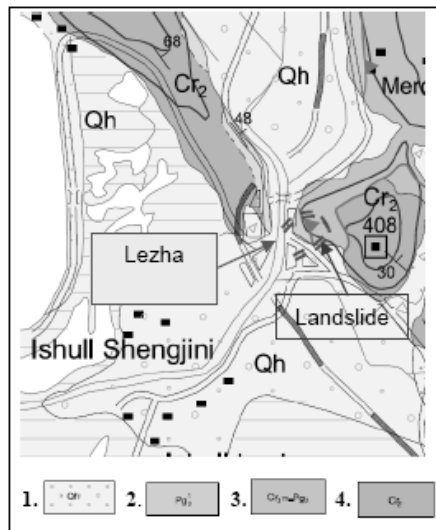
Figure 2. Geological map of Lezha region

Geologically the urban area of Lezha town are represented from Lower Oligocene formations-flysch rocks are composed of are thin rhythmic clay-siltstone-sandstone-flysch that are part of Kruja tectonic zone and Maastrichtian-Eocene formations-flysch are sequences composed mainly of siltstones intercalated with sandstones and marl layers, which take part on Krasta Cukali tectonic zone. The second one uplift with intensive tectonic zone on Lower Oligocene formations (Fig. 1, 2).

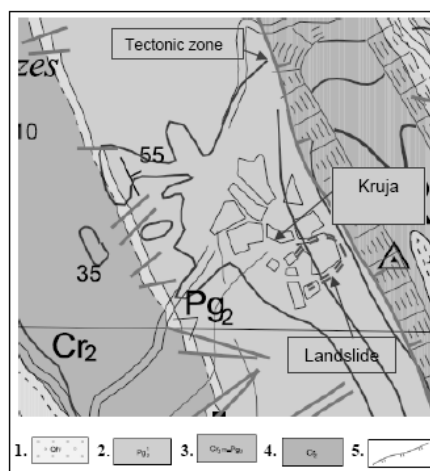
Figure 3. Geological map of Kruja region

From the lithological point of view, the studied area of Kruja town is built from the Lower Oligocene formations-flysch rocks. Mostly of the bedrocks covered by the Quaternary deposits are silts with gravels and sands mixtures (Fig. 1, 3), which form an overturned syncline with dip angle of the limbs to east. Over this structure with intensive tectonic with normal thrust uplift the Upper Cretaceous limestone's rocks, which extent on eastern part of Kruja town. The flysch rocks represent from combination of the siltstones and claystone's layers. Generally flysch rocks are covered by the Quaternary deposits are silts and silty clays with mixtures of gravels and sands.

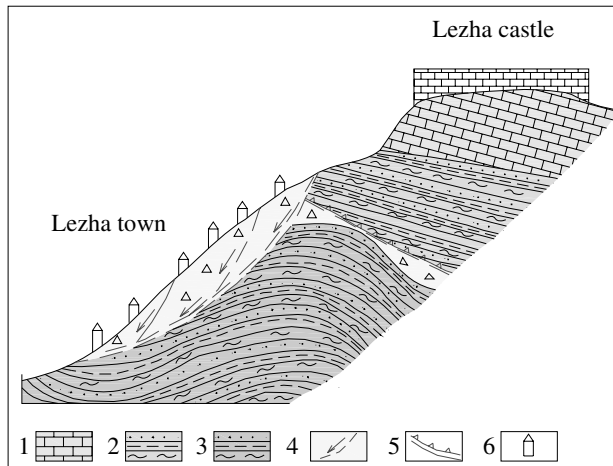
Figure 4. Cross section Lezha landslide

The landslide occurred on hills slopes extend en eastern of urban area of Lezha town (Fig.2, 4). This part is one the most active tectonically area in Albania constituted by thrust fault, where limestones rocks uplift on flysch rocks. During the uplifting of the Krasta tectonic zone over Kruja tectonic zone (Fig.1, 2, 4) the flysch rocks of urban area have changed their geotechnical properties, transforming from rocks to soils. So, decomposition of the flysch rocks from this phenomenon and weathered processes produces conducive conditions to mass movement in this area. Beside of them, the landslide was triggered by the rainfalls-storms, with the most notable being the disturbed zone by tectonic phenomenon. From this phenomenon are damaged demolished 8 homes (1-2 stores) and main town road etc. The homes damages are cracks of the walls 4.0-10.0cm, cracks and subsidence of the floor and demolition of the home. There also was widespread debris flow and damage to homes, buildings, and roads in areas along the main boulevard and hospital road of Lezha town. The landslide according to classification of Varner 1978 include in rotational types that are generally shallow-deep. The geologic structure, lithology and morphology of the urban area are profoundly influence by the active processes of regional tectonic. Thus, as above mentioned it, the natural events such as tectonics phenomenon, rainfall, slope morphology, manmade construction activities and underground water have caused of the mass movement. The landslide is vary greatly in their volume of soils, the length, width, depth of the area affected, frequency of occurrence, and movement. Therefore, inherent factors related to rock discontinuities provide a basis for understanding landslides and also in the formulation of long and short-term pro-active responses to natural hazards from slope instability. The size of a landslide is 450-500m wide, 220-250m up to 300m long and 7.0-10.2m deep, whereas the its volume is 1 009 375 m<sup>3</sup>. Slides move in contact with the underlying surface, which are the much disturbed or decomposed of flysch rocks.

1. Limestone, 2. Flysch rocks- siltstones and claystones, 3. Flysch rocks-siltstones intercalated with sandstones and marl layers, 4. Landslide, 5. Tectonic, 6. Building

Geotechnical unit nr. 1. Represents landslide body soils. These soils consist of the sands and clays mixtures with pebbles and rubbles content which are in medium geotechnical conditions and have a thickness range from 7.0-10.0 up to 14.0-16.0m (Fig. 4). According to unified soil classification system these soils are "SC" type.

Geotechnical unit nr. 2. These soils built the slide's plane. They are made of inorganic silts and very fine sands. This layer is situated below geotechnical unit nr. 1, and have a thickness varies from 1.4 up to 1.7 m (Fig. 4). According to unified soil classification system these soils are "ML" type.

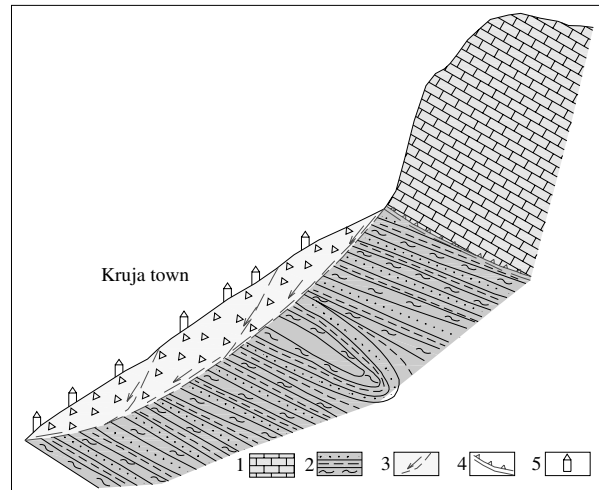
Figure 5. Cross section Kruja landslide

It's located in south-east part of the Kruja town. On this earth slide is constructed a square of the Kruja town, where 12 buildings are demolished by this phenomenon. The slide body is lying over siltstones and claystones of flysch formations (Fig.5). The dimension of the earth slide is 500.0-550.0m long, 400.0-500.0m wide, 8.0-12.5m deep and volume of 2 362 500 000 m<sup>3</sup> (Fig. 3, 5). The slide mass consist of clays, silts, sands, gravels and limestones blocks. The slide plane occurred in these flysch formations, and it has a typically a polished surface at the base, where on it is a thin soft layer (0.2m up to 1.5 -2.0 m). The Kruja town is situated on hills slope, which have a dip angle ranging from 30° up to 45°. It's moving slowly downwards on hills slopes. Taking into account the landslides according Varner 1978 can be classified as rotational and earth flow types that are active, deep and shallow. Some result in private property damage, while other landslide affects transportation corridors, fuel and energy conduits, and communication facilities. They also pose a serious threat to human life. The landslide generally is slow moving and less rapidly moving (debris flows). First at all it cause significant property damages, but are less likely to result in serious human injuries, where rapidly mass movement present the greatest risk to human life, and people living in mass movement prone areas are at increased risk of serious injury. The upper part of the landslide body is situated directly on tectonic zone, which the main factor that has favored this phenomenon. That's because of flysch rocks formations are intensively disturbed becoming more susceptible to landslides than others, the tectonics zone serve as a collector for the karstic water, which drained from limestones rocks of Scanderbeg mountain and infiltrate in the contact of the soils and flysch rocks doing lowering of geotechnical properties of the soils and rocks. It is certified by the several waters spring, which are found along of landslide body. It often triggered by periods of heavy rainfall (1800-20000 mm/year) and excavations, as well. Also, the morphology of the steep slope of this area can also increase susceptibility to landslide event. Beside of them in this area the people can be exacerbated by human activities as the grading for road construction and development where is increased the slope steepness, as well as, the grading and construction of several buildings, which decrease the stability of a hill slope by adding weight to the top of the slope, removing support at the base of the slope, and increasing water content. Other human activities effecting landslides include: excavation, drainage and groundwater alterations, and changes in vegetation. From landslide occurrence are damaged 14 homes-2 stores, town roads etc.

Geotechnical unit nr. 1. The soils of this geotechnical unit built the landslide body soils. They consist of inorganic silty clays with sands content and have a thickness range from 7.0-10.0 up to 14.0-16.0m (Fig. 5). According to unified soil classification system these soils are “CL” type.

Geotechnical unit nr. 2. It's built the slide's plane. These soils are made of silty clays with sands content with sands, and situated below geotechnical unit nr. 1, having a thickness varies from 1.1 up to 1.9 m (Fig. 5). According to unified soil classification system these soils are “CL” type.

Geotechnical unit nr. 4. It's represents by soft rocks – combination of claystones with siltstones layers, grey color and is found below the layer geotechnical unit nr. 4 (Fig. 5).

It needs to mention the laboratories analyses shown that the soils condition of the geotechnical unit nr. 3 of the Kruja landslide are the weathered flysch rocks and related to unified soil classification system they are “CL” type- sandy clays soils with low-medium geotechnical properties. It means that these soils contribute on the new mass movement development. To protect from these phenomena in the studied area of Lezha town are used several engineering measures as retaining structures as concrete walls and piles, whereas in Kruja town are applied retaining concrete walls.
