Evaluation of Full Scale Levee Stability Tests at Booneschans and Corresponding Centrifuge Tests

M. A. Van

Expertise Manager, Deltares, P.O. Box 177, 2600 MH Delft, The Netherlands, meindert.van@deltares.nl

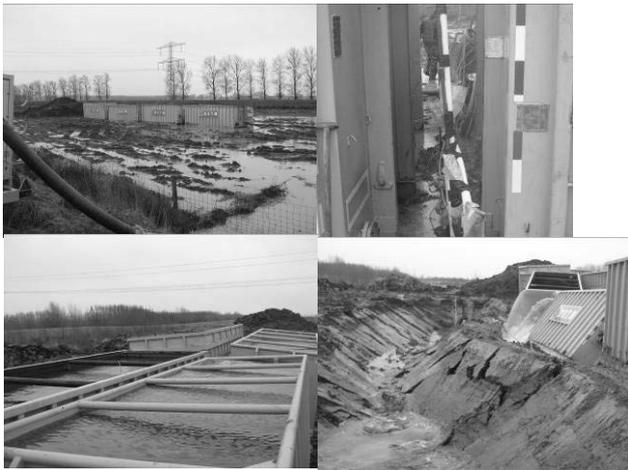
Figure 4. a) Overview preliminary test b) Measurement row at the centre of the container row c) Filling of the containers d) Failure

After failure, the containers were removed and the failure plane was examined by excavating an observation pit. The active part of the sliding plane was found to be very steep, followed by a horizontal part through the peat layer, leading to the ditch bottom. It should be noted that for the location of the preliminary test a 2.5 m thick organic clay layer was present on top of the peat layer.

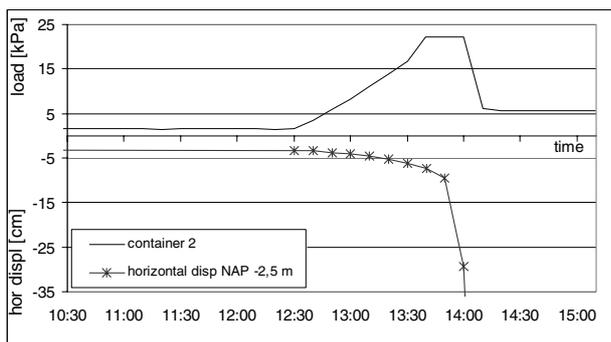
Figure 5. Horizontal deformation of the subsoil at ground level -1.5 m during filling of the containers

The instrumentation consisted of eight pore pressure transducers placed in the peat and clay layer, two open stand pipes for measuring the hydraulic head in the sand layer, a settlement tube placed underneath the container row, and an inclinometer to measure the horizontal deformations in the subsoil. Figure 5 briefly shows an impression of some of the measurements. The top part of the figure shows the filling of the containers. The lower part shows the horizontal subsoil deformation at a depth of NAP -2.5 m, approximately 1.5 m below ground level, at the front of the first container row and close to the ditch. The figure shows that horizontal deformations were activated directly at the start of filling the containers. This was long before deformation could be observed visually at the surface. The observation that horizontal deformations can be measured before failure is visible is also described in Crabb & Atkinson (1991)

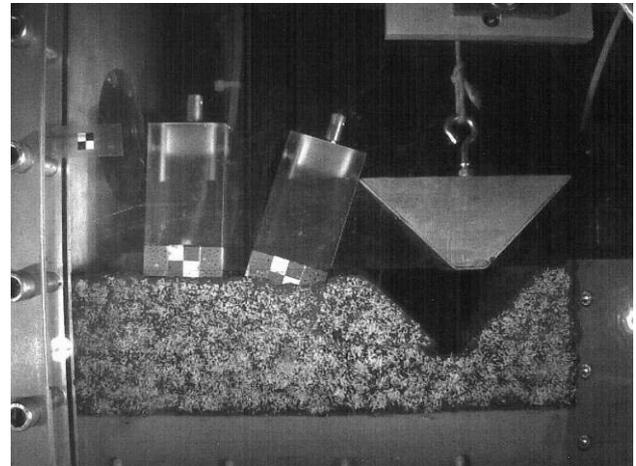
Figure 6. Centrifuge test representing the preliminary test

Figure 6 shows the failure plane observed in the centrifuge tests. Horizontal sliding dominates the failure mechanism. Figure 7 shows the horizontal deformation found in the centrifuge test at three different levels below ground level at the front of the containers. The horizontal displacements are found after creation of vector plots from images like the one shown by Figure 6. The vector plots and the displacement graphs are made using particle image velocimetry (PIV) for use in geotechnical testing(White, 2003). The PIV-analyses was carried out with the PIV software tool developed by White (2002). In comparing centrifuge and the full scale tests, a depth of -18mm in the centrifuge test corresponds to -0.9 m in the full scale test, likewise -28 mm corresponds to -1.4 m and -38 mm to -1.9 m. In the centrifuge test the slip plane lays between -28mm and -38mm. Figure 7 shows that directly when the filling of the containers start, $t=0$, a continuous horizontal deformation starts.

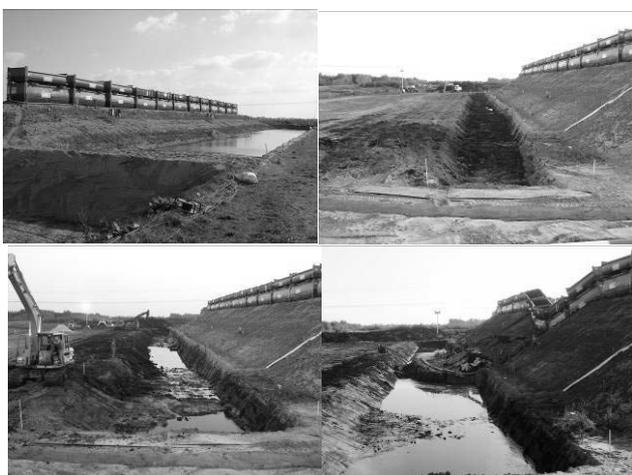
Figure 8. a) River side of the dike, b) Inner side of the dike during excavation of the ditch, c) Inner side of the dike after excavation of the ditch, d) Failure

The construction phase of the test embankment started on August 13th 2008 and was finished on September 19th 2008. The test started on September 25th by filling the bathtub in front of the dike, see Figure 8a. Later that day the top clay layer was excavated, see Figure 8b, at the toe of the dike. On September 26th the ditch was fully excavated, on to the top of the sand layer, see Figure 8c. On September 27th the sand core was filled with water. The filling started at 12:07h, at 16:00h deformation could be observed visually, failure was found at 16:02h, see Figure 8d.

Failure was reached during filling of the sand core; the containers on top of the dike were not filled. The observed failure plane had a width of 40 m. Equivalent to the preliminary test, horizontal deformation dominated the occurred sliding. After failure was reached an observation pit was excavated to examine the sliding plane. The active part of the sliding plane could not be recovered. Probably the active part is present under the centre of the embankment that could not be reached by the excavation. A long horizontal failure plane was found on the transition of the peat layer and the sand layer.

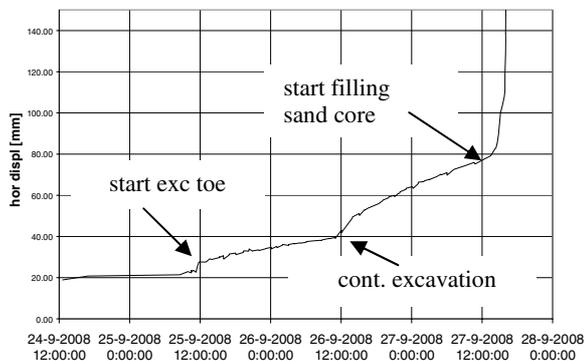
Figure 9. Horizontal displacement at 2 m below ground level

Figure 9 shows an impression of the measurements. The horizontal deformation was measured at 1/3 of the inner slope. The initial horizontal deformation, approximately 20 mm, was found during the construction of the dike. Figure 9 shows that, although not visually observed, the horizontal deformations started to develop as soon as the excavation at the toe started. On the morning of September 26th the deformations seemed to slow down until further excavation started around noon. Then, the horizontal deformation accelerated. The next day, the horizontal deformation further accelerated when filling of the sand core with water started at noon, until failure occurred at 16:02h. The measurements show that continuous and consequent horizontal deformation occurs in the subsoil long before it can be observed visually at the surface.
