Building damage examples due to leakage at a deep excavation in Amsterdam

Mandy Korff^{1,2}, Robert J. Mair², A.Frits van Tol^{1,3}

¹ Deltares, ² Cambridge University, ³ Delft University of Technology

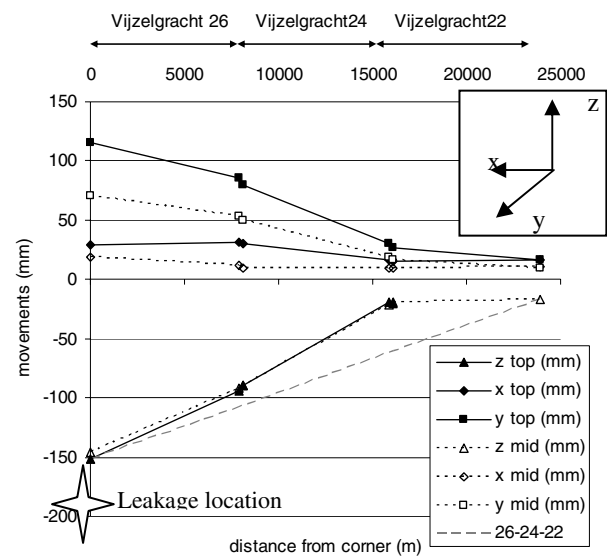
As shown in Figure 3, the block of houses Vijzelgracht 20-26 settled a maximum of 150 mm as a consequence of the incident in June 2008. The building clearly tilted towards the corner of VZG 26 and towards the excavation and the location of the leakage. Both houses 26 and 24 rotated towards the corner of the block. A slight sagging was found between VZG 26 and VZG 24 and hogging towards VZG 22. The cracks on the inside and outside of the buildings were recorded and are shown in

Figure 3 Deformations after incident June 2008 (measurements dated July, 31st 2008)

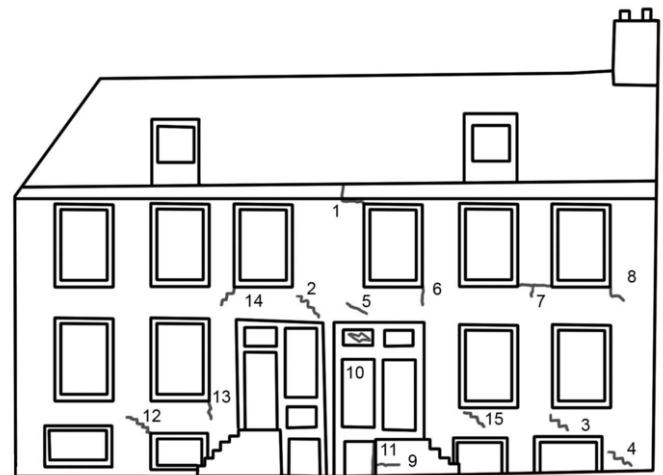
Figure 4 Cracks at the front façade (26 on the left side, 24 on the right)

Cracks 1 to 4 were found on the outside of number 24 and have a crack width of respectively 20 mm, 10 mm, 8mm and 8mm. Cracks 5 to 9 were found on the inside and are smaller than 5 mm. A cracked window was found at number 10. Number 11 is a crack out of plane of the drawing, separating the staircase from the house. Cracks 12 to 14 were found on the outside of number 26 and have crack widths of 2 mm, 7 mm and 2 mm. The location and direction of the cracks indicate a shear deformation with the largest crack width mainly in VZG 24, just as the differential settlements indicate. Cracks at the rear are not shown, but would indicate a twist movement of the building and horizontal extension. Since there are no deformation measurements of the rear façade, these can not be related to the crack directions.

It can be concluded that the damage to the façade is mainly caused by shear deformation and horizontal extension in the plane of the wall. The damage categories found comply well with the actual damage. Damage to the buildings as a whole is especially severe in terms of serviceability due to the overall rotation of the building perpendicular to the façades. Severe sloping and tilting of floors and walls are clearly noticeable and separation of the rear façade from both the main house and the kitchen addition is caused by horizontal extension. Although these could not be calculated because measurements were not taken at the rear, these effects are not easily described in terms of 'traditional' damage criteria.

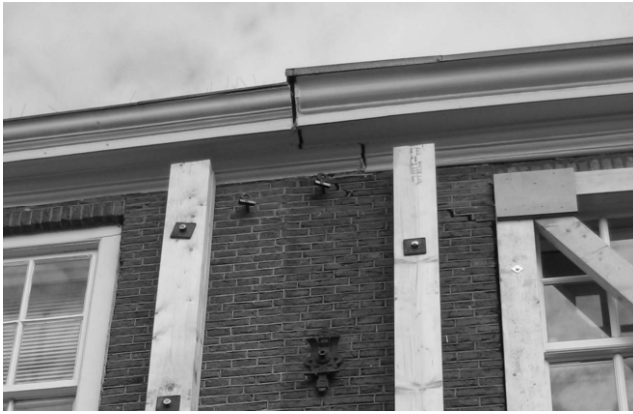
Figure 5 Detail of crack number 1 (crack width max. 20 mm)

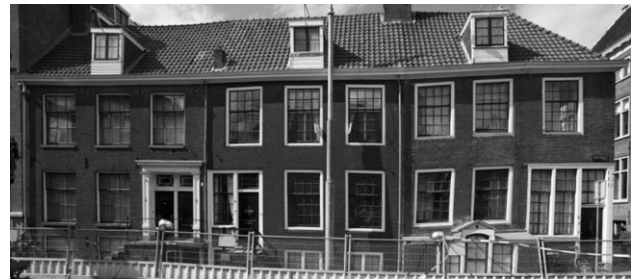
Figure 6 Vijzelgracht 8-6-4 after the incident

The damage clearly evident from the observations for these buildings (VZG4-8) is category 5, very severe. This is associated mainly with the sloping of the floors and walls and the separation of the different houses from each other, resulting in severe serviceability problems. The stability of the buildings was also in question, so the buildings have been temporarily braced by wooden supports.

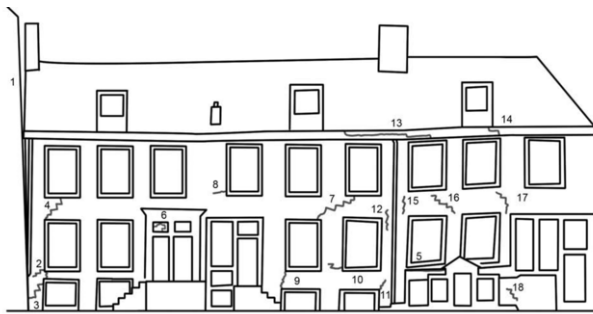
All cracks shown in Figure 7 are on the outside, because the inside was not surveyed. Crack 1 is a separation crack of about 60mm at the top, due to tilt between VZG 10 and 8. Crack widths in the masonry facades itself are generally up to 25 mm wide.

Figure 7 Cracks at the front façade VZG 8 - 6 - 4

The cracks and deformations show that the houses deformed partly in hogging mode (VZG 8-6) and partly in sagging mode (VZG 6-4), with the largest differential settlement found between house numbers 4 and 6. The diagonal direction of the cracks indicates a shear deformation. Both the hogging and sagging mode are consistent with the direction of the cracks.

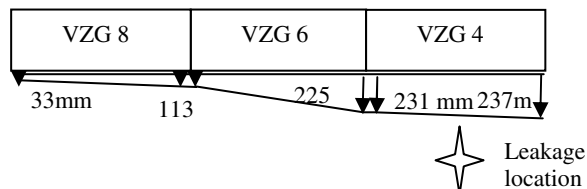
Block Vijzelgracht 4-10 settled a maximum of 240 mm directly after the leakage incident. To some extent damage was already present before the leakage occurred, such as the distorted windows. Figures 7 and 9 focus on new cracks and cracks that re-opened.

Figure 8 Vertical deformations after incident September 2008 (measurements dated 29th October 2008)

The maximum slope of VZG4 perpendicular to the Vijzelgracht is roughly $235 \text{ mm}/9 \text{ m} = 0.026$ or 1:38. Parallel to the Vijzelgracht the maximum slope is also extremely large, being 1:70 over Vijzelgracht 6. Vijzelgracht 10 did not experience much damage, its slope not exceeding 1:550. The deflection ratio in hogging is $\Delta/L = 71 \text{ mm} / 16 \text{ m} = 0.45\%$ and

in sagging $\Delta/L = 187 \text{ mm} / 15 \text{ m} = 1.2\%$. The average amount of horizontal extension is $31 \text{ mm}/32 \text{ m} = 0.1\%$. Combining these according to Mair et al (1996), assuming a central point load, the principal strains become 0.6% for hogging and 0.19% for sagging, both resulting in the damage category severe to very severe.

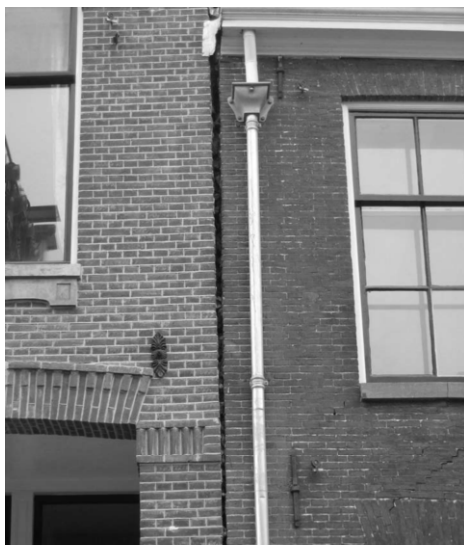
Figure 9. Detail of crack 1 between Vijzelgracht 10 and 8
