Foundation improvement for a building on loess soil

M. Mulabdic & K. Minazek
University in Osijek, Croatia

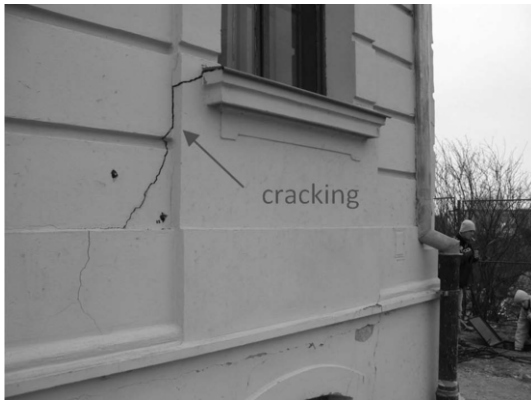
Few years after the war reconstruction (1998), some cracks had been noticed on the building. In the period between 2002-2006 the cracking progressed, regarding both the number and width of cracks throughout the object. The structure was built of massive masonry and was sensitive to settlement. In the early phase of cracking, the settlements of the object was recognized as a main cause for crack formations. There was a concern for a student's safety. The extensive exploratory works, observations and geotechnical measurements on the object and its surroundings were conducted in order to determine the exact cause of the problems. Intention was to identify the regions affected by yielding and to suggest remediation methods. The cracks and their tendency to change in width were constantly monitored so that in case of a sudden crack development the object could be closed for public use. The cracks developed on the facade and within the object are shown in the Figure 2 and Figure 3.

Figure 2. Crackings in facade.

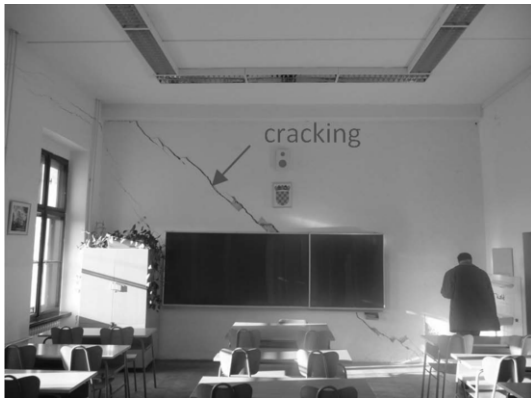
Figure 3. Crackings in one of the classrooms.

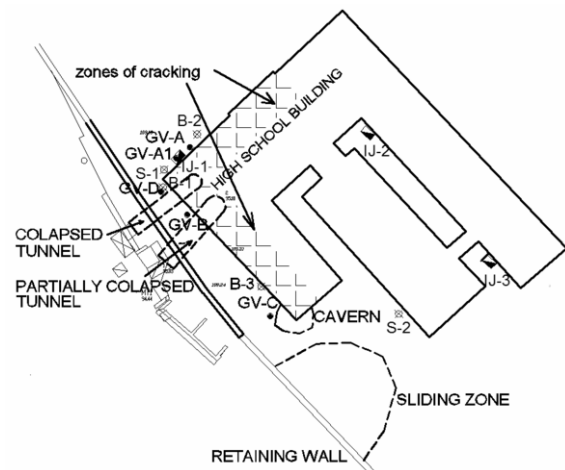
Figure 4. Disposition of boreholes, inclinometer and deformer holes, along the area of the building (boreholes: B-1, B-2, B-3, S-1, S-2, IJ-1, IJ-2, IJ-3, deformers: GV-A, GV-B, GV-D, inclinometers: GV-C, GV-D).

The exploration works have revealed the zone of increased moisture content in the soil right beneath the foundation, to the depth between 9 – 11 meters. This fact provoked collapse of the loess structure, which has been confirmed by the oedometer tests. Wetting and softening of the foundation soil did not affect the whole object equally, and the most affected area was the south-eastern part of the object under which there were tunnels (Figure 4, shaded area).

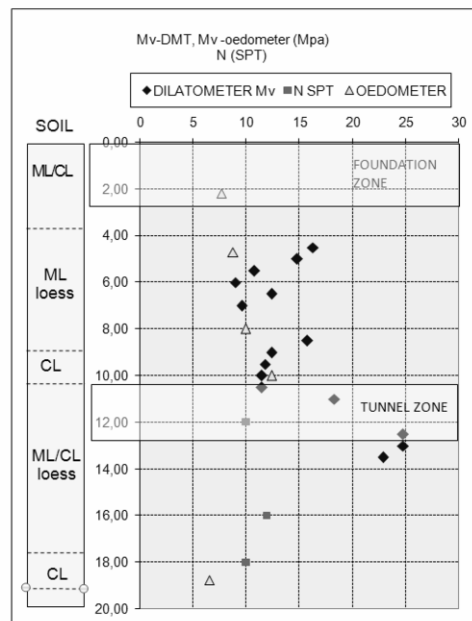
Figure 5. Soil profile and modulus of vertical deformation.

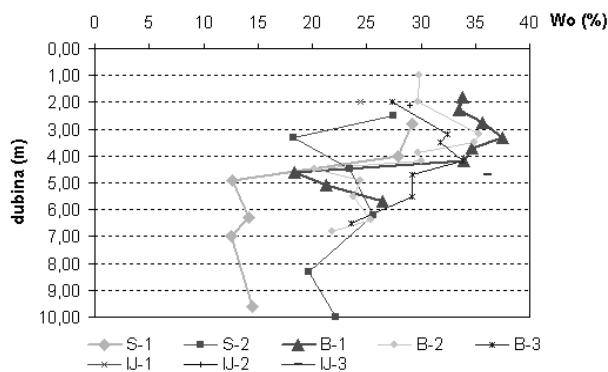
shows the soil profile, and in the Figure 6 the increase of moisture content with depth as a result of precipitation water coming from the conduit system is presented.

Figure 6. Moisture content versus depth for boreholes B-1, B-2 and B-3 from year 2006, and S-1, S-2 I S-3, IJ-1, IJ-2, IJ-3 from year 1998 (position - see Figure 4).

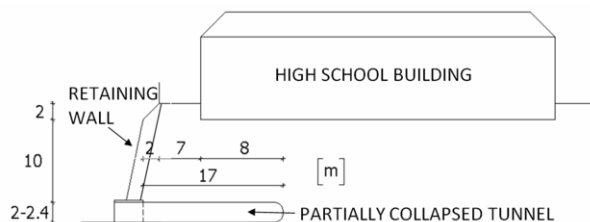
The tunnel vaults under the building (see the cross-section presented in the Figure 7) made of loess became wet because the tunnel served as a drain for the excess water in the soil. Gradually they started to collapse causing the additional soil settlement under the structure. It was therefore decided to fill the tunnels with concrete.

Figure 7. Schematic cross-section of highschool building with position of collapsed tunnels.

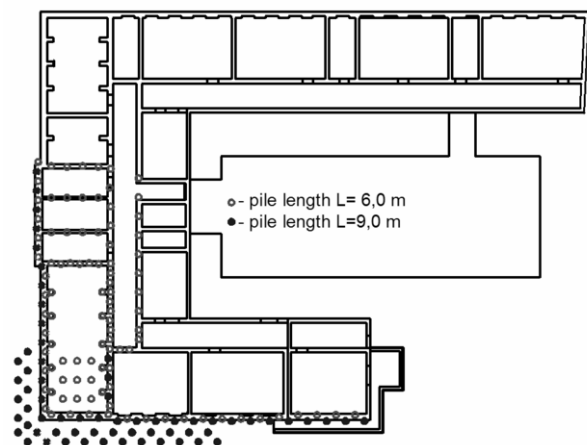
Figure 8. Disposition of piles under footings.

Jet-grouting was the key procedure in the foundation remediation. The area of softened soil was improved by jet-grouting with columns of 60 cm in diameter, to the depth of 6 or 9 meters under the foundation (the foundation depth was cca 2m under the ground surface). The plan view arrangement of jet grouting columns can be seen in the Figure 8. The typical jet-grouted column cross-section for foundation underpinning is shown in the Figure 10. Since the soil in the remediation zone was composed of loess, which is water sensitive, compressed air was used in the jet-grouting preparation procedure (soil cutting). Water was used only to a minimal needed amount in the grout mixture. In order to assure most suitable grouting technique a trial columns of jet-grouting were executed, aside from the object, using different pressures, direction of jet and time of jet action in place. Three different methods were tested and six test columns were made, the two for each grouting procedure. Each method was evaluated by testing the strength of the column core, by means of soil improvement rate determined with SASW method (before and after the test field was made) and on

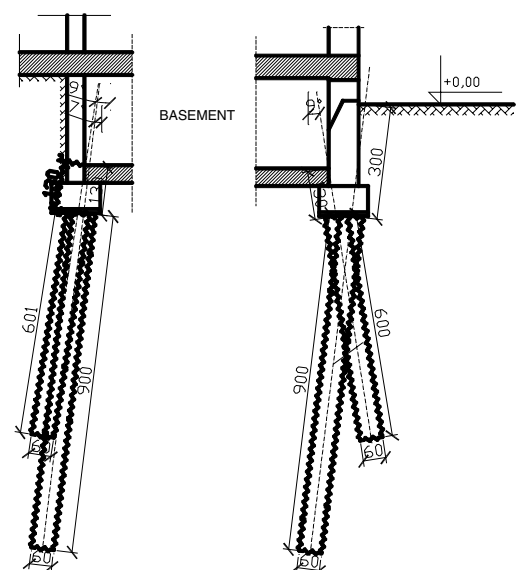
Figure 9. Typical cross sections of foundation with pile positioning and dimensions.

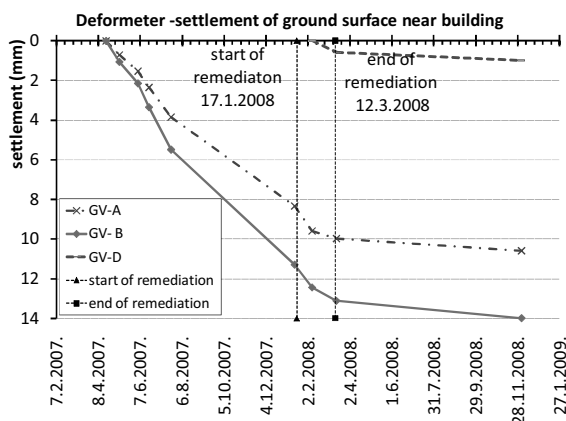
The settlements in the Figure 10 show the increase in the phase of strengthening of the jet-grouted columns and taking load structure, but with the smaller increase than before the remediation. After the grouted columns had strengthened and, after a new static foundation system was formed, the settlements started to slow down until they finally stabilized.

The observation system (cracks, geodetic points, sliding deformer, inclinometer) was used for monitoring the remediation effects and for checking the state of movements a year after the remediation. After the remediation works by soil improvement all indicators measured showed the decreasing tendency, which can be seen in the Figure 10 from the settlement data obtained by a sliding deformer.

Figure 10. Deformer measured settlements of ground surface close to building.
