Ground improvement under historical buildings: a case history

R. Passalacqua

Dep.t of Civil, Environmental & Architectural Eng.g (DICAT) – University of Genoa -Italy

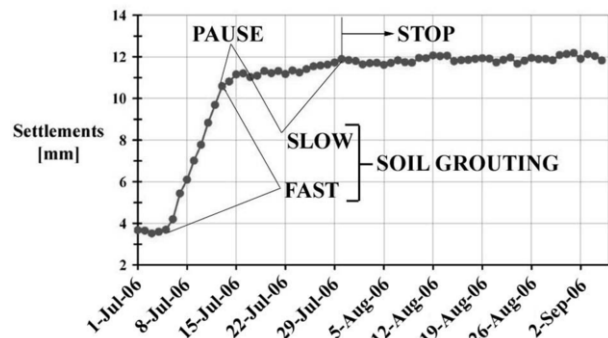
Electrolytic-Pot line nr. 3: Gavotti Palace's facing wall

The grouting-liners were installed on the first week of July 2006 then, after one week from the injections' start (July the 5th), four of them were completed. On the 13th of July the soil grouting was interrupted, because the leveling system showed a steep gradient of the Palace's settling which, as remarked in the following figure 2, gained a dangerous 7 mm increment.

Having at the moment no alternatives and observing that after a five days suspension the settling faded, a lesser aggressive grouting phase was restarted, hence, other nine liners were injected up to a mean 60% of their completion.

Figure 2. The sudden rise and evolutions of the Palace's settlements, retrieved during the soil grouting sequences applied, by a water-cement mix injections, underneath its foundation's level.

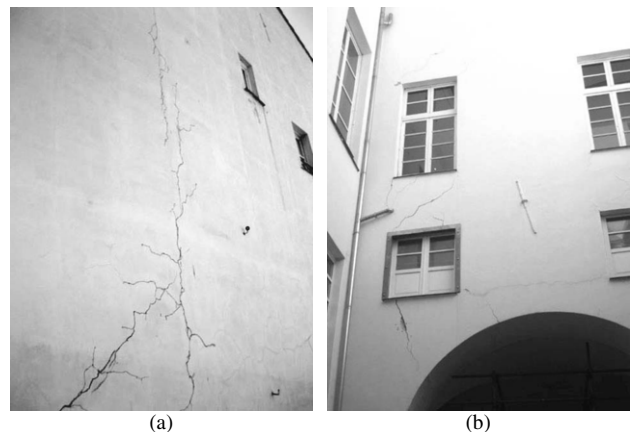
In fact, having the local settlement now reached well over than one centimeter, Gavotti Palace suffered a damagement which spread widely, as happens in structures such alike, diffusing from the perimetrical masonry wall to the inner ones, passing through a multitude of arch ribs and slabs, of barrel and groined vaults (see Fig. 3).

Figure 3. Some examples of the cracks' propagation on Gavotti Palace: along the masonry wall which borders the erecting yard (a), over one of the inner court's façades (b).

What happened during the attempted grouting is, most probably, due to a combination of effects. On the Author's opinion, the main issue is here connected to the long setting time of a Portland cement based grout; accelerators may be added in this case, such as calcium chloride, soluble carbonates, silicates or triethanolamine, to reduce sensibly the setting time but, at most, it never falls below than some hours, because lubricants are always mixed in to improve the grout pumpability and these substances, in the classes of fly ashes or rock flours, act also as retarders (U.S.A. – D.o.D. 2004).

When the injection pressure (here applied from 0.4 up to 5 MPa) is released, at the end of a staged grouting, an expanded and stressed cavity is left in place, just filled by the injected volume; but, this local pressure let gradually go as a consequence of the grout seepage through these soils, thus allowing the shrinkage (or the eventual collapse) of a “deflating” soil cavity where, in effect, is a mix which will stay in a liquid state for hours.

A soil improvement project was immediately planned, to be applied under the Gavotti Palace's foundation by following the operative procedures just established in the second test pit. In the sake of an extreme synthesis, it consisted in forming two vertically grouted screens down to the clay, made along two alignments flanking the Palace's wall on either the yard and the arcaded walkway sides; the screens shall have to confine the subsequent groutings, slant-diffused directly below the existing foundation to improve the mechanical behavior of all its loose-soil bedding. Nine CH borings were set up along the full contour of the Palace's foundation and, by them, the chemical grouting would have to be checked.

In addition, it was planned to modify the original layout of the sheet-piles, by deviating its bordering line farther from the Palace's wall and, just to stay on a safer side, the casings had also to be left in place.

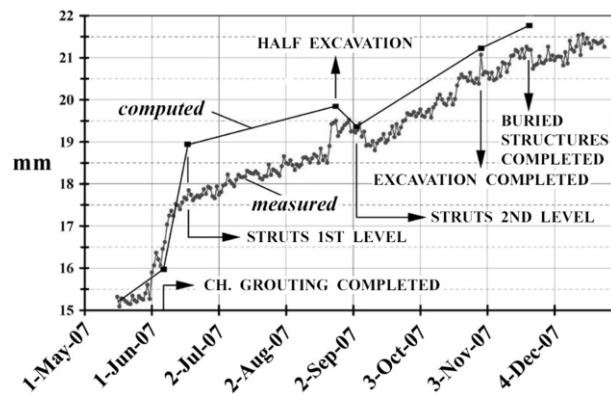
The vertical settlements of the Palace's foundation are shown in figure 5, both the computed and the measured ones, as they evolved during the staged construction; the comparison show a good agreement, even if the FEM simulation overestimated on the first stages: most probably, the chemical groutings had been better than expected.

It musty be finally observed that the full-front excavation, down to 9 meters below GL, caused a settlement of no more than 6 millimeters and, on the contrary, with the suspended first tentative of grouting alone 7 millimeters where surmounted.

Figure 5. Gavotti Palace's vertical settlements comparisons, as measured on-site by the leveling system (jagged lines) and as computed by the FEM analysis (straight lines).
