Remedial works on landslide in complex geological conditions

Ž. Arbanas

Č. Benac

M. Grošić

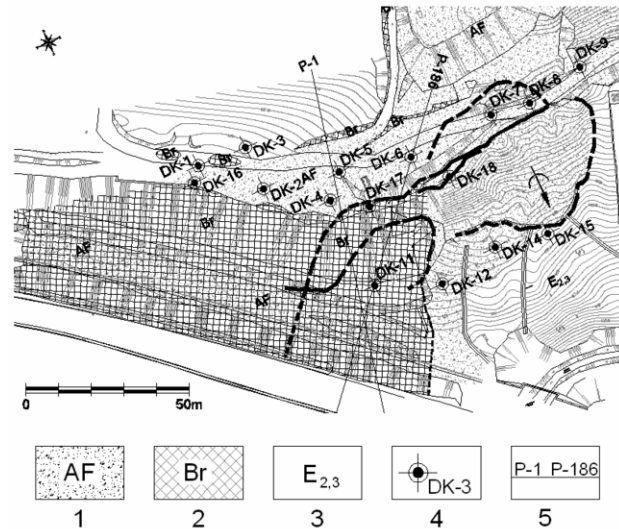
location of landslide. Geological surface mapping were updating the information obtained by field investigation, resulting with adequate geological map (Figure 1) so as geological cross-section to restore competent geotechnical model (Figure 2).

Figure 1. Schematic engineering-geological map of the landslide (1.Fill; 2.Breccia deposit; 3.Flysch deposit; 4.Borehole position; 5.Trace of cross-section).

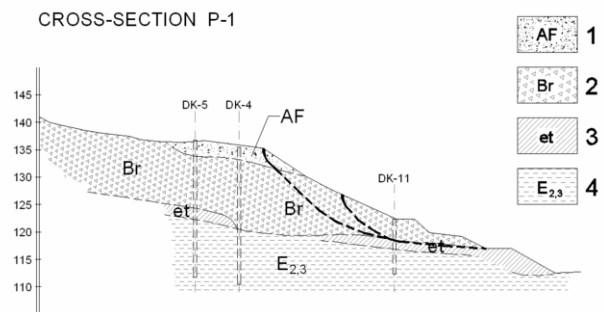
- Fill, anthropogenic mixture of clay, silt, sand and stone fragments so as waste buildings materials;
- Talus breccia, consist of limestone fragments <5 cm bonded with red colored clay, partially completely cemented, partially without binder;
- Flysch bedrock, predominantly consist of homogeny siltstone, yellow to grey to blue colored. The completely weathered zone (CW) of yellow colored siltstone is present on overall location. The moderately weathered (MW), slightly weathered (SW) to fresh siltstone (F) is presented deeper.

The thickness of different layers in geological cross-section significantly vary lateral without rules.

The presence of steady state of ground water was identified on overall location. Fill so s a talus breccia is layers with very high permeability but siltstone formation in the bedrock can be considered as watertight.

Figure 2. Geological cross-section P-1 (1.Fill; 2.Breccia deposit; 3.Weathered flysch zone; 4.Fresh flysch deposit).

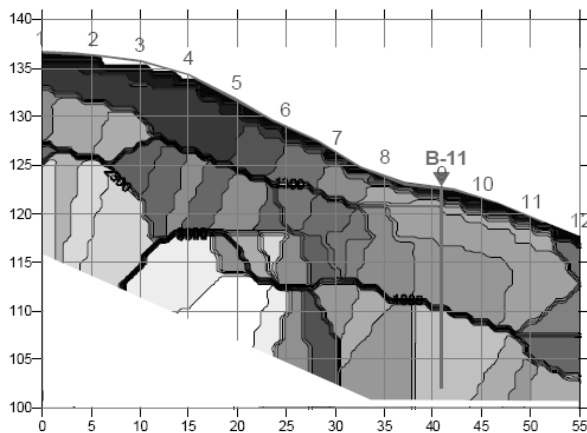
Because of irregular and uneven contact between breccia deposit and flysch bedrock the reconstruction of authentic cross-section was hard and based on results of geophysical measurements. The geophysical methods were especially helpful to identify contact between different layers so as the better bonded zone in breccia deposits (Figure 3).

Figure 3. Geophysical seismic refraction cross-section P-1.

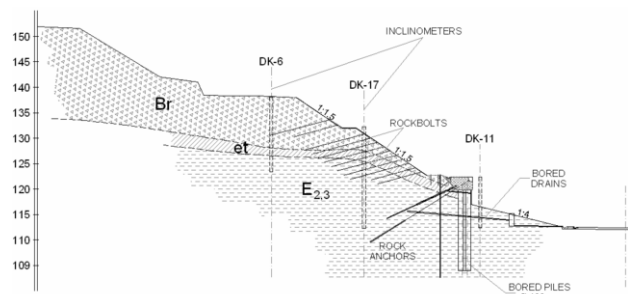
Figure 4. Cross-section of landslide with anchored pile-wall solution.

As an adequate support construction to ensure stability of the highway cut on landslide location the anchored pile-wall construction was chosen. The pile-wall is consisting of bored piles with 1.50 m diameters, length of 18 m, and 10 m bored in siltstone flysch bedrock below future toe of the cut. Pile-wall is connected with head beam anchored in the bedrock with prestressed anchors in the head of each pile. Capacity of anchors was 1000 kN, 25 to 38 m long with 10 m long bond section in siltstone (Figure 4, 5). Between piles in the pile-wall the selfboring drains were performed to ensure lowering of ground water level. To reinforce the upper part of the slope, the rockbolting was used with applied shotcrete structure on the face to prevent possible erosion processes.

To confirm this solution, the stability analyses were performed. The analyses were performed using parameters of rock masses in geotechnical model obtained from back analyses so as usual values for support construction.

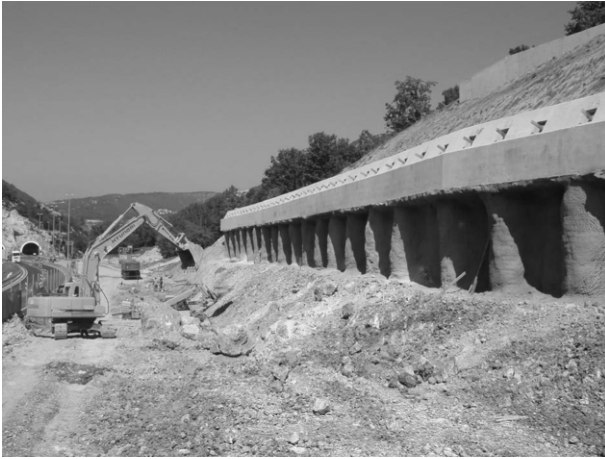
Figure 5. Photo of pile-wall during construction.

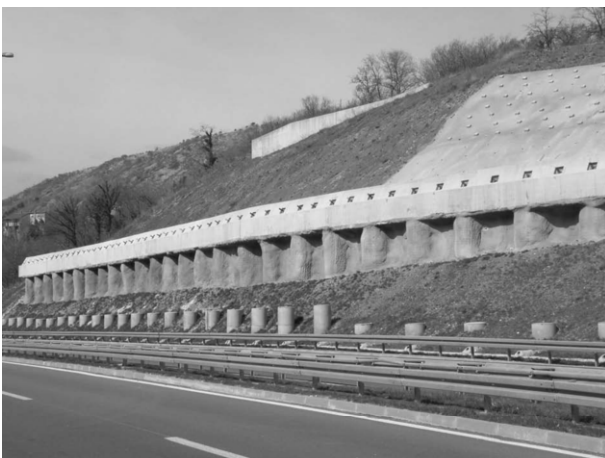
Figure 6. Photo of pile-wall construction in the toe of the landslide.

During the pile-wall construction a monitoring system based on observational method (Nicholson et al. 1999; Kovačević 2003) was established. The monitoring system included measuring of deformation in deformeters and inclinometers, ground water level in piezometers and geodetic surveying. The measured data enabled the control stress-strain back analysis. Based on the results of these back analysis an active design procedure was established (Arbanas 2004; Kovačević 2003) which made possible the required changes in the support construction in cut if the observations indicates on unacceptable deformations. Measured strains on installed measurement equipment showed a good match with the predicted calculated strains and construction was successfully finished in the spring 2007 (Figure 6).
