# Safety appraisal and rehabilitation of a quay wall

C. Valore & M. Ziccarelli

Department of Structural and Geotechnical Engineering, University of Palermo, Italy  
[calogerovalore@tiscali.it](mailto:calogerovalore@tiscali.it)

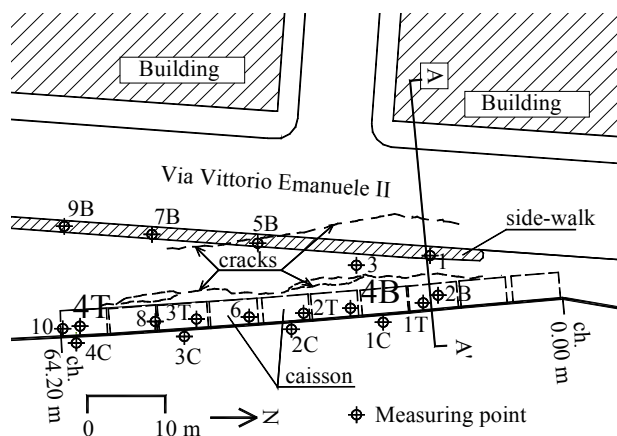
Fig. 2. Schematic plan of Colapesce Quay and location of measuring points for monitoring movements of caissons.

Some well developed tension cracks, almost parallel to the wall edge, were detected on the surface of the backfill behind the quay wall (Fig. 2).

The cracks showed vertical offset of a few centimeters and were approximately located within the active wedge; depressions up to 150 mm deep were also noted on the surface of backfill.

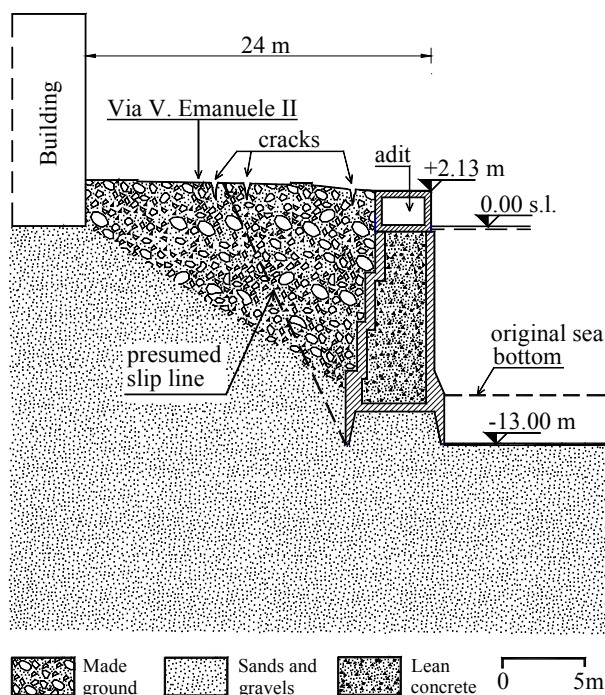
The crest elevation of the wall is 2.13 m above mean sea level. The depth of the sea floor in front of the wall was originally 10m below m. s. l., while it was found at 13m below m. s. l. in 2000, when investigations were carried out.

Fig. 3. Schematic cross section A-A' of the quay wall, foundation soils and backfill material and backfill surface.

The maximum horizontal projection of the upper edge of the caisson out of the perpendicular was 200 mm, corresponding to an outward rotation of  $\arctg(200/1500) = 0.76^\circ$ , which results in fairly good agreement with the criteria for the attainment of active state (Terzaghi, 1934 and 1936; Clough and Duncan, 1991).

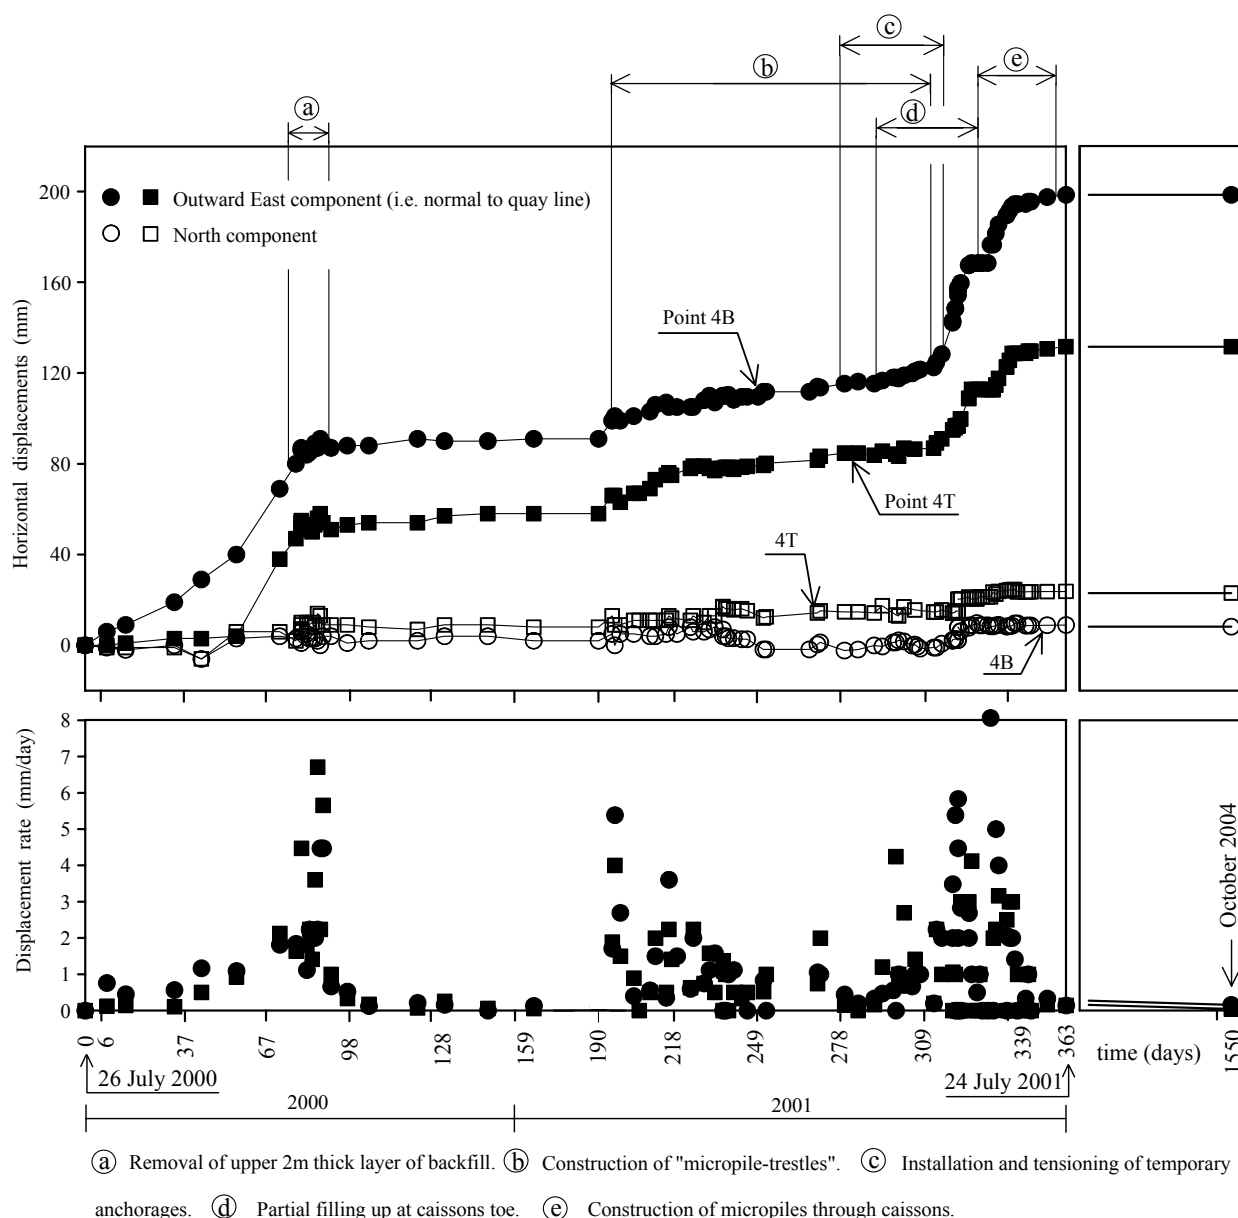
Fig. 4. Typical results of the survey of horizontal displacement of measuring points located on the crest of caissons in relation to stabilisation actions carried out.

Data plotted in Fig. 4 show that moving equipment near to the quay wall during installation of temporary anchors and the placement (from the crest of the wall) of filling material at the toe of the caissons caused resumption of horizontal movement, which, however, became almost imperceptible when the causative operation ceased. Movement was resumed again during the very initial phase of the installation of micropiles

through caissons. One of the anchor was instrumented with a load cell; the tensile force evolved from 19.6 kN (2 t) up to 176.5 kN (18 t) during the execution of works. Movements of the wall slowed down and stopped after the completion of corrective works.

The choice of stabilisation actions in the case under discussion was considerably restricted due to serious concern for possible adverse effects on stability of moving the construction equipment necessary for carrying out the corrective measures themselves. A preliminary "first-aid" intervention was eventually deemed indispensable, and this consisted in the removal of the upper 2m thick layer of the backfill. This measure proved effective in slowing down the rate of horizontal displacement, as can be inferred from Fig. 4.

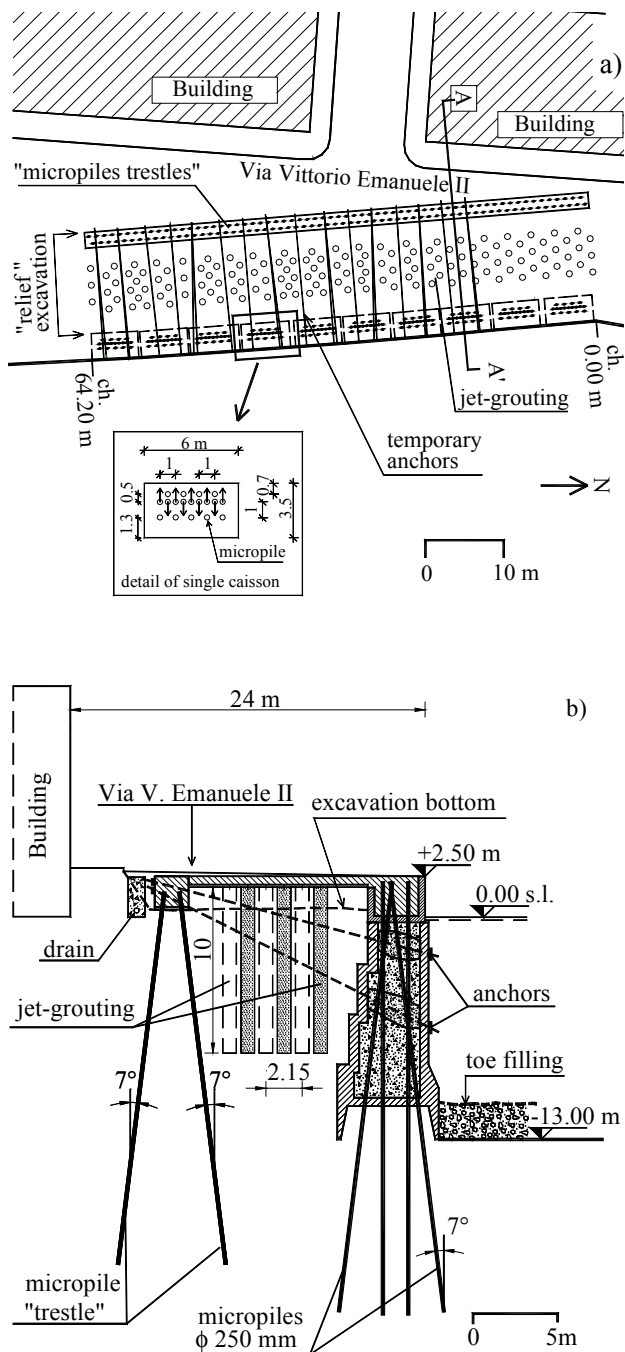
Fig. 5. Stabilisation measures. a) Planimetric layout; b) Vertical cross section A-A'.

Subsequently, definitive stabilisation works were carried out according to a sequence aiming to reduce, as far as possible, the risk of overturning of the structure during the execution of the works. The corrective measures were implemented according to the following sequence (Fig. 5).

1 Construction of micropile "trestle" structure capped by a reinforced concrete beam, capable of withstanding horizontal loads. 2 Toe loading of the quay wall. 3 Temporary anchoring

of the quay wall to the trestle structure. 4 Jet-grouting of the backfill. 5 Injection of cement grout in the cavities at the base of caissons. 6 Installation of micropiles through the quay wall down to foundation ground. 7 Construction of a reinforced concrete slab connecting the head of the quay wall to the "trestle structure", capable of transmitting tensile forces. 8 Placement of ballasted woven-non-woven protective mat at the toe of quay wall, against soil erosion. 9 Construction of a shallow drainage adit to avoid possible raising of groundwater table – as a consequence of the treatments of the ground (injections, jet-grouting) – which might adversely affect existing nearby buildings.

Micropiles were reinforced with steel tubes (outer diameter 139.7 mm, thickness 14.2 mm). Features of anchors were: total length 16.70-18.20 m; free length 13.00-13.50 m, ample enough for avoiding excessive overstressing as a consequence of anticipated outward movement of caissons; fixed length injected inside the caissons after placement of inflatable packer bags; two-strands tendon; steel bearing plates placed underwater on

the caisson outer wall and on the landward side of the trestle structure; initial stressing force 19.6 kN (2 metric tons).
