## Failure of peat dikes in The Netherlands Rupture de digues en tourbe aux Pays Bas

Adam Bezuijen, Gerard A.M. Kruse & Meindert A. Van

*GeoDelft Delft, The Netherlands*

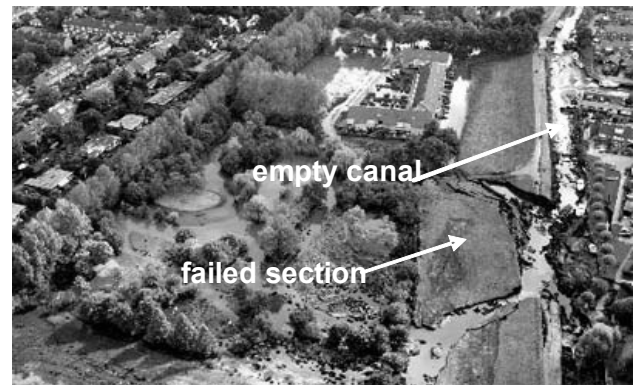
Figure 1: Failed canal dike at Wilnis, August 2004.

The failures consisted of coherent horizontal translation of about 6 m over a 60 m stretch at Wilnis, and a few meters at Rotterdam over a width of tens of meters. Vertical displacement was less than a few decimeters. At Wilnis, a planar horizontal basal sliding plane was reconstructed from borehole and excavation data and located to have been at the base of the peat, i.e. at the top of the sand. The failed slices at both locations were bound laterally by major linear fractures oriented outward at angles smaller than  $45^\circ$ , indicating the wedge to have been pushed by a force from the canal. Displacement of the slice was accommodated in part by filling a ditch and, mainly, in a subsequent upthrust over the existing terrain surface. The movement of the toe and part of the failed slice at the Rotterdam location was accommodated by surficial folding without significant

thrusts. Only a small part of the lateral bounds of the failure was found to have been influenced by terrain features. At the Rotterdam location shrubs and small trees had moved with the sliding mass. At Wilnis a tall poplar tree at the toe of the slide had remained in place with its roots firmly anchored in the underlying sand, cutting the about 4 m thick sliding peat and clay mass.

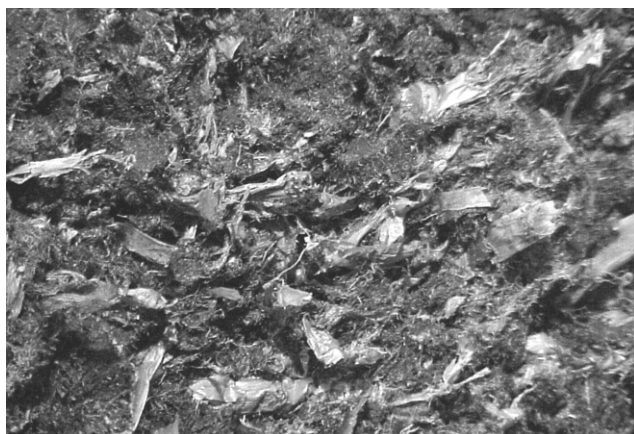
Figure 2: Close up (width of view 3 cm) of the reed peat forming the larger part of the failed dike sections.

The archetypal build up of the subsurface at the sites of the 2 failed dike sections is given in Table 1. Figure 2 shows details of the typical structure of reed peat forming a larger part of the failed sections. Most larger fragments are oriented horizontally, resulting in a marked anisotropy. Vertical stem and root elements, however, can extend over several decimeters thickness, which, with the hollow stem and root structure, results in the omnipresence of vertical shortcuts for gas and water transport in

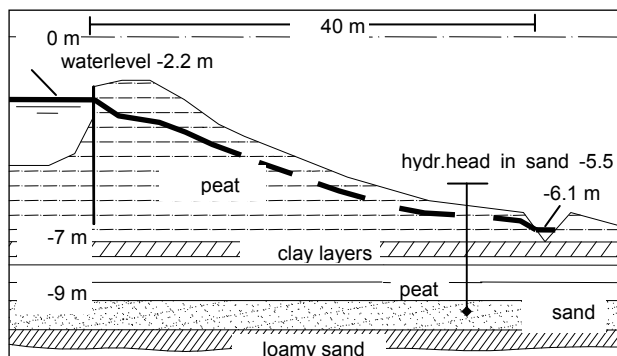
The illustration in Figure 3 provides an overview of the piezometric levels, build up and geometry of the dike, canal and terrain at Wilnis before failure. Here, some characteristics of the 2 locations are given, which influence the hydrology of the dike, notably the unsaturated zone and piezometric head development at the base of the peat, and which may cause strength and stiffness anomalies.

The dike of the Wilnis location has a grassland cover. A sheet pile wall with board lengths up to 4.5 m, had been placed along the canal about a decade ago for bank protection. Maintenance dredging of the canal to a water depth of about 2 m was carried out 1 year before the failure. A wide ditch drained the

Figure 3: Cross section with relevant geometry specifics for the Wilnis location

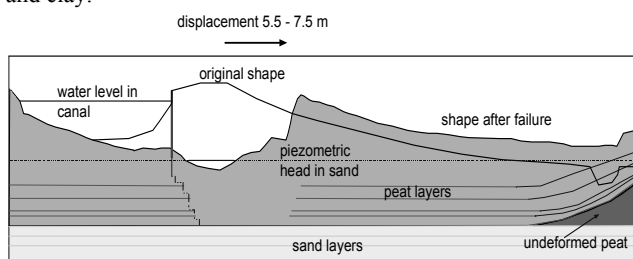
Figure 4: Embankment geometry before and after the failure at Wilnis. The various layer boundaries in the subsurface are indicated after failure, as well as the original water level in the canal and the piezometric head in the sand.

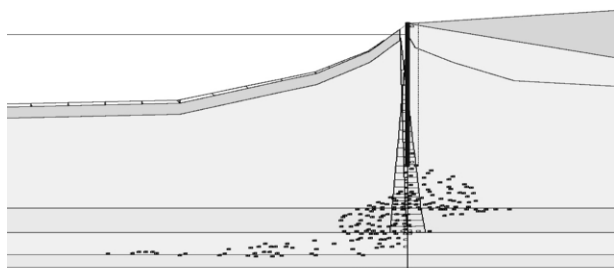
The sheet pile bank protection along the canal at Wilnis, locally piercing clay layers in the peat, had a major influence as came out of the initial hydrological analyses. The results from hydrological calculations incorporating leaks from the piles in the peat and clay layers made clear that the leaks had effect on

the head in the sand below the bulk of the dike. The leaks would have to extend deeper than the piles, however, and had to be wider than mere local millimeter cracks in order to cause the head in the sand to rise to a level causing loss of friction at the base of the peat. An investigation of the effects of water pressure in vertical cracks in peat showed the cracks to widen substantially upon pressure, due to the very low stiffness of the peat, and in spite of the peat not being very impervious (Figure 5). The resulting shear stresses at the tip of the water filled cracks in the peat were found sufficient to cause fracture expansion and growth. Thus penetration of the hydraulic head of the canal a few meters deep along the sheet piles in the peat would result in fracture propagation. Shrinkage of peat due to the dry weather conditions adversely affected stresses and deformation at the sheet pile wall. Increase in evaporation causes negative pore pressure, which induces shrinkage of peat below the already intensely fractured top layer, creating tensional stresses parallel to the dike surface over the depth of the zone experiencing negative pore pressure. The tensional stresses exert a pull on the peat at the sheet pile away from the canal (Figure 5), thus enhancing creation of space along the piles and adding some tensional stress at the tip of shallower cracks. It must be noted that horizontal fracture-like surfaces are widespread in the peat mass. The extent to which the sub horizontal stresses can be transferred across such rough planes was not investigated. These planes are known to be conduits for water in peat, however, enabling high water pressures to be transferred efficiently through the peat mass. Fracturing of the peat mass by water pressure is therefore not limited to the tip of the initial leak.

Figure 5: Cross section of the canal and dike with sheet pile. The dots at the base of the pile indicate occurrence of plastic behaviour in calculations using a Mohr Coulomb model.
