# Failure of a hangar built in embankment on soft clay

Alexandre Duarte Gusmão

This paper presents the case of a hangar that was built in an embankment having 2000 m<sup>2</sup> and 6 m high. The subsoil is formed by a layer of organic clay and peat having 12 m of thickness. The hangar was constructed without knowing the bearing capacity and compressibility parameters of the clay under the embankment. The construction started with the ground being covered by a mixture of waste and remains of others constructions. A retaining wall of gabion was executed having 3 to 6 m of variable height in order to contain the embankment. During earthmoving operations, there was a slide in one corners of the ground and the soft clay and peat appeared upward. Several cracks were observed in the floor parallel to the retaining wall. Some fissures appeared in the masonry of the hangar. After some months later, the movement grew up accelerating and the complete ruin of the hangar occurred. The geotechnical characteristics of the clay deposit was made by borings (SPT), vane test and laboratory tests (oedometer and triaxial) in undisturbed Shelby samples. The results of this investigation are presented

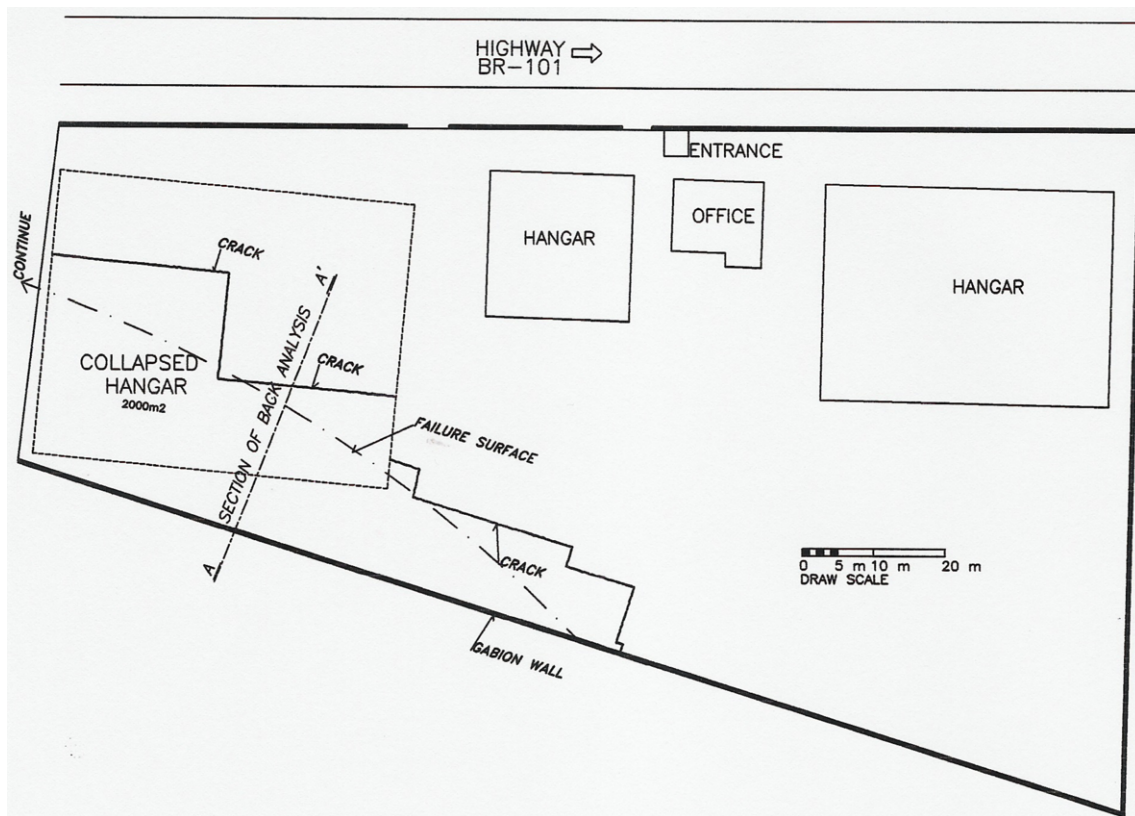
Figure 1 – Plan of the site with the failure surface.

The adopted section for the back analysis is shown in Figure 1. The beginning of the failure surface was defined by the opening joints in the hangar floor, and the final of the surface was admitted where the ground moved upward. The correction proposed by Bjerrum (1972) was considered and the correction factor is 1.0 because the plasticity index is 19%.

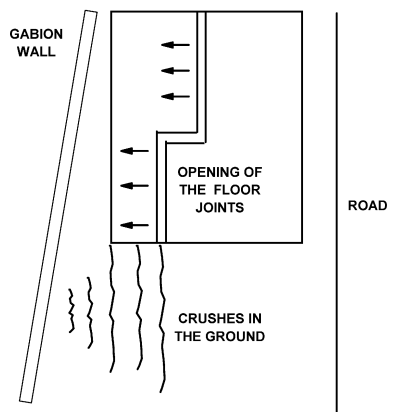
cracks started to appear on the ground parallel to the retaining wall since the beginning of the construction (Figure 2).

These lateral movements reflected on the structures showing cracks in the ground and openings of joints in the floor. The vertical movements from settlement caused fissures in the masonry when the columns settled.

Figure 2 – Horizontal movements of the ground before the ruin of the hangar.

With the damage diagnosis concluded, the consulting firm proposed two separate solutions. For the horizontal movement, it was recommended the construction of a berm in the lateral side of the area.

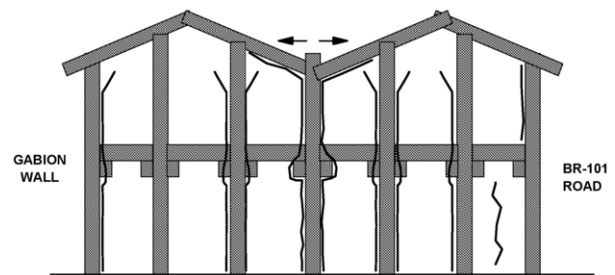
They have been closed immediately. Some fissures occurred in the masonry of the largest building that was situated next to the wall (Figure 3). There were also many openings of joints in the floor.

Figure 3 – Fissures occurred in the masonry of the hangar.

For the vertical movement, it was proposed to reinforce the foundations with steel piles.

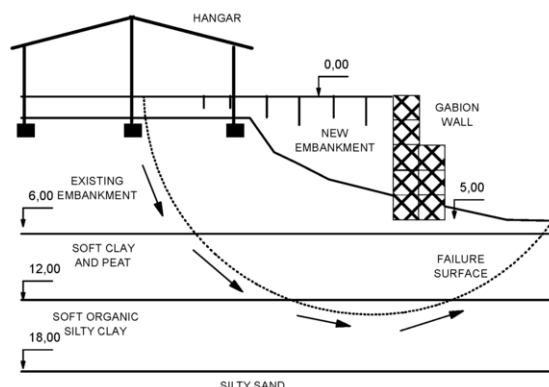
However the berm and the foundation reinforcement were not done and the movements grew every day. After some time later, there was an acceleration of the movement of the ground and the complete ruin of the hangar (Figure 4).

Figure 4 – Mechanism of the ruin of the hangar.

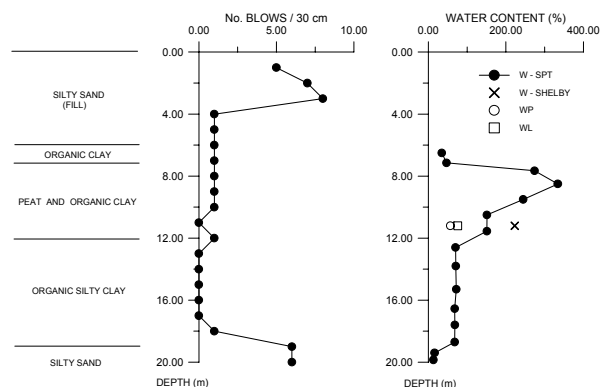
Figure 5 shows a typical subsoil profile obtained with boring (SPT), including the natural water content of the soils that was determined by SPT sampler.

It can be observed the existence of two sublayers with different geotechnical characteristics (7 to 12 m and 12 to 18 m). It is also observed that the water content obtained by SPT sampler is smaller than that obtained by shelby sampler.

Figure 5 – Profile of the subsoil with SPT and natural water content.

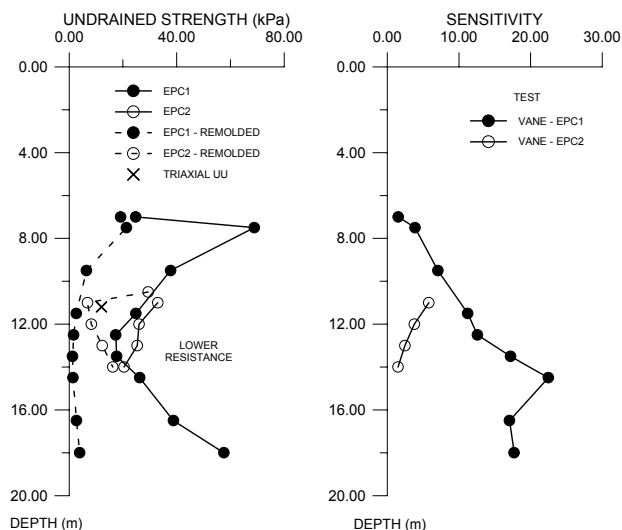
It is observed that the undrained strength in triaxial test UU has a value of 12 kPa that is below the value 33 kPa obtained by the vane test in the natural soil. However, it is very close to the vane test in the remolding soil (6.8 kPa after a large rotation in vane test). This proves that the laboratory samples were disturbed and their laboratory results should be used with special care. The effective angle of friction  $\phi'$  was found equal to  $15^\circ$  in CU test.

It is also noted that the deposit of soft soil presented a lower value of undrained strength around 12 to 14 m of depth ( $S_u = 20$  kPa). This indicates that the surface of rupture possibly passed at this depth. The result helped to have the back analysis of the problem with the stability of the fill to the bearing capacity of the maximum load.

Figure 6 – Strength parameters obtained by laboratory and vane tests.  
Table 1 – Compressibility parameters.

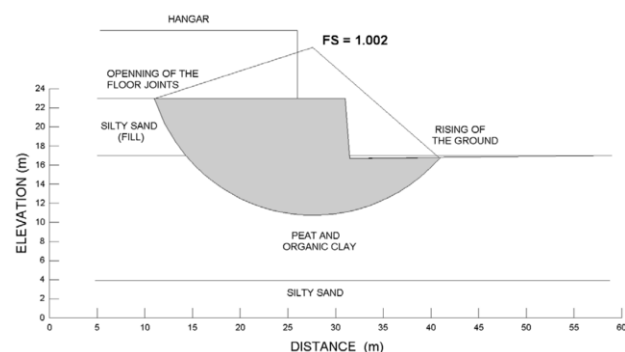
Table 2 shows the parameters used in the back analysis. Figure 7 shows that  $FS = 1$  and the circular surface passes at 12 m deep and it confirmed the vane test results, where it was noted a lower strength of the deposit at this depth.

This fact was explained with the history of the slide. After the first slide, the place was refilled to get leveling the floor. As a result, the place was submitted to a high loading without to offer an expressive increase in the bearing support of the soft soil. Then the fill collapsed sometime later.

Figure 7 – Failure surface obtained from back analysis.
