# Stability and safety assessment of the arch dam Foug Gleita in Mauritania

Y. Scheid & L. Schewe

*Lahmeyer International GmbH, Bad Vilbel, Germany*

The 20 years old arch dam Foug Gleita lies in the southern part of Mauritania on the river Gorgol Noir. The height of the dam is 45 m. Concerns of the Ministry for Rural Development and Environment of the Islamic Republic of Mauritania represented by the National Society for Rural Development (SONADER) on the safety of the habitants downstream and the long term provision of irrigation water from the reservoir led to a stability and safety assessment study. Results of the study are presented in this paper.

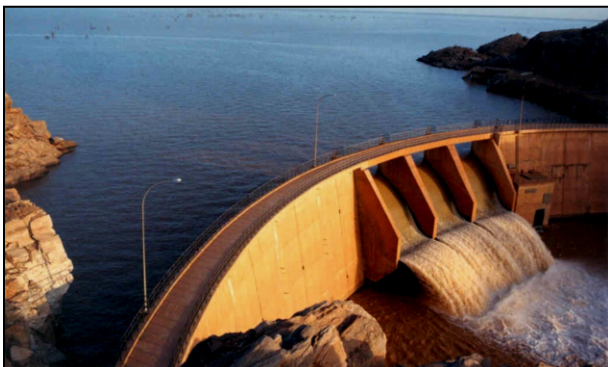
Figure 1. Foug Gleita arch dam

According to the conducted safety assessment programme the dam itself is in generally satisfying conditions for all concrete parts. Only some minor superficial cracks have to be treated.

A major crack in between the left abutment and the rock should be monitored.

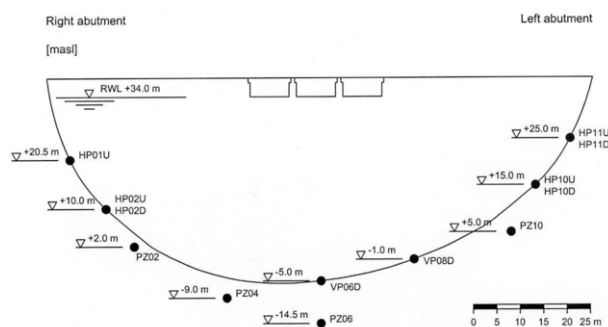
Figure 3. Selected monitoring instruments in the Fom Gleita dam

Figure 3 shows the location of the piezometers PZ02, PZ04, PZ06 and PZ10 below the dam foundation. The retention water level (rvl) of the dam is 34.0 masl.

PZ02 (+2.0 masl) is installed in the right abutment and 5 m below the dam foundation. This is equivalent to 32 m below retention water level. PZ10 (+10.0 masl) is installed in the left abutment 5 m below the dam foundation. The difference to the retention water level is 24 m. PZ04 (-9.0 masl) is installed in between the centre of the dam and the right abutment 5 m below the dam foundation. The difference to the retention water level is 43 m. PZ06 (-14.5 masl) is 10 m below the dam foundation installed in its centre. The difference to the retention water level is 48.5 m.

Figure 3 shows the position of the vertical pressure gauges VP06D and VP08D in the downstream foundation of the dam. Both gauges indicated almost constant values since implementation of the dam. Seasonal differences are low. VP06D in the lowest point of the foundation shows a value of 400 kN/m², while VP08D, downstream in the left abutment, designates a value of 800 kN/m². This distribution of stresses is characteristic with arch dams that redistribute forces to the abutments (Boggs et al., 1988 & U.S. Army Corps of Engineers, 1994).

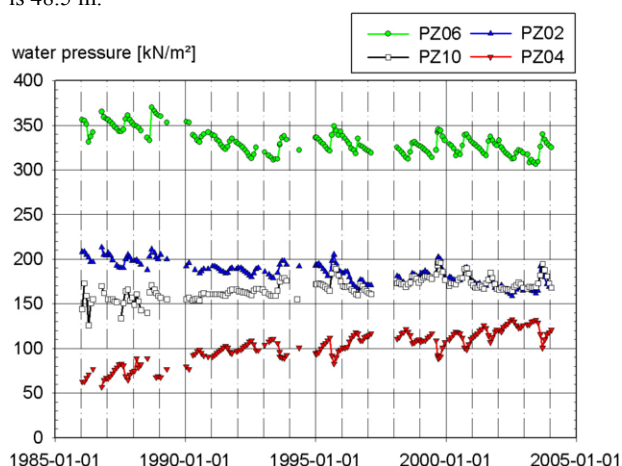
Figure 4. Piezometer readings since implementation

Figure 4 shows the readings of the four operational piezometers since implementation of the dam. Mostly, their pressure level agrees with their installation depth below water table.

PZ06 shows highest values. Seasonal variations correspond to the variations in water table.

PZ04 shows the lowest pressures, were higher values were expected. It is supposed that the high potential decrease occurs upstream of PZ04. While the three other piezometers showed an almost constant or decreasing piezometer head, pressure in PZ04 increases slowly since implementation time. The historical peak value reached in June 2003 was 132 kN/m². The medium value doubled from 60 kN/m² to 120 kN/m². The increase is most probably due to transportation of fines in joints. However, a regression analysis by the Consultant confirmed that the gradient is decreasing. An extrapolation to 2008 showed that a constant value slightly above of 120 kN/m².

The Consultant conducted a safety analyses that proved that none of the piezometers has reached critical uplift values. Until today the dam foundation is safe and sound.

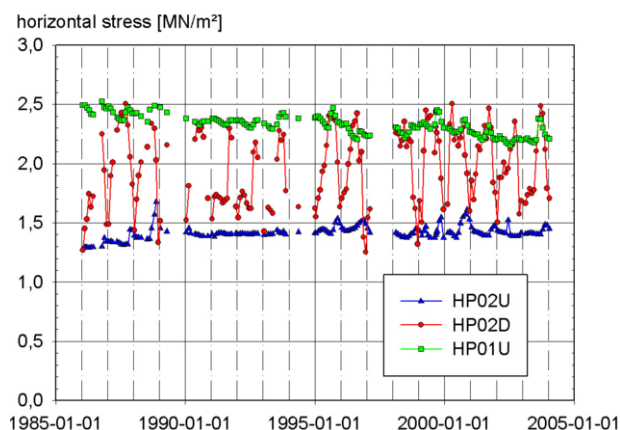
Figure 5. Horizontal normal stresses in the right abutment

Horizontal normal stresses in the upstream side of the right abutment are about 2.3 MN/m² at the level of +20.0 masl (HP01U) and 1.4 MN/m² at the level of +10.0 masl (HP02U) with only little seasonal variations (Figure 5). Downstream important seasonal variations were observed (HP02D). An explanation for this behaviour is that the seasonal deformation caused by varying reservoir tables has a higher impact on the downstream abutment. The maximum value in HP02D is reached after the hibernation, when the reservoir is full.

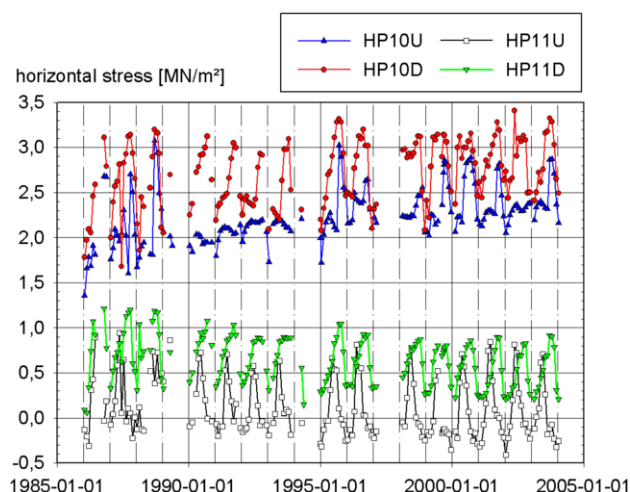
Figure 6. Horizontal normal stresses in the left abutment

The stress distribution in the left abutment (Figure 6) shows different behaviour. Stresses are higher in the lower pressure gauges (HP10U and HP10D) and seasonal variations in the upstream and downstream gauges more important than in the right abutment.

This is due to higher deformations in the left abutment. An explanation therefore is that the joints in the left abutment are oriented parallel to the normal forces. In the right abutment their orientation is perpendicular.

The average horizontal pressure on the left abutment at the level of +15.0 masl is 2.8 MN/m² upstream and 2.3 MN/m² downstream respectively.

Average horizontal pressure on the left abutment at the level of +25.0 masl is about 0 upstream and 0.5 MN/m<sup>2</sup> downstream respectively. The 0 at the upstream side at 25.0 masl could be interpreted as an alarming sign. Additionally, tension was measured seasonally. Nevertheless, since the filling of the reservoir this instrument indicated tension seasonally. The downstream instrument showed that contact was always assured.

These results are reassuring. Nevertheless, as mentioned, the Consultants identified a crack in the respective position. The proposed improved monitoring programme shall consider these findings.

- Continued recording of stresses, water pressures and water levels
- Periodical topographical survey of the dam to assess deformations
- Observation of the crack in the left abutment via installation of a fissure meter
