Strengthening the foundations of the main building of Tartu University, Estonia

K. Avellan

KAREG Consulting Engineers, Helsinki, Finland

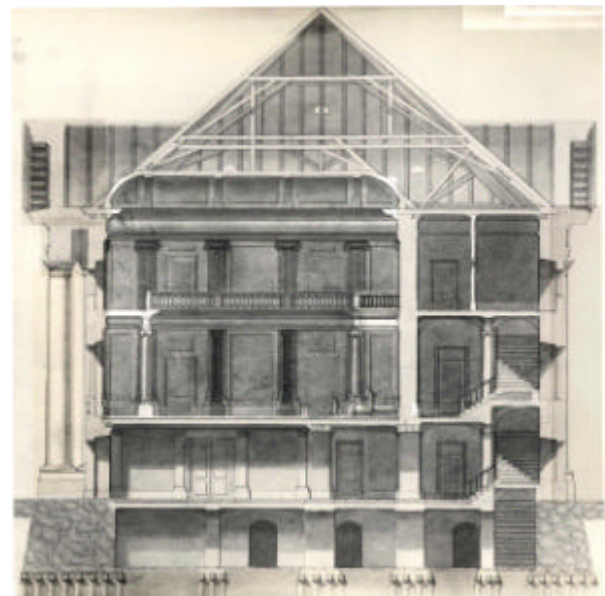
Figure 1. Historical section of the building.

Massive stones are set over two to three layers of timber rafts, which are supported on timber piles. The timber rafts stay at the level of about five meters below the street level. The basic soil is soft freshwater marl. The thickness of the marl layer varies from 3 to 5 m and the deformation modulus is about 2 MPa. Marl is laying on very dense layer of gravelly soil. The structures and the Dorian columns upon the foundation of the entrance wall are shown on the left side in the historical section of the building (Figure 1).

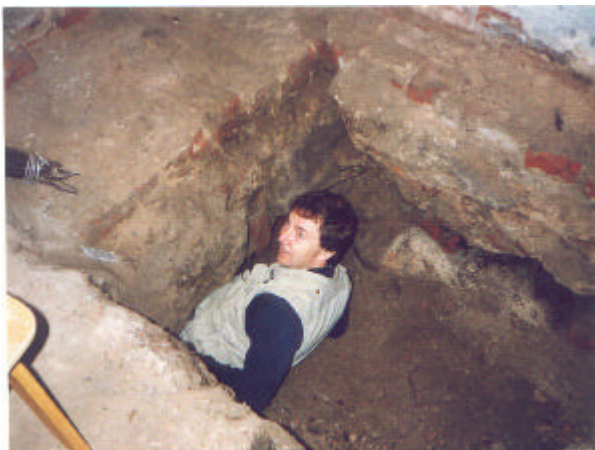
In early 1990's it was noticed that the situation under the center part of the building started to be critical. In pre-work archeological diggings the wooden rafts were in some places totally rotten leaving empty cavities at a place they used to be. To proof the situation of cavities, the main author of this paper was asked to be in situ under the foundation (Photograph 1). Especially the area of the main entrance needed immediate repair to prevent any serious damage of the building (Photograph 2).

Photograph 1. In situ proof under foundation.

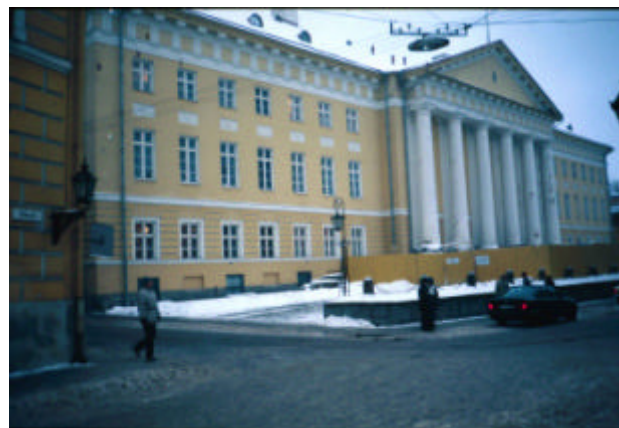
Photograph 2. The University building during the work in 1995.

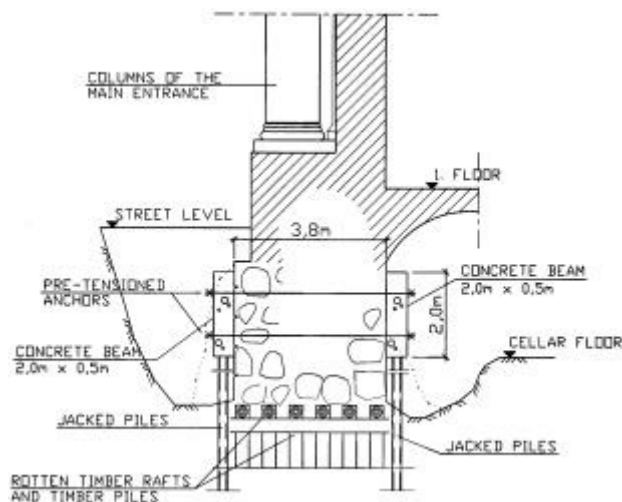
Figure 2. The principal of the work under the main entrance wall of the building.

The strengthening work in the area of the main entrance started by casting concrete beams $h \times b = 2.0 \times 0.5 \text{ m}^2$, both sides against the original stone and brick masonry of the cellar wall (Figure 2 and Photograph 3).

The stone and brick masonry wall of the main entrance was injected. Then reinforced concrete beams were cast and post-tensioned against the old structure.

Each post-tensioned anchorage consists of 7 plastic-sheathed greased strands (monostrand) SUP 1630/1860, $A_s = 140 \text{ mm}^2$.

At first stage the anchorage of seven wires was pulled to 1350 kN. Re-tightening of the anchorages were made nine months after original tensioning, to eliminate any fall in compressive force due to creep of the original masonry. At re-tightening, it was confirmed that each pre-stressed force of anchorage was at minimum 1050 kN as planned. At last the holes of the anchorages were injected with concrete mortar, and anchorage pieces were protected with concrete casting.

Jacked piles Ø 218 x 10 were made under the concrete beams of the external wall. Piles were filled with concrete. The permissible load for the piles was $P_w = 500$ kN and load test/end wedged action load was $P_t = 750$ kN. At both ends of the external wall were installed two jacked piles Ø 140 x 8. Before jacking the ends of the wall foundation, consisting of stone and brick masonry, was supported by concrete casting. At last, the steel wedges of the heads of the piles were covered with concrete casting to ensure long time resistance of the structure.

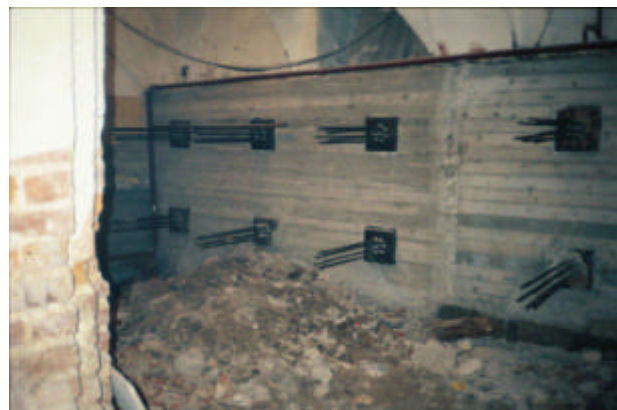
Photograph 3. Concrete beam $h \times b = 2,0 \times 0,5$ m² against the old cellar wall and pre-tensioned anchors.
