Restoration of foundation of northern library of Bayon temple, Angkor

Y. Iwasaki
 Geo-Research Institute, Japan

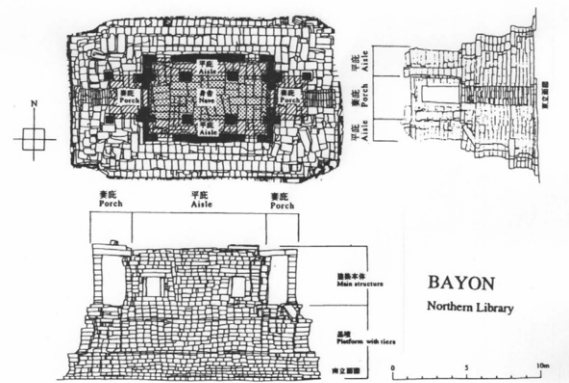
Figure 2. Northern Library, Bayon (H=9.5m, L=19m, W=11m)

gallerly called northern and southern library. The library is meant a structure to store books, however, so called a library in Angkor consists of masonry structure with open windows and is difficult to use as “library” practically. The word was used to refer the structure as symbolic measure. The northern library as shown in Fig.2 was found severely damaged at both of east and west ends and was decided to consolidate by JSA.

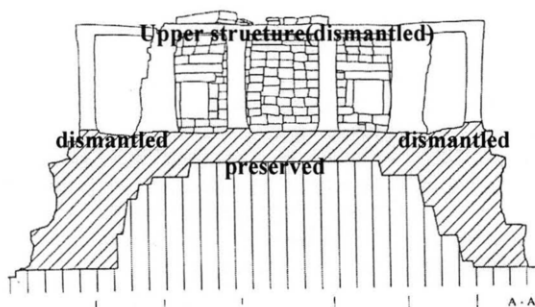
Figure 4. Dismantling portion of the northern library

Damaged parts are upper structure of stone masonry and east and west ends of the foundation. The dismantled part of the foundation is shown in Fig.4. During the dismantling process of foundation, the inside structure became to be exposed as shown in Fig.5.

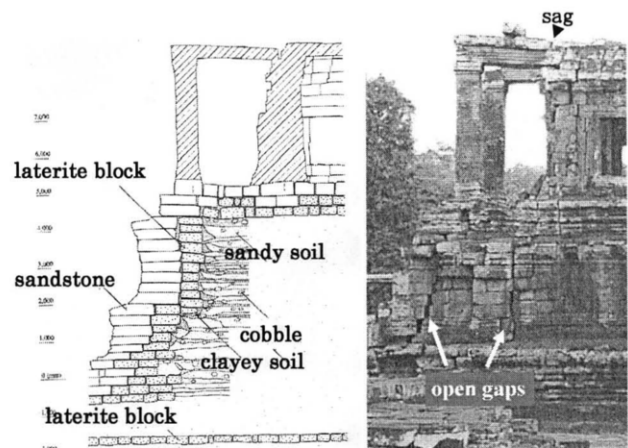
Figure 5. Inside and side look of west end of foundation

From the base to top of the foundation, Surface of the retaining wall of the foundation consists of sandstone blocks. Inside the sand stone, we found laterite blocks that protects compacted fill of about 5m in height. The fill consists basically find sand and clayey layers of sandwiched structure as shown in Fig.5.

As shown in Fig.5, open gaps were recognized between sand-stones blocks continuously. However, no clear slide surface was identified inside the fill, it was estimated that horizontal outward displacement of the foundation fill without any specified slide surface m

ay be major reason for the open gaps. Sag at the roof may be due to local settlement at the top surface of the foundation fill. Plate loading test was performed on the dismantled surface of the manmade fill foundation with a circular plate with a diameter of 10cm as shown in Fig.6. The Young's modulus of the compacted fill was estimated as $E=15.1\text{MPa}$ assuming $\nu=0.3$.

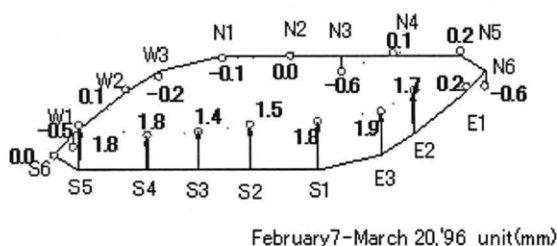
Figure 10. Differential heave caused by dismantling

Differential heave during dismantling was measured by horizontal inclinometers (Fig.9). A reference level point was damaged and the absolute settlement was not known. The results were shown in Fig.10. Relatively larger heave was measured at southeast side compared to northwest side. The differential heave was about $d=2\text{mm}$. The unload due to dismantle was estimated as 370kN. Assuming the Young's modulus of 15.1MPa, the heave may be estimated as the following equation.

The estimated heave is $\delta=1.4\text{mm}$, which is less than the measured differential heave. Since one sided heave was caused by more or less even unloading, the base ground beneath the foundation may not be uniform. The southeast side is weaker than the northwest side. However, there is no specialized heave near at both ends where the upper structure had deformed. Also the difference in heave is considered small and does not affect upon the reconstruction of the monument.

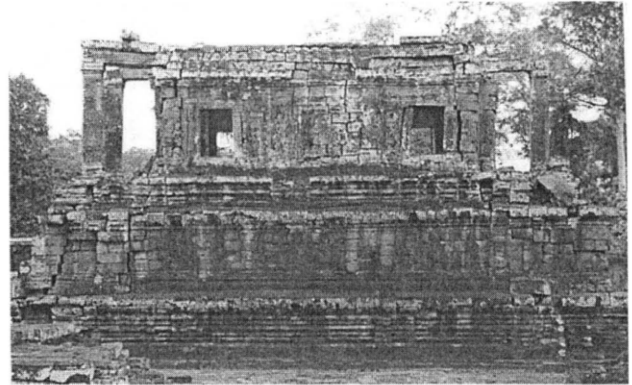
Photo 2 Northern Library, Bayon Temple-before restoration

The roof of the library is fallen down, which might have been caused by large displacement of wall and columns. Level measurement of the top of the foundation shows some settlement at the both ends of the foundation. Increased gaps of the stones of the north and south sides at the both ends were recognized as to show instability of the ends of the foundation. The main reasons are considered as weathering of laterite block inside the sand-stones and flow out of the compacted fill that have resulted settlement of the filled foundation.
