Modern technology introduced to safeguard old monuments in Angkor

V.M. Santoro

I.Ge.S., Geotechnical and Structural Engineering, Rome, Italy

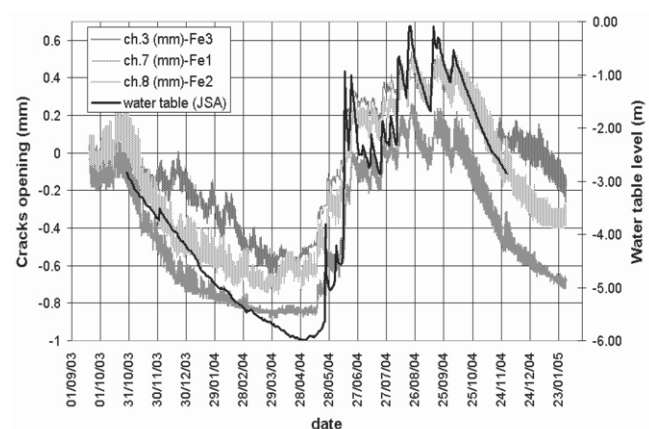
In the South gallery of the Temple of Angkor Wat a monitoring system was installed. The gallery is covered by a 2-span dry jointed stone blocks vault sustained by a wall and two rows of sandstone columns. A generalized strain pattern, quite evidently all along the gallery, could be recognized in the vaults, namely for the large rotations of the horizontal beams under the smaller vault, at the downhill side, testifying the tilting of the smaller lateral columns. Fig.1 shows a close correlation between the water table level and the opening of the joints, the process seems to be almost fully reversible. It suggests to exclude the presence of any subsidence phenomenon and makes few realistic a hypothesis of plastic deformation of the foundations of the columns. More reliable seems the scenario of elastic rotation pattern of the closure retaining wall caused by the increase of back water pressure due to lack of drainage, that causes the enlargement of the cracks and joints of the beams. The risk level of the structure appears undoubtedly high, due to the sensitiveness of the vault to the limit state of displacement of the columns.

Fig.1: Correlation between cracks opening and water table level.
