# Research on the Evaluation of Service Status of Tunnel Structure Near the Station

**Abstract.** To study the service status of the tunnel structure near the station, a disease detection of Metro Line 1 near the station during the operation period was carried out. The four major tunnel structural diseases including water leakage, segment stagger, open joints, and lining cracks were counted. The distribution law of the structural diseases along the longitudinal and circumferential directions of the interval tunnel was analyzed. The service status of segment components and connecting bolts were evaluated based on existing specification. The overall service status of the tunnel was determined. The service status level of the upstream line was determined as "iii", and the service status was "degradation", the service status level of the downstream line was determined as "iv" and the service status was "deteriorated".

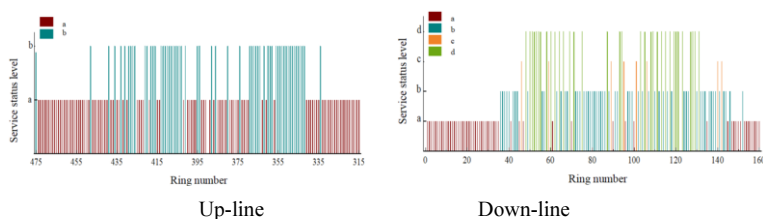
According to the geological survey data, the chloride ion concentration in the groundwater near the site is less than 100 mg/L, The environment where the tunnel located is relatively humid. Based on the requirements of the specification [8], the environmental action level is defined as Class B, and the service status of the components is divided according to the cracks and water leakage of the pipe segment. The service status of each ring segment of the tunnel is shown in figure 1.

**Figure 1.** Service status evaluation of segment structure.

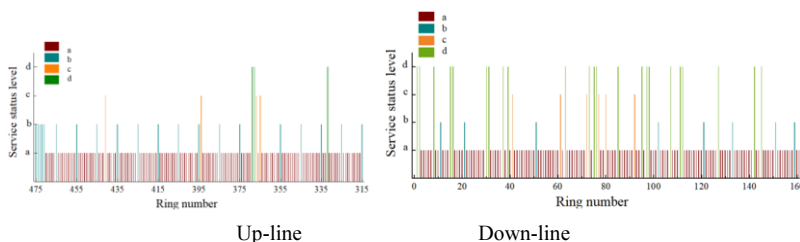
According to the water leakage at the joints of the pipes, the opening of the joints, and the misalignment of the pipes, the service status of the connection of the pipes is classified [8]. The service status of the segment connections is shown in figure 2. Compared with the up-line, the segment connections of the tunnels in the down-line are in poorer service status, mostly at level d.

**Figure 2.** Evaluation of the service state of the segment structure connection.
