# Feedback Analysis and Prevention & Control Strategy of the Real Causes of the Gallery Cracks in Super-High Arch Dam

**Abstract.** Gallery cracks occur commonly in concrete dams, but their cracking mechanism has yet to be effectively revealed. In this paper, the actual temperature, stress change history and cracking process of a gallery area were uncovered, based on the safety monitoring data of cracks in a super-high arch dam. In addition, the basic development and change laws, as well as the corresponding cracking mechanism, were analyzed, and the real causes and influential factors of cracks at the site were revealed, which will provide a reference for the prevention of cracks in similar projects in the future.

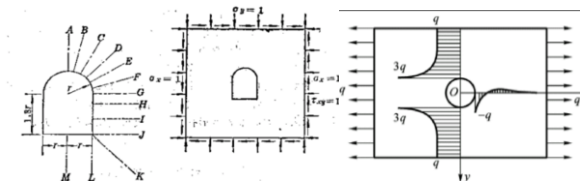
**Figure 1.** Typical cracks distribution in the gallery of a high arch dam.

The causes of gallery cracks in high arch dams mainly include the temperature stress and structural stress caused by weight. The local stress concentration area is formed in the roof arch and floor of gallery under the gravity load. Coupled with the superposition effect of temperature stress, cracks will occur after the stress exceeds the tensile strength of the concrete, which is generally caused by the superposition of two stresses. In addition, improper maintenance during the construction period may also result in shallow cracks, due to dry shrinkage. Due to the restricted fissure effect of steel bars surrounding the gallery, the gallery cracks are generally irregular. Typical gallery cracks in the roof and floor are shown in figure 1.

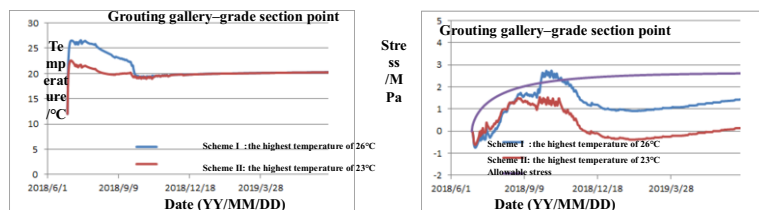
Figure 3. Typical curve of temperature and stress at typical points on the roof of gallery.

A high arch dam in southwestern China has many galleries inside the dam body, including a grouting gallery, inspection gallery and drainage gallery. After the beginning of the project, in view of the problem of gallery cracking, simulation analysis was adopted to predict the risk of gallery cracking during the construction period of the dam, as shown in figure 3. According to the simulation calculation results, if the temperature control shown in Scheme I were to be adopted, then the risk of local cracking in the gallery of a steep slope dam block is very high. Only when the highest temperature shown in Scheme II, which does not exceed 23°C, is taken, and the later thermostatic control inside the gallery is ensured, can the risk of cracking be controlled.

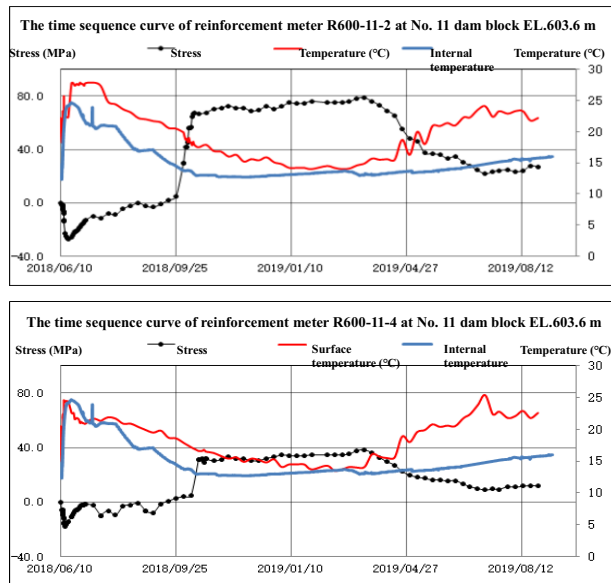
Figure 5. Monitoring data of temperature, stress and strainmeter at the roof arch of the gallery.

Figure 5 shows the monitoring value of the monitoring instrument in the gallery area. It can be seen that the values of the reinforcement meter and gallery strainmeter of the reinforcement meter (No. R600-11-2 and R600-11-4) of the No. 11 dam block clearly show a sudden change and continued increase during the period of September 25, 2018 to October 13, 2018. The increase amplitude exceeds 30 MPa and 300  $\mu\epsilon$  in the short term, and this is completely consistent with the temperature change process. This gradual increase does not tend to decrease until the internal temperature of the gallery begins to rise in early February, 2019. The surface stress change in the surface gallery area is clearly closely related to the temperature change process. During the daily on-site inspection on October 13, 2018, shallow microscopic checks were observed on the roof of the gallery. The width of the crack was less than 0.1 mm, the depth of the crack was 4–5 cm, and none exceeded the first layer of break-stop steel

From a theoretical analysis perspective, when the tensile stress of the concrete on the roof arch of the gallery gradually approaches the tensile strength of the concrete, then the steel bars will gradually share greater tensile stress. In addition, when the surface stress of the gallery exceeds the tensile strength of the concrete, then the cracks are formed on the surface of the gallery. At that time, the stress in the gallery area will be redistributed, the steel bars in the gallery area will share more tensile stress, and the stress of the steel bars will suddenly increase. According to the monitoring data of the on-site steel bars shown in figure 5, the actual situation is highly consistent with the theoretical analysis results.

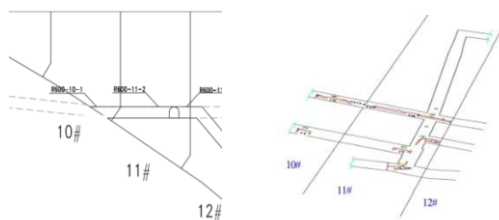
**Figure 6.** Plane distribution diagram of gallery cracks.

bars. The actual crack direction is shown in figure 6. It is not difficult to see that the situation observed by the monitoring instrument is able to accurately reflect the development and change of stress and strain in the gallery area of the dam.

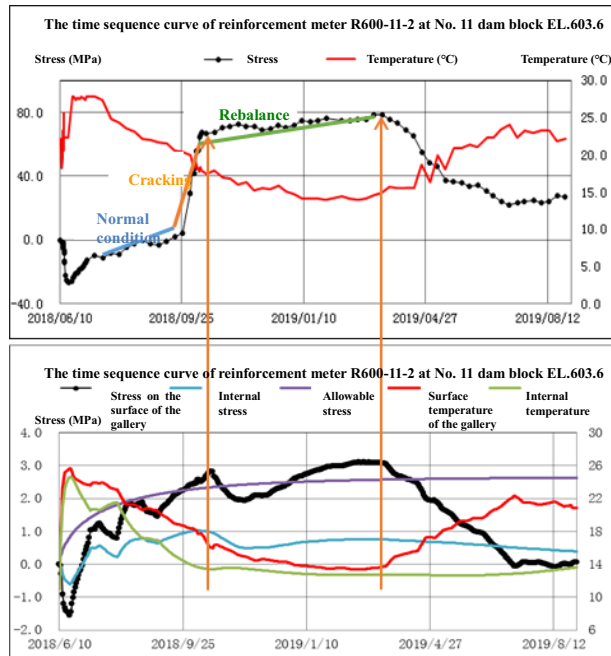
**Figure 9.** Comparison of measured temperature, stress and feedback simulation value of typical parts of the gallery.

Figure 9 shows the comparison curve of the temperature, stress and strength curves of the gallery roof of No. 11 dam block. It can be seen that, since September 25, 2018, the stress exceeded the allowed stress which means the safety coefficient of the concrete on the surface of the gallery roof had fallen below 1.5; as required in the Code, the safety coefficient must be over 1.5. At this time, the internal temperature of the gallery area was 14.5°C, which has not reached the design arch sealing temperature of 13°C, and the temperature on the surface of the gallery roof was still approximately 18.7°C. After this, as the overall temperature of the dam dropped to the arch sealing temperature, the stress reached the first highest point. Next, the later stress continued to increase with the further drop of the temperature on the surface of the gallery. In late February of 2019, the temperature reached its lowest point, and the stress reached another peak.

to about 1.5, then the risk of cracking becomes very high. This is basically the same as the time when cracks are observed on-site. The change process of stress and safety coefficient is consistent with the change trend reflected by the monitoring value of on-site surface strainmeters and gallery reinforcement stress meter, thus indicating that the feedback simulation results can basically reflect the change law of the overall stress and safety status of the gallery area of the No. 11 dam block. Among them, the tensile stress generated by the overall and local temperature drop in the dam forms a concentration effect in gallery roof, which is the main cause of gallery cracks.

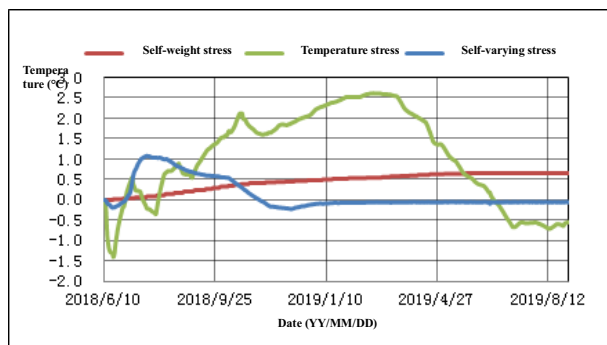
Figure 10. Comparison of stress curve of different influential factors.

The above simulation results verify that the cause of the cracks is caused by the combined stress exceeding the standard. Due to the fact that this combined stress is the result of the combined effects of different influential factors, it is necessary to clarify the contribution of different influential factors to the stress of the gallery, so as to provide better ideas and directions for the prevention and control of gallery cracks. The main causes of gallery cracks in this project include three types of loads of temperature, gravity and autogenous volume deformation. The dry shrinkage load is not considered in this project, as the entire process of spray curing is carried out inside the gallery following the construction. Figure 10 shows the contribution of different loads to the stress of the gallery roof. It can be seen that the contributions of temperature, gravity and autogenous volume deformation are 1.55 MPa, 0.33 MPa and 0.55 MPa at September 25, 2018 respectively. Clearly, at this stage, the temperature factor occupies a relatively large proportion. The main reason for this is that the gallery is in the strong foundation restraint area and is in the second-stage cooling, and the stress level in the gallery area is relatively large. Therefore, in this project the reduction of temperature stress is of primary importance from the perspective of gallery crack prevention.

(3) In order to reduce the risk of gallery cracking, in addition to lowering the highest temperature in the gallery area as a whole, the entrance and exit of the gallery must be closed as much as possible, so as to reduce the influence of outside temperature on the gallery. Meanwhile, the necessary maintenance is also beneficial to preventing shallow dry shrinkage cracks.
