Investigation on the Micromechanisms of the Cracking of 316L Heat Exchanger Tubes

Department of Materials Technology, Huadian Electric Power Research Institute Co., Ltd., Hangzhou, China

Obvious leakage was detected at the upper tube bundle of a heater, leading to the leakage of water to both sides of the heater employed in the heat-network heaters in a power plant. In order to find the underlying reason for the leakage, systematic experiments were carried out in order to check the material properties of the tube. The heat exchanger tubes were made of 316L stainless steel with the dimensions of 19mm in diameter and a thickness of 1mm. The total running time of the tubes were about 7500 hours, with steam side temperature (outside the bundle) is 395°C, the steam pressure is 0.35MPa, the water side (inside the bundle) temperature is 70-130°C, the water side pressure is 2.1MPa.

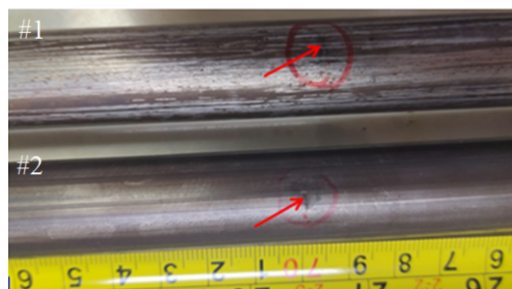
The appearance of the cracked heat exchange tubes is shown in figure 1. There is a penetrating torodirectional crack (indicated by the arrow in the figure) with a length of 5-8mm in each cracked tube. However, there is no obvious mechanical damage around the crack, also without any obvious swelling, wall thickness thinning or plastic deformation.

Figure 1. Macroscopic appearance of two tube samples.

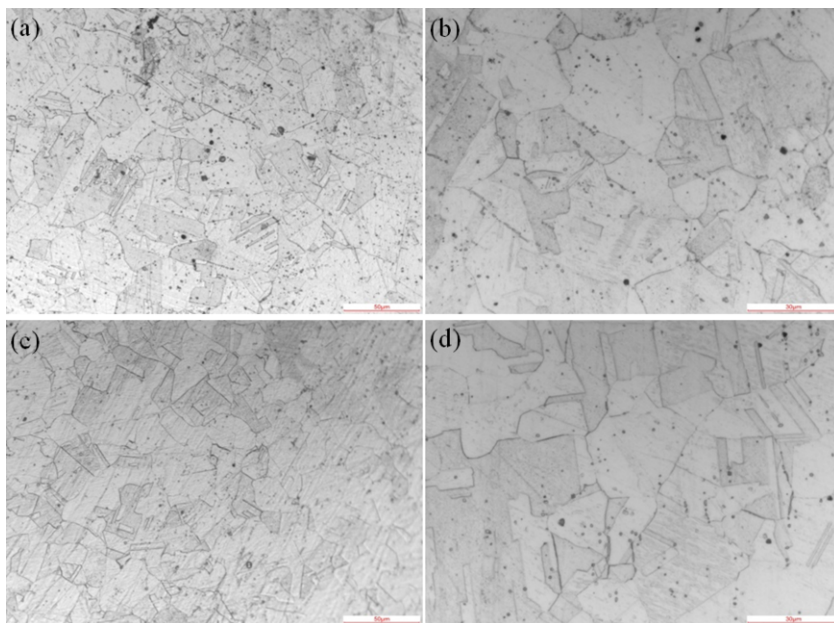
The microstructures of tube samples of #1 and #2 are shown in figure 2. It can be found that both tubes have the austenitic structure with a few annealing twins in some grains

and coarse granular carbides imbedded along grain boundaries. There is no significant difference in microstructures between the two tubes, and the aging grade of two tubes is about 2.5.

Figure 2. OM inspection of microstructures in two tubes: (a) #1, 500 \times ; (b) #1, 1000 \times ; (c) #2, 500 \times ; (d) #2, 1000 \times .

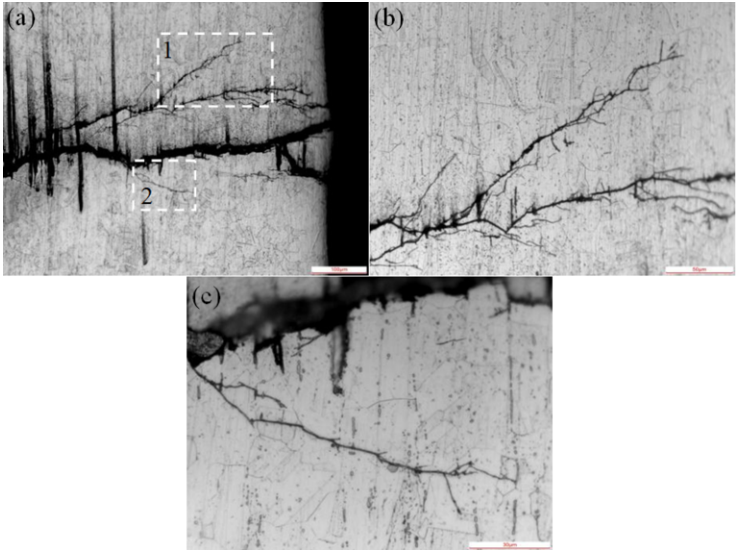
The morphology of crack propagation on the outer surface of #2 tube was depicted in figure 3. It can be seen that there are several small secondary cracks near the toroidal main crack surface, and the secondary cracks will further bifurcate in the process of propagation, forming dendritic crack propagation morphology (figure 3a). The magnified picture of multiple branching cracks reveal that the propagation mode of these cracks was dominated by both intergranular and transgranular characteristics. The microcracks and the main cracks connect with each other, and then propagated toward the outer wall of the tube (figures 3b and 3c).

Figure 3. Crack morphology of #2 tube: (a) overall look; (b) partial enlarged view of block 1; (c) partial enlarged view of block 2.

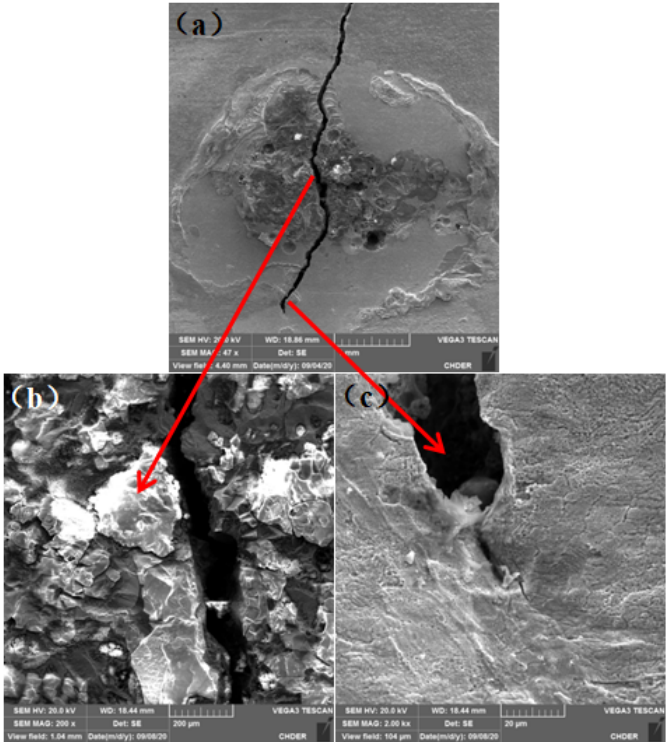
The cracking morphology at inner wall of #1 tube was shown in figure 4. It can be found that the crack width in the middle of a pitting corrosion pit on the inner wall of the tube is the largest, while the crack width that keeping away from the middle position of the pit gradually decreases. It can be deduced that it was the position of cracking source. Further observation demonstrates that one end of the crack propagated along the ring towards the outer wall of the tube, and finally penetrated into the outer surface of the sample. While the other end of the crack propagated more slowly, the crack tip locates near the corrosion pit. The crack nucleation area is covered with a thick layer of corrosion products, which are gray-white, smooth surface, sharp edges and corners, and many micro-cracks are formed due to its crushing.

Figure 4. Crack morphology on the inner wall of #1 tube: (a) corrosion pit; (b) nucleation site; (c) crack tip.

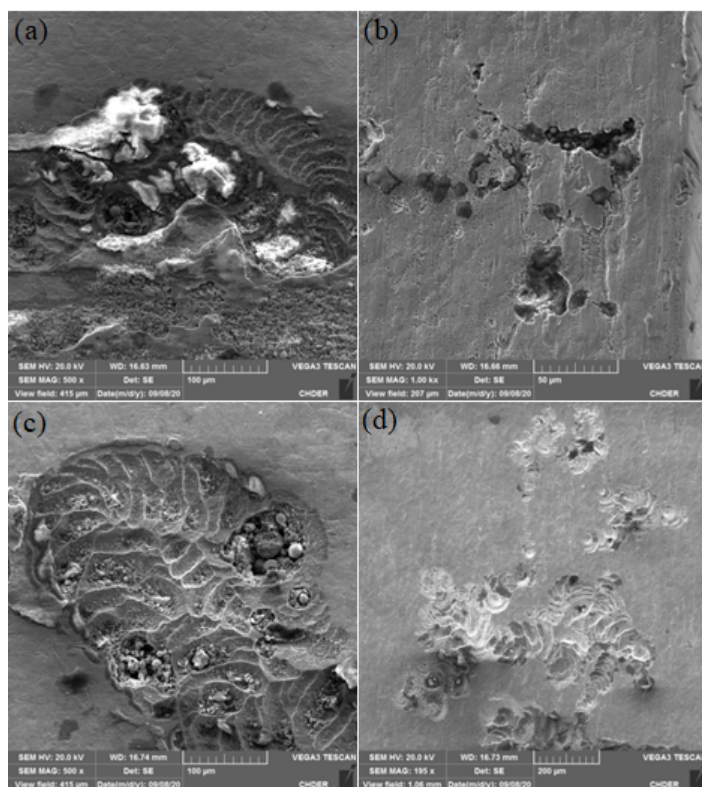
Further observation found that there were smaller size of corrosion products and corrosion pits in the local area of the inner wall of the two tubes. As shown in figures

5a and 5b, small-size corrosion pits in #1, #2 tubes are produced by the exfoliating of corrosion products with a certain number of spherical inclusions. The continuous formation and shedding of corrosion products also resulted in the formation of small cataphracted corrosion pits in local areas, and these small corrosion pits would gradually converge and merge into larger corrosion pits, finally generating cracks (figures 5c and 5d).

Figure 5. Local corrosion morphology on the inner wall of tube sample: (a) corrosion products of #1 tube; (b) corrosion products of #2 tube; (c) cataphracted corrosion pits of #1 tube; (d) cataphracted corrosion pits of #2 tube.

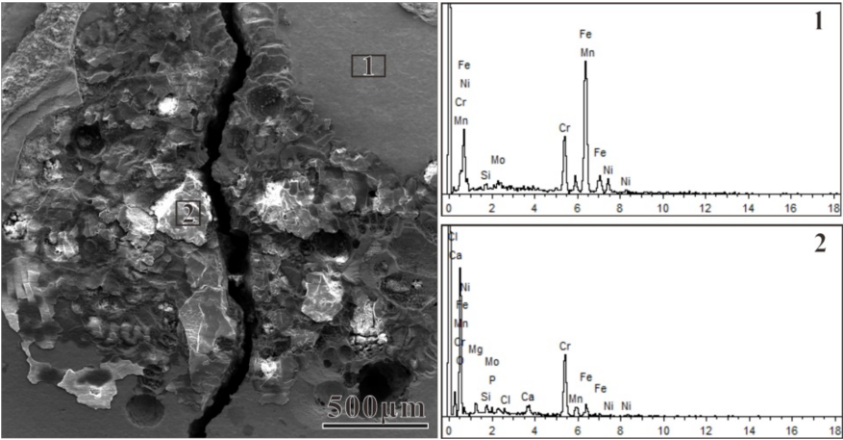
Energy spectrum analysis experiments were carried out on corrosion pits with cracked inner wall of tube samples. The results are shown in figures 6 and 7, tables 4 and 5. It can be seen that there is no chloride ion in the matrix of #1, #2 tubes, but the chloride ion is detected in the corrosion products near the crack, the content is 0.61% and 0.50%, respectively.

Figure 6. EDS results for #1 sample with two points, 1-matrix, 2-corrosion products.

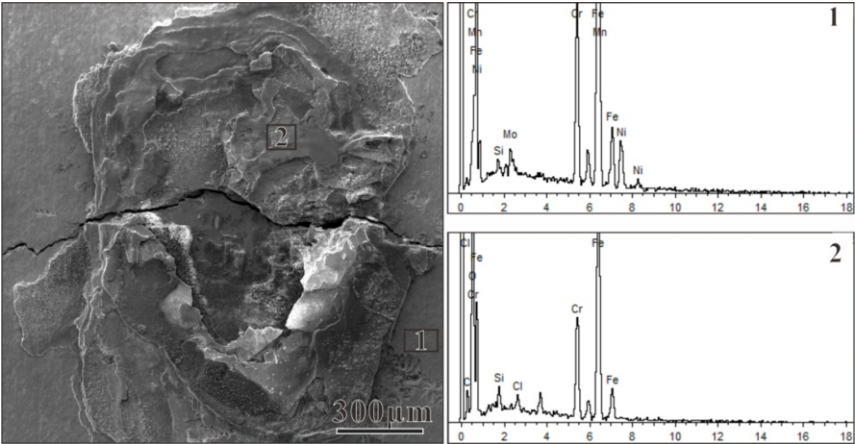
Figure 7. EDS results for #2 sample with two points, 1-matrix, 2-corrosion products.
