# Microstructure Evolution and Element Redistribution in Carburizing Process of Ethylene Cracking Furnace Tube

**Abstract.** Carburizing is the main damage form of ethylene cracking furnace tubes. In this process, the microstructure of the furnace tube would change and the element diffuses and redistributes. After serving for about 41000h, the radiation section of a plum blossom tube of SC-1 tubular cracking furnace from a petrochemical company was tested and analyzed in this article. Results show that the higher the service temperature, the more serious the carburizing of the furnace tube. In the inner-wall carburized zone of the middle temperature section of the furnace tube with an initial C content of 0.1wt%, the maximum C content reaches 1.83wt% and the number of carbides increases obviously as well as its organizational morphology changes from fine granular to coarse block or chain like and its organizational type changes from single  $M_{23}C_6$  to the coexistence of  $M_{23}C_6$ ,  $M_7C_3$  and MC type carbides. The Cr and C elements in the carburized zone are mainly concentrated in the grain boundary area in the form of carbides. At the same time, the diffusion of alloy

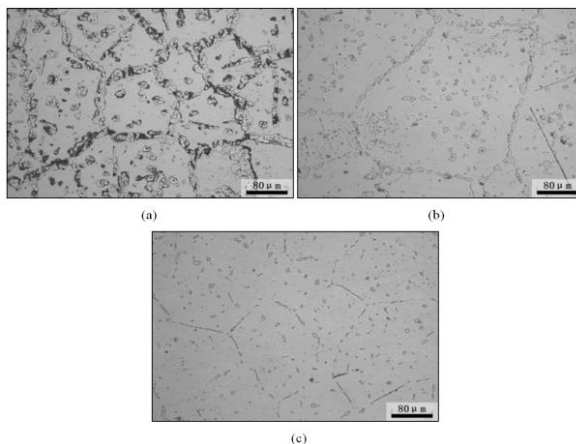
Figure 5 exhibits the microstructure morphology of different areas in the cross section of the II# furnace tube part. Obviously, in the non-carburized zone of the furnace tube, only a small amount of carbides exist at the grain boundary and in the grain, which are secondary carbides formed by aging precipitation of the carbon solidly dissolved in austenite. Meanwhile, in the carburized zone, not only the amount of carbides increases, but also the morphology changes from fine granular to coarse block in the grain as well as chain at the grain boundary. This is mainly resulted from the high content of C in the carburizing zone leading to the formation of a large number of secondary carbides in this region in the process of high temperature service, some of which gradually grow up in the grain, and some grow up to the grain boundary in the shape of chain.

Figure 5. Microstructure of different regions in the furnace tube part of II#. (a) carburized zone, (b) transition zone, (c) non-carburized zone.

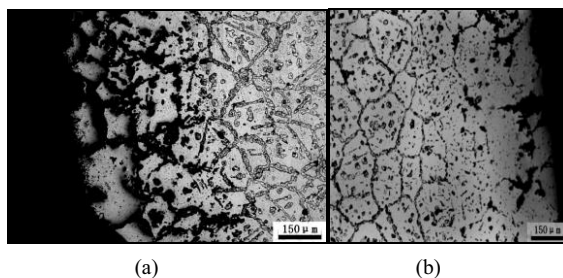
There are obvious damage layers on both the inner and outer surfaces of the II# furnace tube part, as shown in figure 7.

**Figure 7.** OM images of the (a) inner and (b) outer surface damages in the furnace tube part of II#.

The analysis indicates that an obvious intergranular oxidation zone of  $Cr_2O_3$  exists in the inner surface damage layer and a poor carbide zone locates right in its adjacent area followed by a carburizing zone. Meanwhile, only a small amount of  $SiO_2$  appears in the damaged layer on the external surface and the loss of C element is obvious due to the decarburization environment of the external wall, and simultaneously, Cr element continuously diffuses to the interface and gets oxidized to form oxidation products in the service process, which finally results in the lack of Cr in the outer sub-surface of the furnace tube. The element distribution maps in the damaged area on the inner and outer surfaces are shown in figures 8 and 9, respectively.

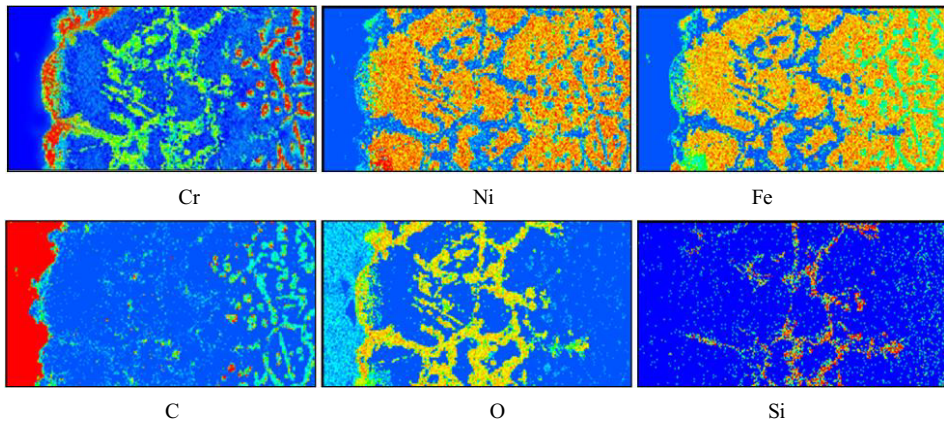
**Figure 8.** Distribution of alloying elements in the internal surface damage zone of the II# furnace tube by EPMA in mapping mode.

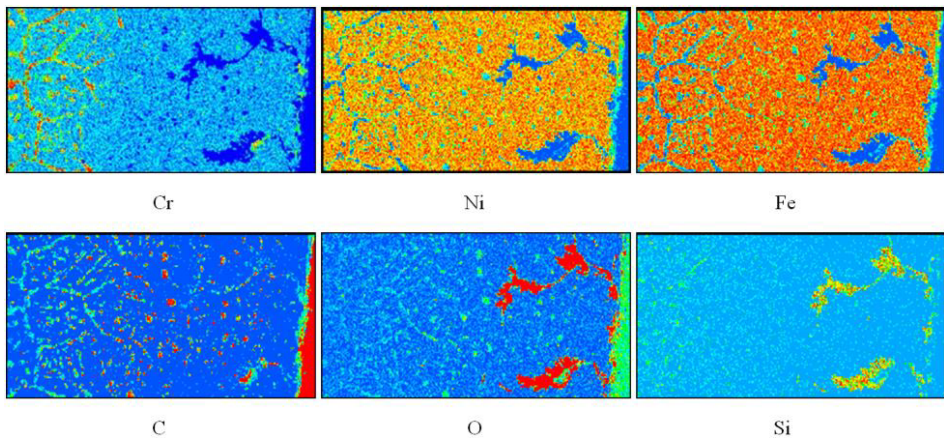
**Figure 9.** Distribution of alloying elements in the external surface damage zone of the II# furnace tube by EPMA in mapping mode.

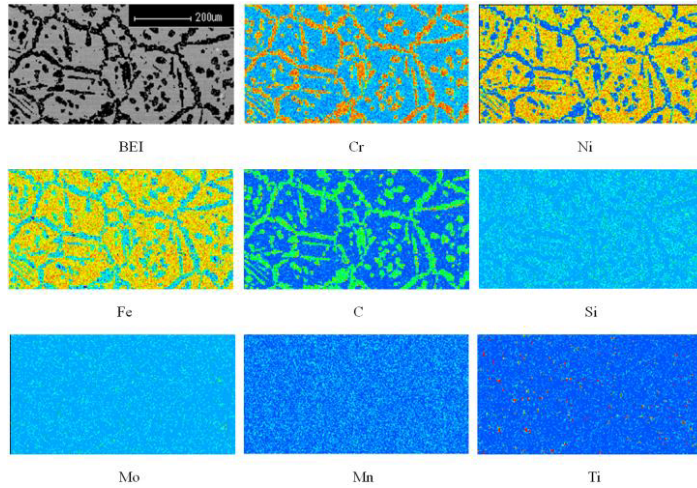
As present in figure 10, electron probe was used to test the element distribution in the 1 carburizing zone of the II# furnace tube part. Seen from the images, Cr and C are mainly concentrated at the grain boundary in the form of carbides, while Ni is still solidly dissolved inside the austenite grain and the other elements of Si, Mo and Mn are less and evenly distributed inside the grain. In the service process of the furnace tube, carbides will gradually precipitate and grow up following the change of type and the diffusion to grain boundary, which will result in the lack of Cr in the matrix and consequently reduce the high temperature oxidation resistance of the furnace tube.

**Figure 10.** Distribution of alloying elements in the carburized zone of II# furnace tube by EPMA in mapping mode.
