Characteristics of Tunnel Explosion Accident and Its Emergency Disposal Process

Abstract. In this paper, recent typical tunnel explosive accidents in China, such as Bamianshan tunnel explosion accident, No. 5 Futuyu tunnel explosion accident, Yanhou tunnel explosion accident, Qidaoliang tunnel explosion accident and so on, have been collected and reviewed. Particular attention has been paid to these direct and indirect causes of explosive accidents, accident tunnel structure, accident process and loss, and subsequent emergency disposal measures. Based on details and information about these accidents, characteristic of various types of explosive accidents, including non-large tunnel explosion accident and large tunnel explosion accident in tunnel has been analyzed and their basic reason has been proposed. It shows that the leakage of mashgas and improper loading of explosives during construction, inflammable and explosive chemicals and materials transportation, vehicle crash and tire spontaneous combustion during operation could cause of explosion accidents in tunnel, while the combination among these causes could finally lead to a series of explosions, large-scale burning, a large

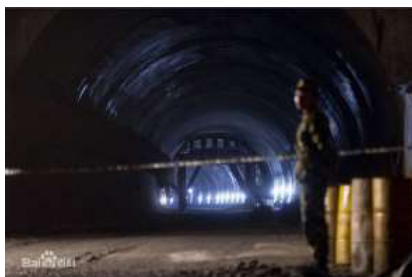
Bamianshan tunnel explosion accident occurred at the tunnel under construction from HunanYanru Expressway without any fire protection facility. As shown in figure 1, the explosion accident was caused during unloading process of 288 kilograms explosives from agricultural vehicles. There were 24 people in tunnel during occurrence of explosion, and the explosion caused 20 deaths, one serious injury and one minor injury. Professional coal mine search and rescue team, fire department and public security department participated in the on-site rescue after the accident. In order to prevent the tunnel collapse during search and rescue, the safety experts about bridge structure were invited to command the rescue. A rescue vehicle and a truck were sent to the accidental tunnel by the fire department for performing the rescue. Search and rescue in combination with smoke exhaust and drainage work were carried out in the accidental tunnel after the warning line was set in the entrance. Because of poor air quality and low visibility in tunnel under construction, the search and rescue team used life detectors and other equipment to operate two searches and rescues. The direct cause of this accident was caused by an explosive explosion during unloading process, while its indirect cause is the ineffective safety management on transport vehicles for explosives and related people in tunnel under construction [1].

Figure 1. Bamianshan tunnel explosion accident from HunanYanru Expressway.

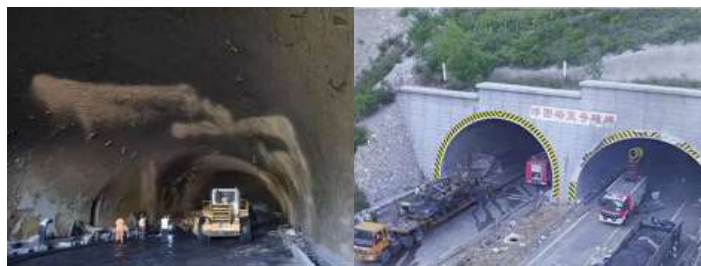
In figure 3, the accidental tunnel is No.5 Futuyu Tunnel, located at Zhangshi Expressway in Hebei Province. It is a double-arch two-lane one-way expressway tunnel with a length of 626 m, a width of 13.25 m, an internal longitudinal slope of 1.75 % downhill, and the design speed of 80 km/h. The explosion accident was caused by the overload of sodium chlorate by vehicle, friction between loaded cargo to generate heat, spontaneous combustion of rubber tire to ignite binding ropes, rags, sealing cloths, and then explosion of sodium chlorate, which resulted in 15 civilian deaths, 19 injuries and direct property loss estimated at 42 million. During the accident, the vehicle exploded with a huge fireball and dazzling white light and the resulting shock wave, high temperature and flame caused casualties and the damage of vehicles. Subsequent chain explosions occurred among fuel tanks, brake tanks, fire extinguishers and tires. The scattered sodium chlorate dust floated out of the tunnel. The vehicle still burned, the tank behind the vehicle disappeared, and several coal trucks were ignited after the explosion. And the accidental tunnel entrance burned black, and the guardrails of dozens of meters were damaged. The ground was covered by black soil slag with a pungent burning smell. Several houses about 100 meters away from the explosion were destroyed with the various degree, and coal blocks were scattered around. After the accident, the public security traffic police and transportation department immediately launched the emergency rescue plan, aggregated more than 300 people from the public security traffic police, fire protection, medical treatment, safety supervision, environmental protection, and arrange the related equipment for the emergency rescue. Fire department dispatched 4 fire trucks to the accidental tunnel, diverted and controlled the vehicles from Zhangjiakou and Shijiazhuang, opened the central guardrails of No.3 and No.4 tunnels, and commanded the rear vehicles to turn around, leave the accidental tunnel and dredge the road. In order to ensure the safety of transportation recovery in the accidental tunnel, experts were organized to examine the structural stability of the tunnel, mountain and geological environment and propose the repair plan. The direct cause of the accident was the explosion of sodium chlorate. Sodium chlorate is a strong oxidant, which is easy to be exploded, and its explosion

occurs when it is subjected to strong heat or in contact with strong acid. The indirect causes could be listed as follows: (i) transportation enterprises privately changed dangerous chemical transportation vehicles, illegally transported dangerous cargo by covering dangerous transportation warning signs, used tarpaulins without flame retardant treatment; (ii) dangerous cargo transportation monitor did not record according to the prescribed procedures [4, 5].

Figure 3. No. 5 Futuyu tunnel explosion accident.

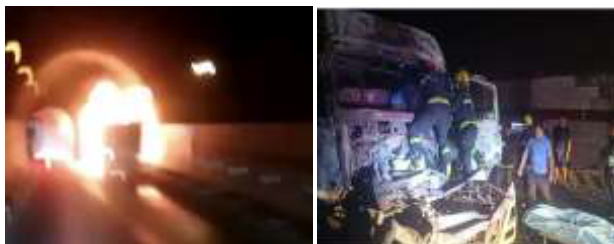
In figure 6, the accident tunnel is Bapanshan Tunnel in Lvliang of Qingyin Expressway. The total length of the tunnel with three bends is about 4.1 km, and the height difference from east to west is 80 m. The accident occurred in the tunnel (Shaanxi direction) 1 km away from the exit, which resulted in 1 civilian death and trapped 49 vehicles and more than 80 civilians in the rear. The vehicle caught fire instantly after collision, and then the sudden explosion of the accidental vehicle's tires led to the second re-ignition during the period. The explosion accident was detected according to monitoring screen collected by the tunnel management station. After receiving the alarm, the emergency disposal plan was started immediately. The traffic police, the road administration, the fire department and other related departments participated in the rescue. During rescue, the tunnel entrance closed at the first time, and the rescuers decided to close the two-way tunnel and cut off the power supply in the tunnel. The emergency vehicle was used to assist the detained personnel to quickly withdraw from the accidental tunnel. Exhaust equipment was adopted to change the wind direction and deal with the heavy smoke caused by the explosion of the vehicle tire when the rescuers could not reach the accidental scene due to the heavy smoke in the tunnel. Then, on-site investigation and inventory confirmation operated after the removal of smoke in the accidental tunnel. The direct cause of the accident was the collision fire of the vehicles. During the period, the explosion of the vehicle tire near the accident site led to the second re-ignition, and the emergency disposal in this accident was successful. The tunnel was reopened 4 hours after the accident [10].

Figure 6. Vehicle explosion accident in Bapanshan tunnel.

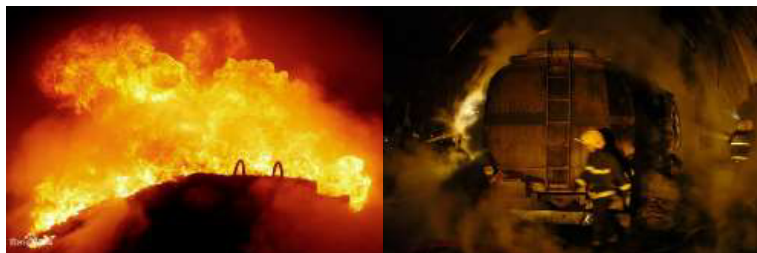
Figure 7 shows that the accident tunnel is Qidaoliang Tunnel of Lanlin Expressway in Gansu Province, which is a double-line extra-long highway tunnel. The net width of the tunnel is 10.8 m, the net height is 7.1 m, the total length of the double-hole is about 8.1 km, and the design speed is 80 km/h. The accident occurred at 1500 m away from the entrance to Linxia due to the rear-end collision of two tanker cars and then combustion and explosion of 40 tons No. 190 solvent oil loaded, which resulted in 4 civilian deaths, 1 injury and property loss estimated at 1.0 billion, and serious damage in tunnel facilities. After the accident, a large amount of concrete from both sides and the top of the wall was blasted into fragments and scattered in the tunnel, facilities in the top and lighting system were deformed and destroyed, and damage length of tunnel structure reached up to 800 m. At the same time, the huge fire ball generated during combustion after explosion burned rapidly along the south exit of the tunnel, which has the distance of 700 m from the accidental tanker car. During rescue, the related management department immediately closed the highway and commanded 10 fire trucks to spray water for cooling the accidental tanker car and tunnel. The firefighters used emergency lighting facilities to operate in-site rescue, and remove the accidental tanker car after pumping all the solvent oil into other tanker cars, in order to prevent the re-explosion caused by the leakage of the accidental tanker car. The direct cause of the explosion accident was the combustion of No. 190 solvent oil, which could be classified to III type dangerous chemicals [11].

Figure 7. Qidaoliang tunnel explosion accident.
