# Assessment of the Service Status of the Tunnel Structure Adjacent to the Station

**Abstract.** To assess the operational reliability of the tunnel structure adjacent to Metro Line 1 station during its active service, we conducted a comprehensive investigation. This investigation involved the detection and precise measurement of four significant structural concerns within the tunnel: water infiltration, segment misalignment, exposed joints, and lining fractures. We conducted a detailed analysis of the spatial distribution patterns of these structural issues along both the longitudinal and circumferential axes of the intermediate tunnel section. Additionally, we conducted an assessment of the operational condition of segment components and connecting bolts, adhering to established standards. This comprehensive approach allowed us to achieve a thorough evaluation of the overall operational condition of the tunnel.

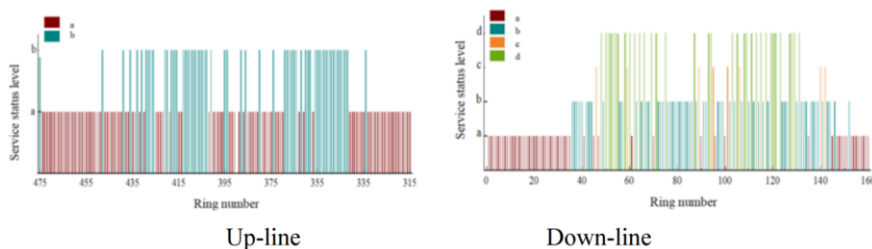
**Figure 1.** Evaluation of the Service Condition of Segment Structures.

It's important to highlight, based on the results of the geological survey, that the concentration of chloride ions in the groundwater near the site consistently remains below 100 mg/L. Furthermore, the tunnel's surroundings are characterized by a moderately humid environment. In strict accordance with the specified standards [8], the environmental impact is classified as Class B. Consequently, the assessment of the

component's operational condition is determined by the presence of cracks and water leakage in the pipe segments, as depicted in figure 1.

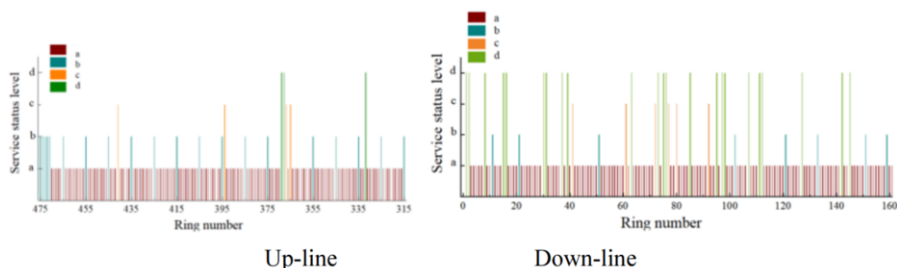
**Figure 2.** Assessment of the Service Condition of Segment Structure Connections.

Evaluating the dependability of connections within the segment structure involves considering several factors, which encompass water seepage at pipe joints, the extent of joint openings, and pipe misalignment. These variables play a pivotal role in categorizing the overall operational state of the pipe connections, aligning with well-established guidelines [8]. Figure 2 offers a comprehensive overview of the operational conditions of segment connections.

Figure 2 presents a comprehensive representation of the operational conditions of segment connections, taking into account factors such as water seepage, joint openings, and pipe misalignment. The classification system employed allows for a comprehensive assessment of the structural soundness of these connections, in accordance with the guidelines [8].

When comparing the up-line tunnels to the down-line tunnels, it becomes evident that the reliability of segment connections in the down-line tunnels is notably lower, primarily falling into the "d" classification. This distinction underscores the need for targeted maintenance and repair efforts to ensure the ongoing dependability and safety of the tunnel structure.
