# Analysis of On-Load Tap-Changer Failures Based on Lightning Overvoltage

**Abstract.** Transformer faults have now become a major cause of power system failures, with transformers being more susceptible to malfunctions in adverse weather conditions. This article takes the example of a fault in the on-load tap changer switch of a transformer caused by a localized overvoltage short circuit during severe thunderstorm weather. The author elaborates on three types of lightning-induced overvoltage, combining fault analysis with extensive on-site experimental data and comparisons with standard values to convincingly identify the fault causes. The article briefly discusses five types of overvoltage in neutral point ungrounded systems and, in conjunction with one of the transformer's crucial components, the on-load tap changer switch, provides a concise analysis of four main fault types associated with OLTC. Finally, the author traces the root cause of the fault, summarizes the findings, and presents effective recommendations to prevent similar incidents in the future.

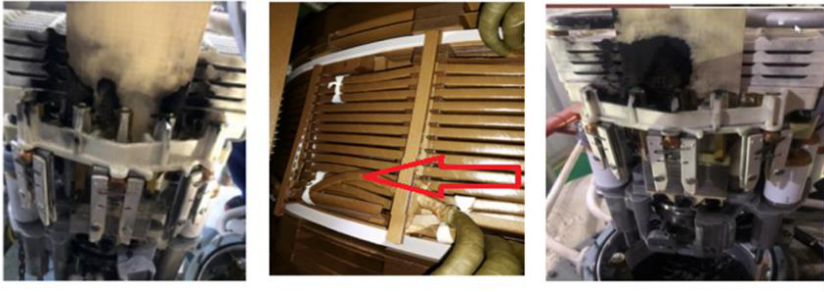
No. 2 main transformer body inspection, according to the inspection condition can be clearly found No. 2 main transformer on-load voltage regulator tap-changer burned, the bottom of the oil chamber is damaged and oil leakage.

Entering the No. 2 main transformer tank internal checker, it was found that the A and C two-phase high-voltage windings had obvious deformation, the on-load regulator tap-changer core a and b phase gap burnt, current limiting resistor burnt, and the bottom of the on-load regulator tap-changer oil compartment was damaged.

After completing the No. 2 main transformer inspection, the No. 3 main transformer body was inspected and found to have a certain degree of damage to its on-load switch.

Into the No. 3 main transformer tank internal inspection, compared with the No. 2 main transformer, the No. 3 main transformer did not find A, B, C three-phase high-voltage windings have obvious deformation, tampering, loose situation. Winding ends neatly without tampering, no loosening, tap line and on-load connection terminals firmly.

**Figure 1.** The basic situation of No.2, No.3 transformer

1. For the two transformers with different damages, combined with the needs of production and power generation, the main transformer with less damage will be dismantled by the on-load tap-changer and changed to the fixed tap operation mode, and the other transformer will be returned to the factory for repair. According to the standard test, the main test items are DC resistance, ratio, winding deformation, dielectric loss, AC withstand voltage, local discharge test, etc., after passing the test, the power supply is put into standby.

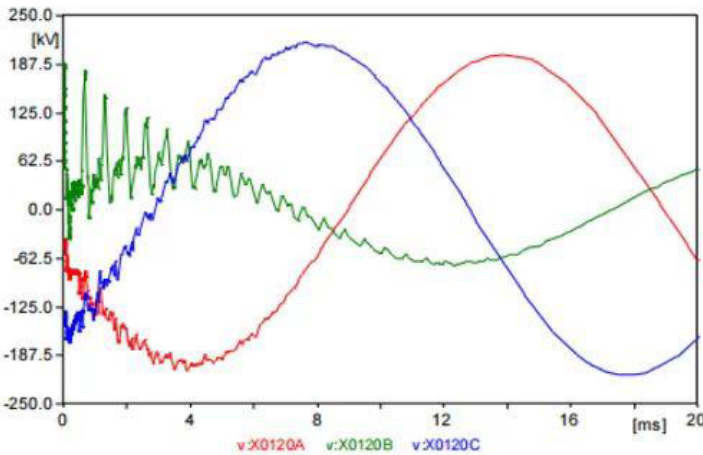
**Figure 2.** Waveform diagram of fault recording device 3U<sub>0</sub> for power substation

Analyzed from Figure 2 waveform: grid 220kV line B phase and 110kV line B the same when the ground faults, 57ms after 110kv line C phase ground. After understanding the grid 220kV and 110kV with the tower, the day the power plant is located in the local climate for thunderstorms and windy weather analysis that the bad weather caused by external line ground faults [6].

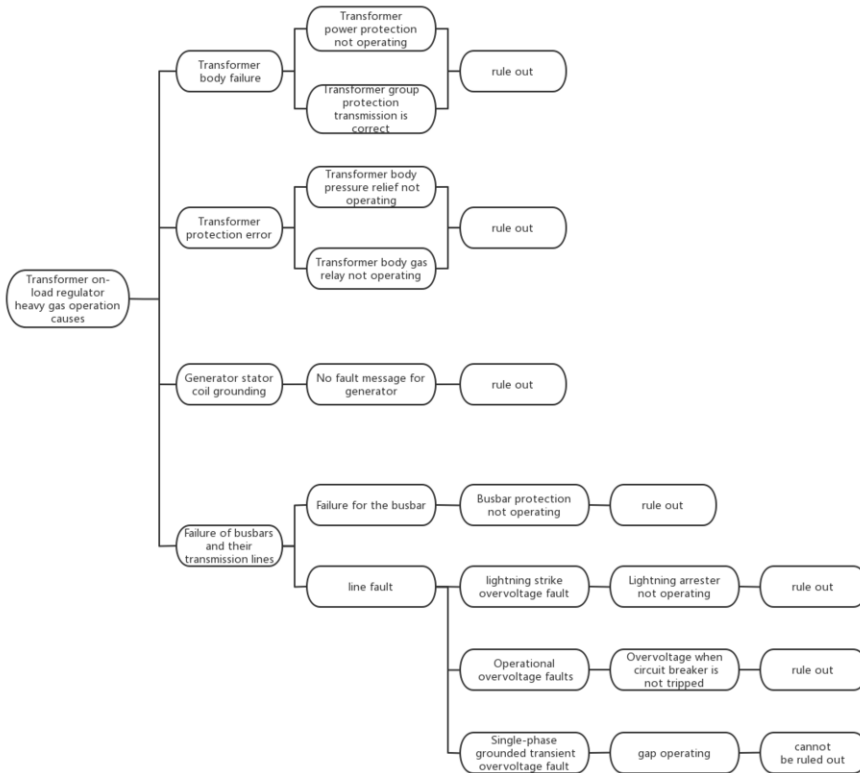
By accessing the fault recorder waveforms, relay protection action, according to Figure 3 process analysis and judgment, clearly indicate the direction of the accident is a single-phase grounding of the line to form a transient overvoltage, resulting in the gap action of the on-load tap-changer discharges and develops into a fault.

Figure 3. Flow chart of transformer fault analysis
