# Geotechnical Forensic Engineering: Settlement of Structures in Industrial Facilities Located in Puerto La Cruz, Venezuela

Alvaro BOIERO<sup>a,1</sup>, José L. OLIVER<sup>b</sup> and José I. AMUNDARAY<sup>c</sup>

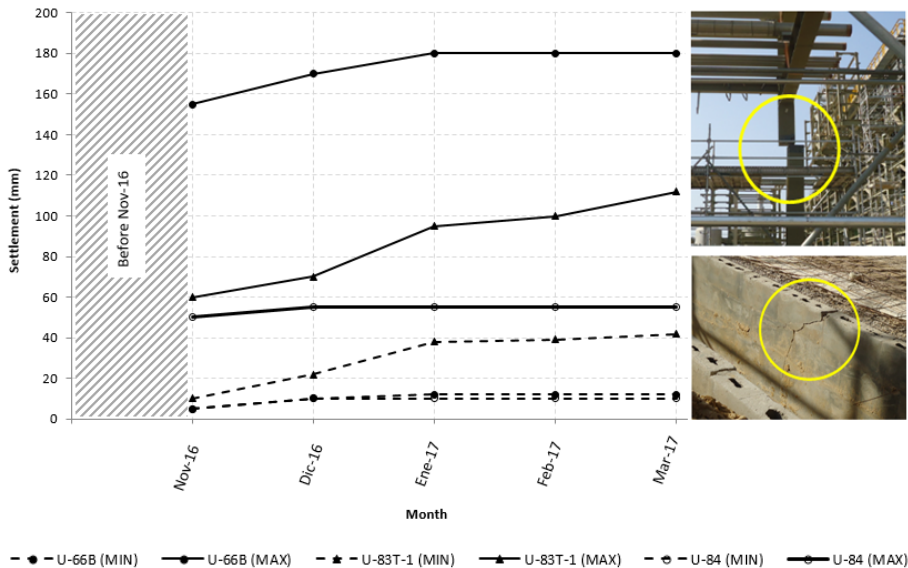
In Figure 1, measurements corresponding to the topographic control of the project are observed. These measurements correspond to the extreme settlements (minimum and maximum) in the most affected units. Also, photographs illustrating the effects of registered settlements are shown.

Figure 1. Settlement measurements and field deformations evidences.

Topographic deformation measurements before November 2016 (when the settlements of the structures reached, in some cases, more than 40 mm) were not reported, which suggests that a progressive topographical control of the foundations' coordinates was not carried out during the construction stage. Also, based on the values shown in Figure 1, it is evident the occurrence of variable differential settlements between 45 mm and 168 mm, inadmissible for the structures installed in the project.

The proposed foundation solution, basically consists of installing a number of micropiles, which will cross the existing foundation, and build a cap head that serves as a connection between these deep elements and the existing foundation. In this way, the loads transmitted by the superstructure will be completely absorbed by the micropiles.

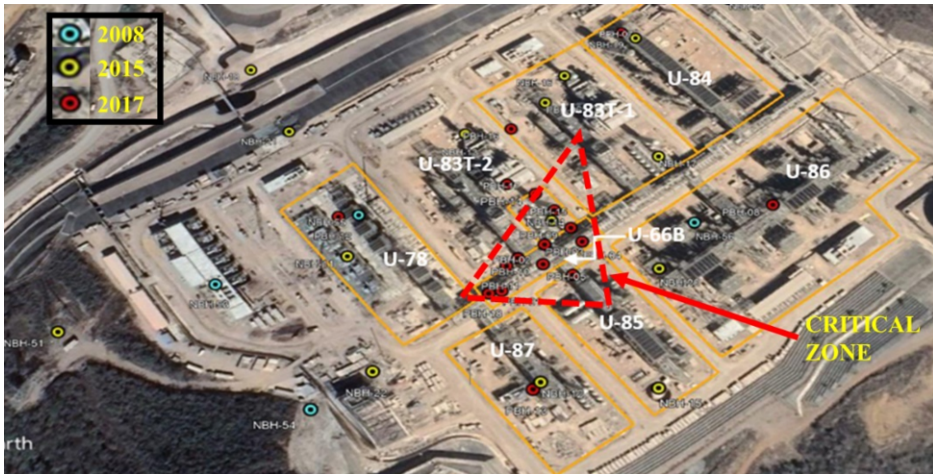
**Figure 2.** Critical zone of the parcel, considering explorations performed on 2008, 2015 and 2017.

According to the above, the presence of a layer of low rigidity materials between the surface and 11.5 m depth is evident, in which a critical sector of very low soil rigidity between 3 m and 8.5 m of depth is observed.

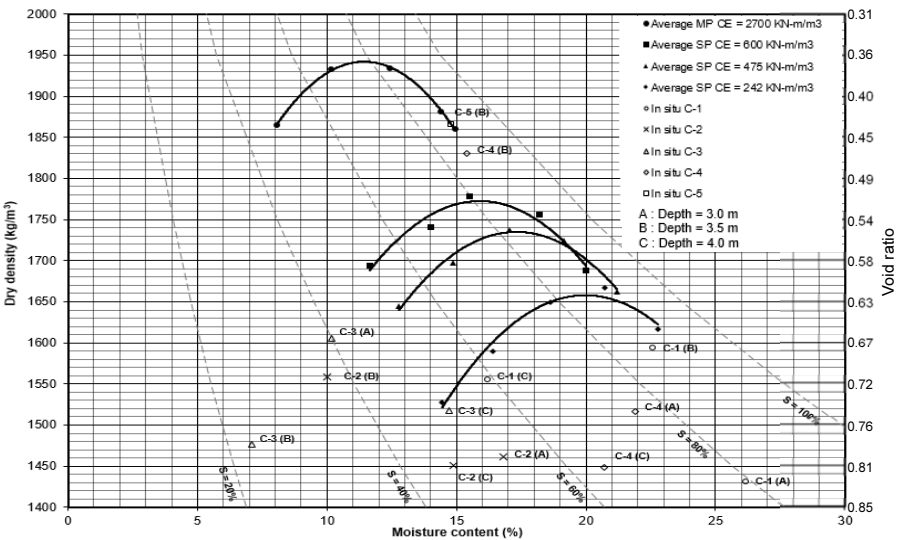
In Figure 3 it can be seen that, in general, *in situ* dry density values are lower than  $1,600 \text{ kg/m}^3$ , which is equivalent to compaction energy levels below  $275 \text{ kN-m/m}^3$ . The *in situ* moisture content values present a great dispersion, with a minimum of 7% and a maximum of 26%. The degree of saturation of the backfill presents a variable range between 40% and 80%, without reaching the degree of total saturation. Also, it can be observed that the void ratios determined for *in situ* conditions are considerably higher than the void ratios corresponding to compacted materials.

Figure 3. Compaction lab tests and *in situ* compaction measurements in trial pits C-1 to C-5.

Considering the previous analyzes, it is evident the existence of around 5 m of an uncontrolled backfill (even conformed without any type of compaction, or simply compacted by the passage of trucks) below the foundation levels (between 3 m 8.5 m deep), in those sectors of the parcel where significant settlements were observed in the installed structures. Likewise, it is clear that the degree of compaction of backfill conformed in the critical zone of the parcel, does not comply with the conditions stipulated in section 3.7 of the PDVSA AK-11 standard.

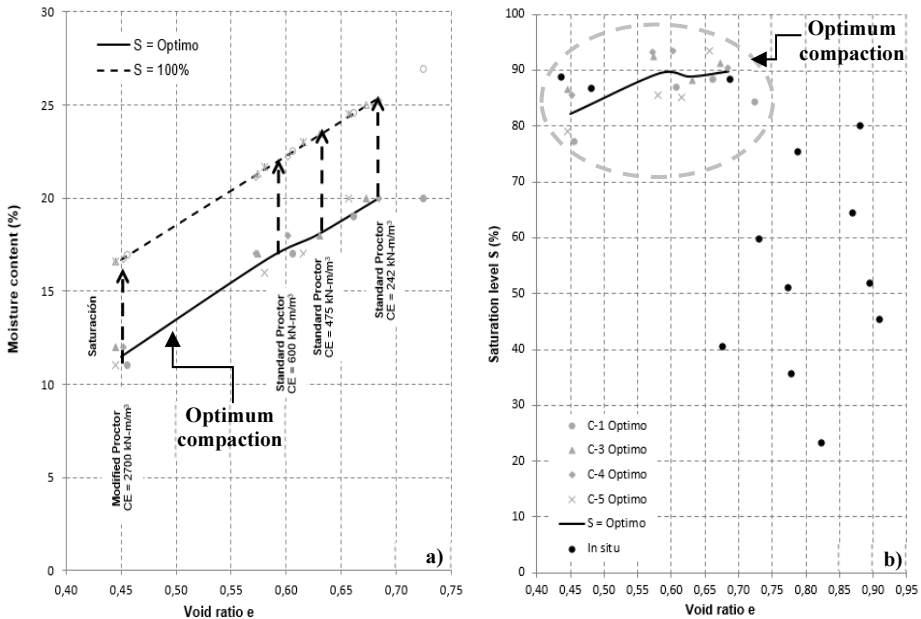
**Figure 4.** Moisture content vs. void ratio for different compaction energy levels (CE) and saturation ( $S$ ), and *in situ* conditions according to measurements in trial pits C-1 to C-5.

According to the information shown in Figure 4, the materials compacted according to the pattern derived from a modified Proctor test, and subsequently saturated due to some external reason, would not reach moisture content values higher than 18%. For uncontrolled backfills conformed with the same material, in which the void ratio could be greater (and therefore have greater capacity to store water), moisture content values higher than 30% would be reached in case of saturation of the material.

Considering the analyzes carried out, it is clear that, in general, the effect of softening by saturation of the backfill is less significant than the low resistance of the material due to the low compaction energy. This can be explained because the *in situ* saturation levels present a great variability (between 20% and 90%), and also due to the fact that the greater settlements recorded, do not necessarily correspond to the sectors with higher saturation levels.
