Importance of Shear Stress Anisotropy and bottom drainage on Tailings Dam Stability: a Case History

A slope failure occurred in February 2007 at one of the tailings ponds operated by Solvay in Bernburg, Germany, about 70km North-West of Leipzig. The failure involved about 150,000 m³ of tailings material which flowed through a breach in the dam slope. A detailed investigation was carried out to determine the causes of the failure, so that suitable changes could be made for the future safe operation of the facility.

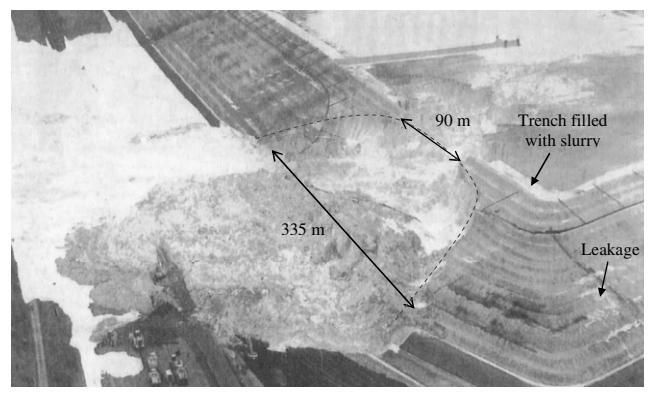
It has been deduced that the failure started by an outward sliding of rigid blocks over a well defined and substantially horizontal shear surface. There were 2 blocks of the dam slope that apparently moved almost horizontally by about 30m to 40m and remained almost intact. The presence of distinct blocks that remain intact, and a steep back scarp, suggests an initial "blocky failure", or rupture of essentially intact material over distinct shear surfaces.

The failure apparently happened quite suddenly and quickly. The dam material at the slope surface, which is brownish due to oxidation with the air, slid and displaced but remained essentially intact. The part of the sliding block that suddenly came to rest on the Pioneer Dam broke into pieces with the shock loading, while the pioneer dam itself remained in place.

Figure 2 - Aerial photograph of failure

The initial slip failure was confined to the slope of the dam itself, rather than extending behind the dam crest. The shape of the initial failure mechanism is illustrated by the red dotted line on Figure 2. The failure mechanism is about 335m wide at the toe and 90m wide at the crest of the dam.

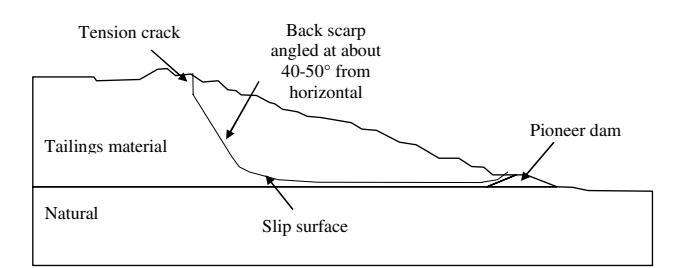
A cross-section of the initial failure mechanism is shown in Figure 3. The slip surface is composed of a vertical segment of about 3.5m and another segment inclined at about $40-50^{\circ}$ from the horizontal. The vertical segment is likely to be due to tension cracks that developed before the failure occurred.

The base of the failure mechanism was hidden by the flow of liquefied tailings that took place following the initial failure, but this was investigated by trial pits and cone penetration tests, as well as simple excavation of the slide material. A clear junction was found between disturbed and undisturbed tailings material, and this slip surface was substantially horizontal and located within the tailings just above the natural terrain.

The Pioneer Dam remained in place and was not part of the initial failure. This implies that the failure surface did not follow the natural soil all the way to the toe of the slope but rose up to avoid the (relatively strong) Pioneer Dam.

Figure 3 - Schematic view the initial slip surface

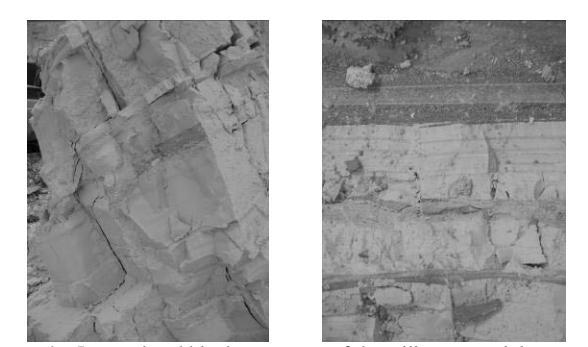
A strong horizontal layering was apparent in the intact tailings material exposed by the slope failure. Many planar discontinuities can be observed in the material, both in broadly horizontal and vertical orientations, as illustrated in Figure 4. This tendency for the material to "break" or "cleave" on well defined planes and surfaces is likely to be a result of the deposition process used for the tailings, or it may be an intrinsic characteristic of the tailings material itself. This structure would suggest possibly anisotropic shear strength conditions. A lower shearing resistance on near horizontal planes through the tailings would also be consistent with preferential sliding along a bedding plane.

Figure 4 – Layered and blocky structure of the tailings material

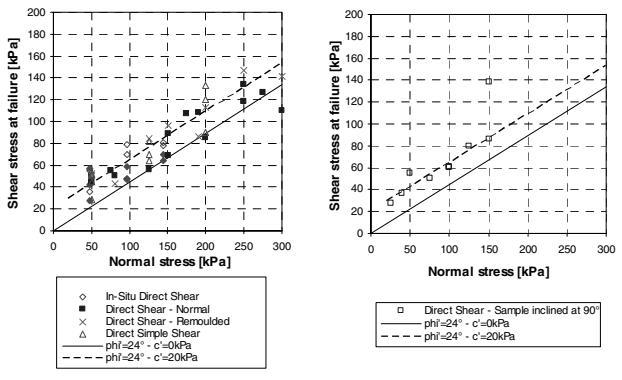
For the relevant range of effective stress investigated (predominantly less than 200kPa), a shear strength envelope defined by a friction angle ϕ '=24° and a cohesion c'=0kPa was found to provide a lower estimate to the measured peak strength, as shown on Figure 5a. This may be considered applicable for shearing along fissures or discontinuities. An additional cohesive component of shear strength is applicable for shear through intact material, and may be represented by a simplified shear strength envelope with a friction angle ϕ '=24° and a cohesion c'=20kPa, as also shown on Figure 5a. At low effective stresses a tension crack is assumed to form at the crest of the slope.

A number of direct shear tests was completed on samples rotated by 90° to represent shearing on inclined surfaces through the tailings, across the natural stratification of the material. The data from these tests are plotted on Figure 5b and correspond quite well with the shear strength envelope assumed for the intact tailings material, Figure 5a.

Figure 5 - Drained shear strength measured in various types of tests

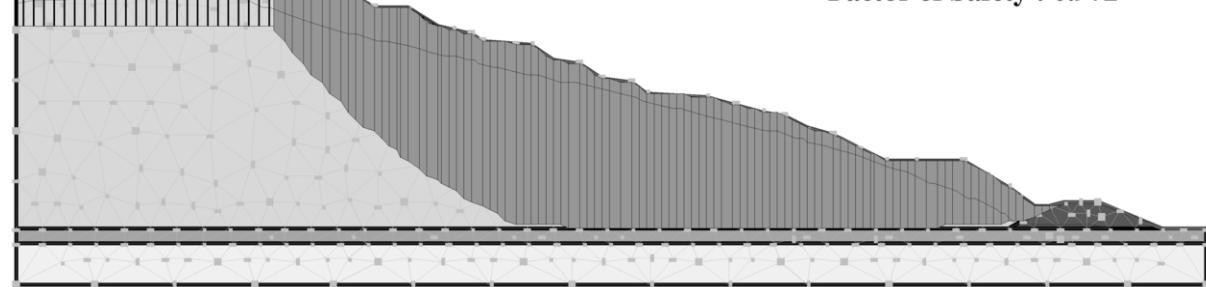
The position of the water level resulting from the steadystate seepage analysis is close and mainly parallel to the dam slope, as shown on Figure 6. This is in line with the observations made on site (i.e. leakage at about mid height of the dam, traces of water at about 3.5m from top of dam).

The slip surface found from stability analysis (assuming the pore water pressures computed from the seepage analysis) captures many observed features of the slope failure. The slip mechanism is illustrated on Figure 6 and the important features include:

- A slip surface within the slope of the dam rather than extending behind the dam crest,
- A steep inclined back-scarp,
- A horizontal plane following the natural soil, and
- A Pioneer Dam that remains in place

Most importantly, the stability analysis indicates a minimum factor of safety close to unity (0.972) for the slope implying limiting equilibrium and expected failure conditions.

Factor of Safety : 0.972

Figure 6 - Failure back-analysis
