Stabilisation of a soft fill slope by compacted rockfill – an example of good practice Stabilisation des pentes de remplissage mou par enrochement compacté – un exemple de bonne pratique

Slobodan B. Mickovski

Jacobs Engineering UK Ltd., 95 Bothwell Street, Glasgow G2 7HX, Scotland, UK

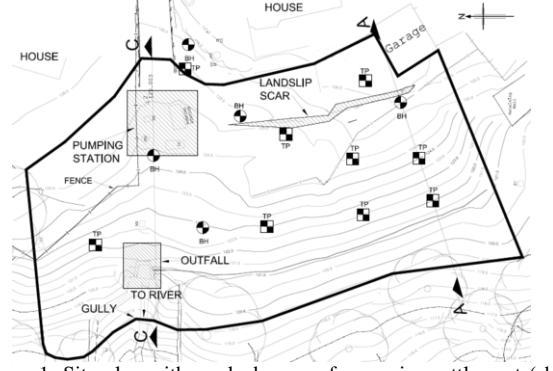
Figure 1. Site plan with marked areas of excessive settlement (shaded regions) and GI locations (BH-borehole, TP-trial pit)

The pumping station comprising a wet well, control chamber and valve chamber, is situated between two residential properties (*Figure 1*). The site boundary includes land owned by the local council, as well as land belonging to the individual owners of the two adjacent properties.

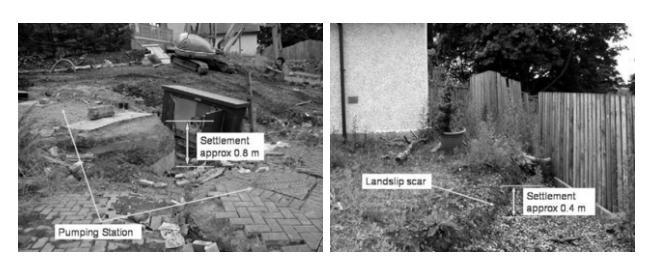
The part of residential development where the Glen Noble SPS is located was completed in 2000, when the SPS was presumably installed. Available records showed that the SPS was fully functional until noticeable ground settlement around the pumping station became evident in February 2005. On the basis of the available records and photographs, the subsidence around the SPS in 2005 is estimated to have ranged between 0.10 m and 0.60 m. The ground settlement around the SPS appeared to have increased in magnitude to 0.6 m – 0.8 m by the end of 2007, when the works described in this study began (*Figure 2a*).

In addition to this, during the same inspection in 2005 a tension crack (landslip backscar) became evident around 10 m to the south of the pumping station, in the garden of one of the properties adjacent to the pumping station (*Figure 2b*). This scar, visible over a 10.0 m length of the slope crest, ran from north to south, approximately 7.0m from and parallel to the western wall of one of the residential properties. The settlement

at the scar increased from 0.1 m- 0.2 m in 2005 to 0.4 m - 0.6 m in 2007.

Figure 2. Magnitude of settlement around the pumping station and in the garden of the adjacent house .

historical records suggested mining as a possible cause. An investigation of the available mining records obtained from The Coal Authority showed mining activity adjacent to the site. However, this mining was at depth and would have resulted in different form of settlements. A more plausible explanation for the settlement was leakage of the water pipes and seepage through the fill materials, softening and reducing shear strength, washing out fine particles and promoting settlement. This was corroborated by the Contractor's reports of displaced and broken pipes at approximately 4.0 m bgl adjacent to the PS several months prior to the commencement of the restoration works.

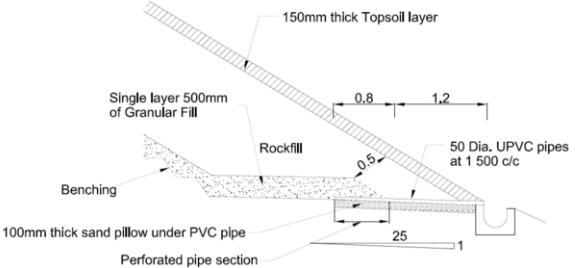
Figure 3. Typical design of filter layer and contour drain channel.

On-slope drainage was provided via a contour U-channel drain made of 1.0m long concrete sections running along the toe of the remediated slope and discharging into the new outfall structure (*Figure 3; Figure 7*). Permanent surface drainage in form of a new gully channel drain was installed on crest and above SPS to prevent surface water from entering the slope.

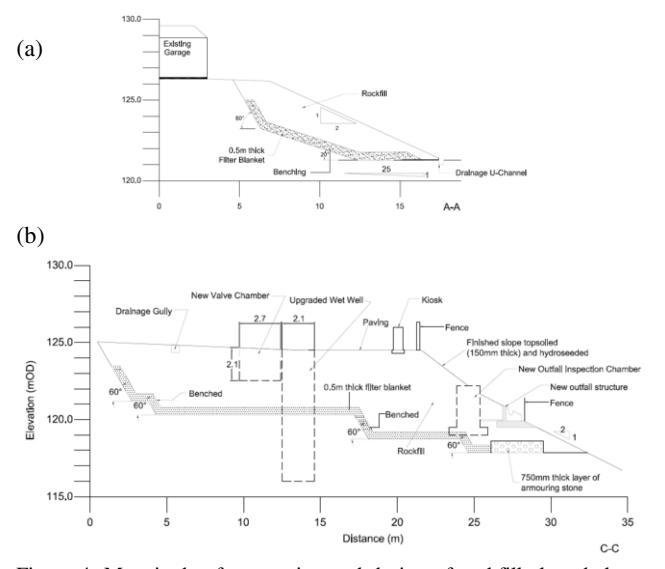
Figure 4. Magnitude of excavation and design of rockfill slope below the landslip scar (a) and around the SPS (b).

During construction, special attention was paid on the correct excavation angles for the back- and the side-cut, to ensure maximum excavated soft material at safe back-cut angles (*Figure 4*). All excavated slopes were benched as recommended by the Highways Agency (2007) and GEO (1984). The total excavated volume was approximately 1800 m³.

Due to the variability of the fill thickness, depth to in-situ till and/or depth to bedrock throughout the site, the thickness of compacted rockfill ranged from 2.0 m to 5.5 m, and was greatest in the area adjacent to the PS (*Figure 4*).

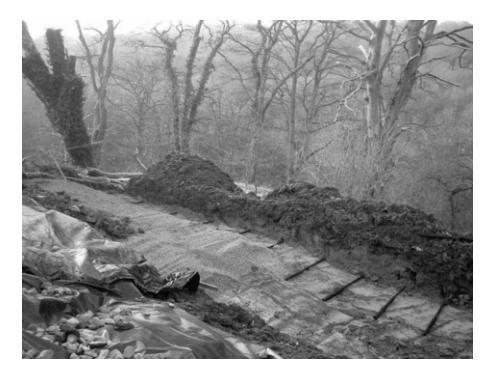
Figure 5. Laying out of the perforated drainage pipes and the filter layer.

After excavation to the base line, a 100 mm thick sand layer was laid and the perforated PVC pipes were laid on top of the sand (*Figure 5*). The purpose of this layer was to prevent migration of fines from the clay base and potentially blocking the drainage pipes. Granular filter layer was then laid and lightly compacted above and around the pipes, before placement of the layers of rockfill and compaction (*Figure 6*) in accordance with Specification for Highway Works (The Highways Agency 2009).

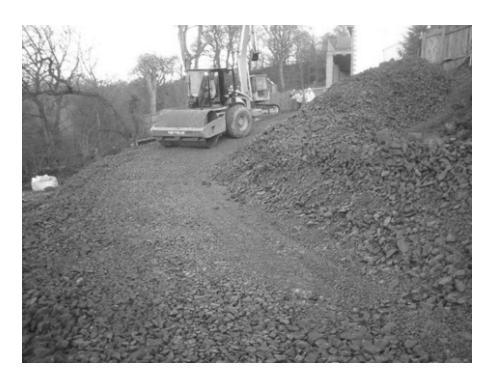
Figure 6. Compaction of the rockfill in layers.

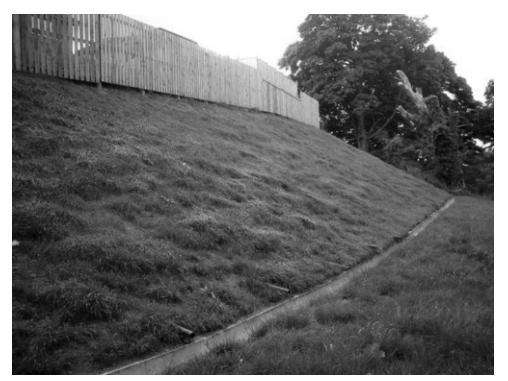
Figure 7. Completed vegetated slope with contour channel drain at the toe.

Compacted rockfill was used to stabilise a failed fill slope around and adjacent to a pumping station in a residential area south of Glasgow, Scotland. It was considered that the cause for the failed slope was connected to washout due to burst utilities. The rockfill provided advantages over the option of re-use of the existing cohesive fill such as faster, easier and safer construction. The filter layers and drainage pipes were designed remove any water entering the slope. Hydroseeding and planting has proved very successful as shown on *Figure 7*.
