Engineering assessment of jet-grouted structures Valoration technique des structures en sol traitées par jet grouting

M. Arroyo & A. Gens

Department of Geotechnical Engineering & Geosciences, UPC, Barcelona, Spain

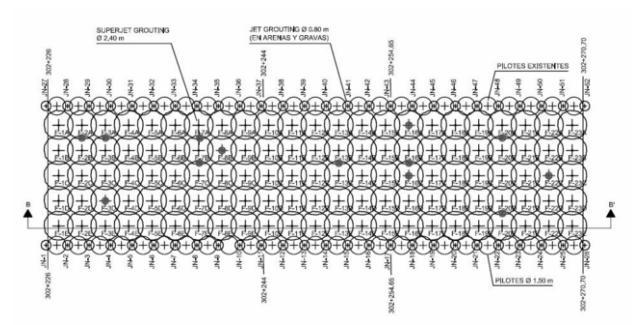
Post-construction treatment control was based on soundings and laboratory testing of recovered samples. A total of 10 soundings were initially considered necessary, and three more were added later. The layout of these soundings is visible in Figure 1; it can be observed that they were located both at the column axis and at column intersections.

Figure 1. Layout of treatment and control soundings at site A

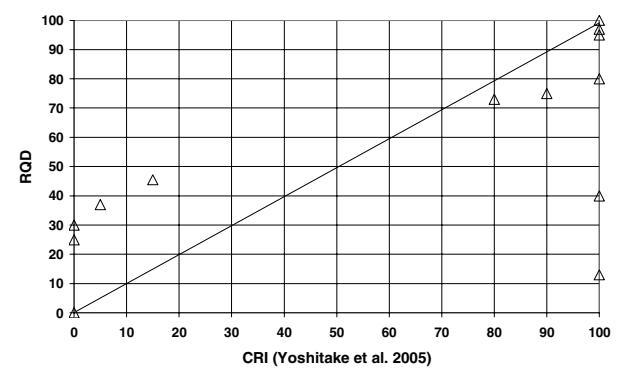
From the results obtained it was clear that crew A was using a drilling practice that damaged the cores, resulting in apparently poorer treatment quality. That was made even clearer when detailed inspection of the coring logs revealed that quality increased systematically when crew A switched from their favorite single-barrel tool to the double-barrel one. Curing time of the columns was long enough for not having had significant influence on the results.

It was interesting to note that the CRI results were less ambiguous than RQD and clustered at both extremes of the scale (Figure 2). Finally, it should be mentioned that the poor recovery of crew A largely diminished the expected amount of samples available for laboratory testing. Only seven samples were finally tested but the worst result recorded was more than three times larger than the target characteristic UCS.

Figure 2. Qualitative evaluations of jet grout cores at site A

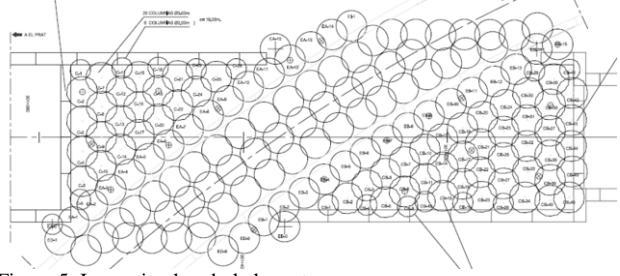
The control plan included several items. On the one hand 17 boreholes were performed for the direct inspection of the treatment outcomes. There were only 102 columns outside the tunnel shadow, thus the rate of direct inspection was fairly intense. The borehole layout is shown in Figure 5.

Figure 5. Inspection borehole layout

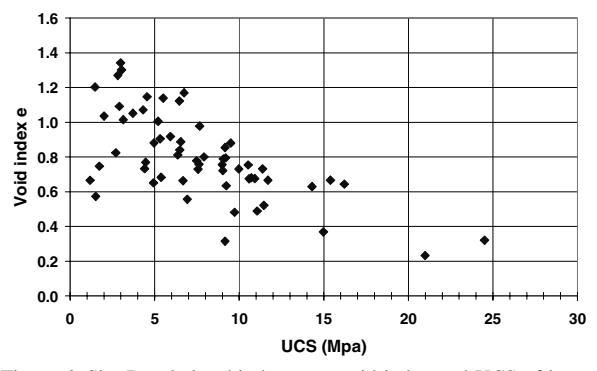
Laboratory tests on the recovered samples showed a profile of UCS that, to a certain extent, mimicked that of cone resistance at the site. The values measured were well above those required. It was interesting to note that there was a clear inverse relation between the void ratio of the treated soil and the UCS (Figure 6). It was noted that a large number of samples had void ratios that were well above those initially estimated for the original soils. On the basis of these results the material quality of the treated soils was deemed appropriate.

Figure 6. Site B: relationship between void index and UCS of jet-grout samples

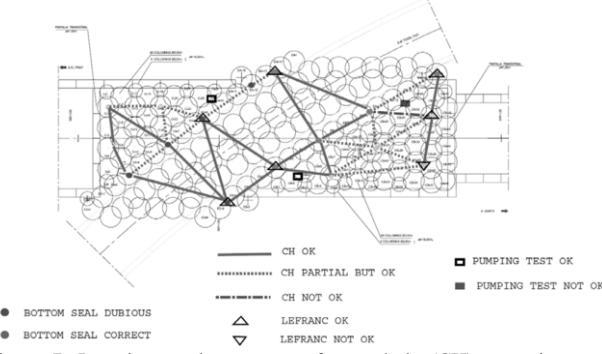
Cross-hole results were sometimes affected by borehole obstruction. This meant that alongside several paths the tests were only partially penetrating. About 25% of the 1 m spaced shots had problems in transmitting shear waves. However, whenever such failed shots were isolated, borehole sealing problems were deemed responsible. When there were several shots in series showing the same problem and different results where observed in other directions, treatment gaps were suspected. Whenever transmission was successful, the original shear wave velocity multiplied by a factor of 5 or more. The cross-hole paths were thus classified as shown in Figure 7.

Figure 7. Locations and outcomes of cross-hole (CH), pumping and Lefranc tests, and estimation of bottom jet grouted slab state

The three pumping tests were transient-type and permeability was obtained from recovery curves. Those tests resulted in significantly higher permeability values than the Lefranc tests. Two of them gave values around 1E-4 cm/s and the third gave a permeability of 1E-3 cm/s. The latter result was taken as an indication of treatment deficiencies. The locations of the permeability measurements are indicated in Figure 7.

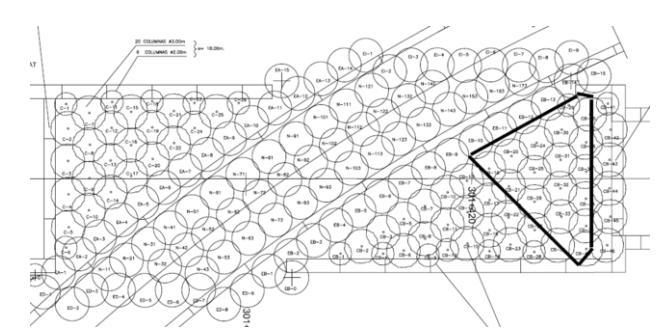
Figure 8. Treatment zone that was reinforced with low-pressure grout at inter-column gap locations

As a result of the various controls, there were significant doubts concerning several areas of the treatment and a number of repair actions were advised in the accessible areas (outside the existing tunnel shadow), before starting the excavation. the main one consisted of low-pressure grouting at a series of inter-column gaps, in the area where permeability tests and cross-hole results were unsatisfactory (Figure 8).
