Corrective grouting in sand to restore pile foundations, Vijzelgracht, Amsterdam Injection corrective dans le sable pour reconstituer la portance des pieux de Vijzelgracht à Amsterdam

A. Bezuijen

F.J. Kaalberg, R.E. Kleinlugtenbelt & R.P. Roggeveld Witteveen + Bos Consulting Engineers, Amsterdam, The Netherlands

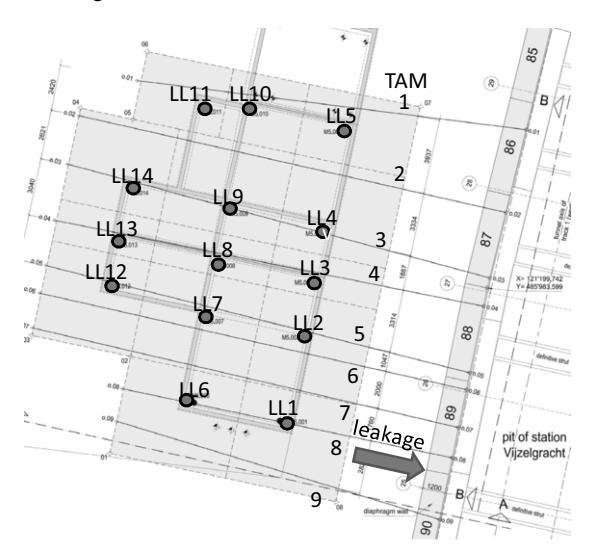
Figure 1. Top view of corrective grouting location, Vijzelgracht.

The layout of the site is shown in Figure 1. The diaphragm wall is shown on the right side of the picture. The big grey area is the corrective grouting area, the lines are the TAMs and the thick, grey lines show the positions of the foundations of the settled buildings.

The foundations of these 17th century buildings consist of a row of 2 wooden piles under the brick walls to a depth of -13 m below surface into the 1st sand layer, see Figure 4 (Netzel and Kaalberg, 2000). The positions of the liquid leveling instruments (LL1 through LL14) attached to basement walls

that were used for the displacement monitoring, are presented in Figure 1 as well as the position in the diaphragm wall where the leakage occurred (between panels 89 and 90).

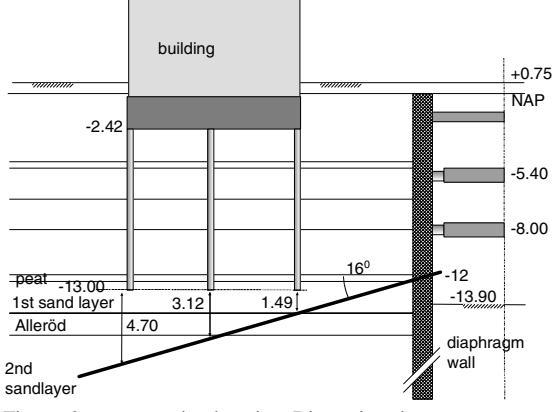
Figure 2. cross-section location. Dimensions in m.

A cross-section is shown in Figure 2. The TAM's were placed at an angle of 16 degrees. Horizontal TAM layout was not possible because it was not allowed to excavate the box further before stabilizing the buildings.

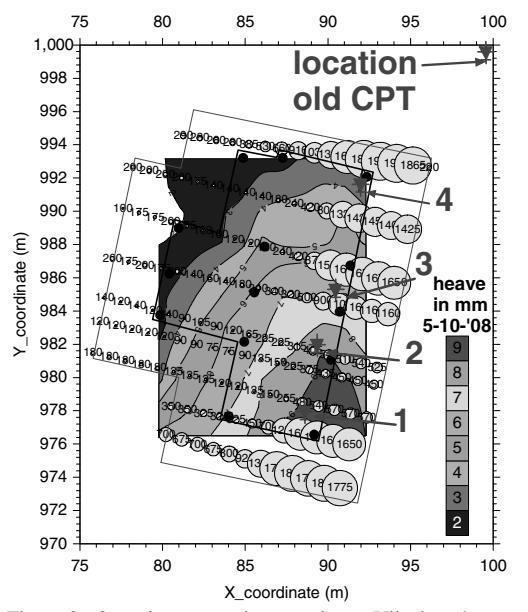
Figure 3. Overview corrective grouting at Vijzelgracht, see also text.

Figure 3 shows an overview of the corrective grouting site. The figure shows in plan view the position of the piled foundations (the black lines), the positions of the liquid leveling points (the black dots), the total amounts of grout injected in litres during the project (the grey circles) and the heave created at the end of the corrective grouting project. The heave indicated is the heave of the basement walls and is interpolated from the results of the liquid leveling system. Additionally Figure 3 shows the position of 5 CPTs: An 'old CPT' taken before the start of the works for the station, and 8 CPTs in the basements of the building. (4 taken before and 4 after the corrective grouting). Each pair of CPTs indicated with the same number are performed within a distance of 0.5 to 1 m.

The achieved heave pattern (see Figure 2) is almost exactly according to the target values, however the correlation with injected volumes is not directly clear. A lot of grout was injected using the TAMs 8 and 9 (see Figure 1 and Figure 3) before some heave is created in this area. The soil has to be strengthened in areas of former ground loss before heave can be achieved. The achieved heave decreases gradually towards TAM 1. One could expect a decrease of injected volumes from TAM 9 towards TAM 1 as well. This is not the case as can be seen in Figure 3). Above the TAM's 5,6&7 a relatively low grout volume is used. The reason for this is the presence of the strengthening timber stability beams which were installed in the buildings. The process operators observed also heave above the TAM's 5,6,&7 when injections were performed in the TAM's 8&9. The stabilizing cross timber beams appeared to have stiffened the buildings so much that it acts like a girder itself, spanning the support area above TAM's 8&9 and 1 to 4. When this phenomenon was acknowledged the bolts connecting the temporary timber cross beams were loosened and the building settled 1-2 mm in the area above TAM's 5-7. In the remaining part of the grouting operation it appeared not necessary to disproportionally increase the injected volumes in TAM's 5-7 in order to maintain a smooth heave pattern. The explanation for having injected relatively large grout volumes above TAM's 1-4, whereas the anticipated (and achieved) heave was relatively small, is related to the fact that this area is connected to an adjacent building of the block which loads also partly have to be lifted. Close before reaching the target values the stabilizing timber cross beams were "locked" again, however it was decided not to remove them but finish the corrective grouting process at the target values, as was agreed before with the municipal authorities.

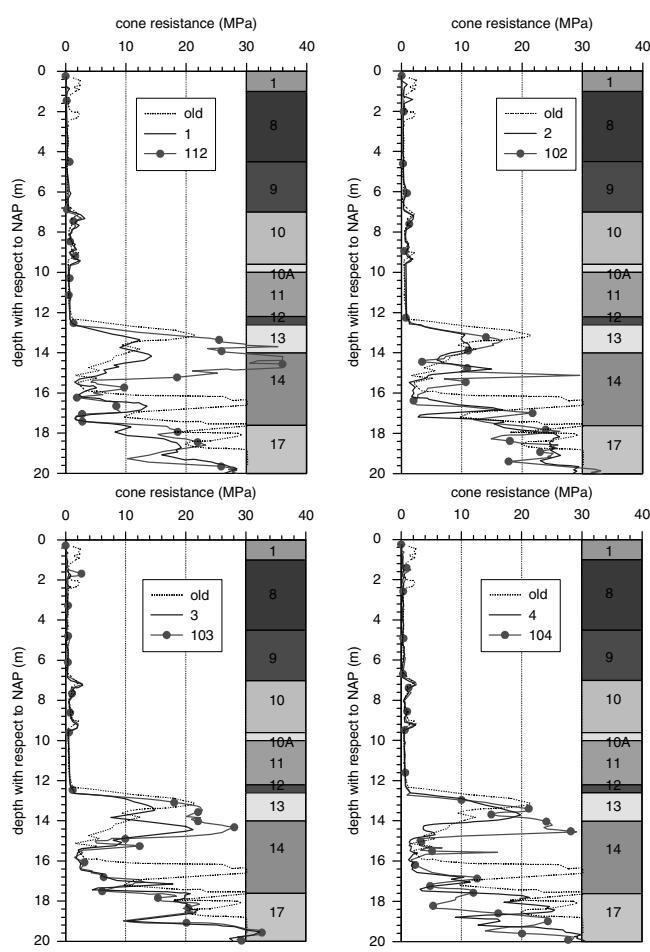
Figure 4: CPTs for location 1, to 4 before (1 - 4) and after (112,102 - 104) the corrective grouting campaign, but both after the leakage compared with the 'old CPT'. Locations see Figure 3.

The results of the old CPT and the CPTs after the leakage, before and after the corrective grouting campaign are shown in Figure 4.

The colours on the right side of the plots show the different layers in the Amsterdam subsoil at Vijzelgracht. Layers with a number less than 13 are soft Holocene layers as can be seen from the CPTs. 13 is the first sand layer, in which the pile toes are founded and which consists originally of medium dense, medium fine sand, 14 is Alleröd, a sandy silt layer and 17 is the second sand layer, fine to medium coarse sand. In places where a lot of grout is injected (at the location of CPT 1), there is a very large increase in cone resistance. For CPT 2, where much less grout is injected, the increase in cone resistance is only limited. For CPT 4 the increase in cone resistance was only limited and the increase in cone resistance is mostly located underneath the first sand layer (no.13).

This corrective grouting project was performed in rather disturbed soil conditions. Due to the ground loss through the diaphragm wall there will locally be areas in the first sand layer (the layer that supports the piles) that have a lower density than other areas. It is clear from the CPTs in Figure 4 that the cone resistance has been significantly reduced close to the location of the leakage (CPT 1 and to a lesser extent CPT 2). Also CPT 3 shows a reduction of the cone resistance in the first sand layer. Only for CPT 4 this is not the case.

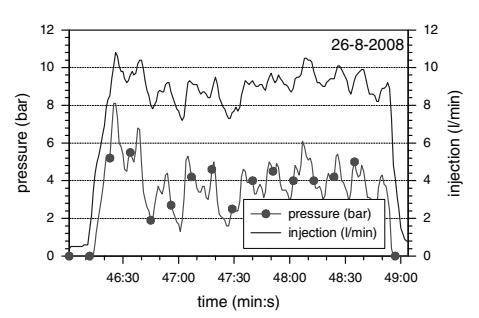
Figure 5. Example of a registration with a low injection pressure.

Figure 5 and Figure 6 show examples of a pressure registration with a low and a relatively high grouting pressure. Taking into account the pressure loss due to the injection system and the TAM, there is hardly any pressure necessary for the injection shown in Figure 5. Both plots show a pressure that fluctuates with the injection rate.

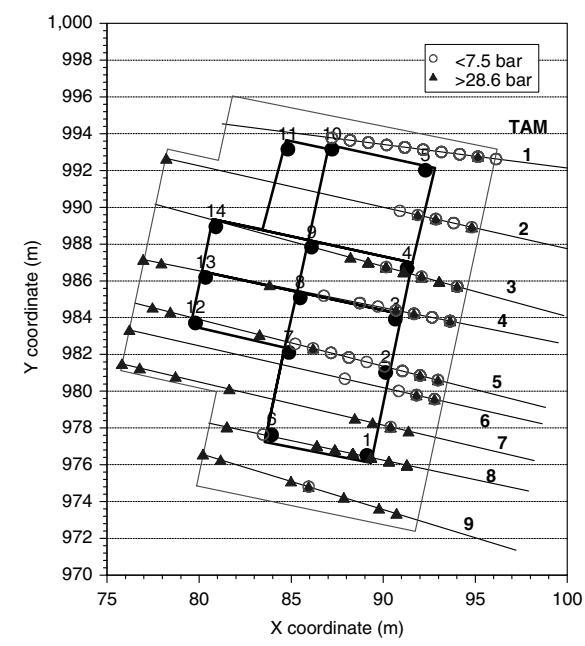
Figure 7. Locations where low and high injection pressures were found.

In addition, it was investigated where the injections with the lowest grouting pressures were found. The 100 lowest and 100 highest pressures found (of the total of 3,535 injections) were selected and their locations are plotted in Figure 7 (some injections with low or high pressure were at the same location, therefore there are not 100 markers for each selection). It shows that from TAM 1 (the highest black line in the plot) a lot of injections were performed with low injection pressures and

hardly any with high pressures. The TAMs 7, 8 and 9 have a lot of injections with the highest pressures.

Still puzzling are the low injection pressures that were found around TAM 1. Compaction grouting should lead to higher injection pressures. It is possible that inhomogeneous soil conditions lead to an easy path for the injection fluid.

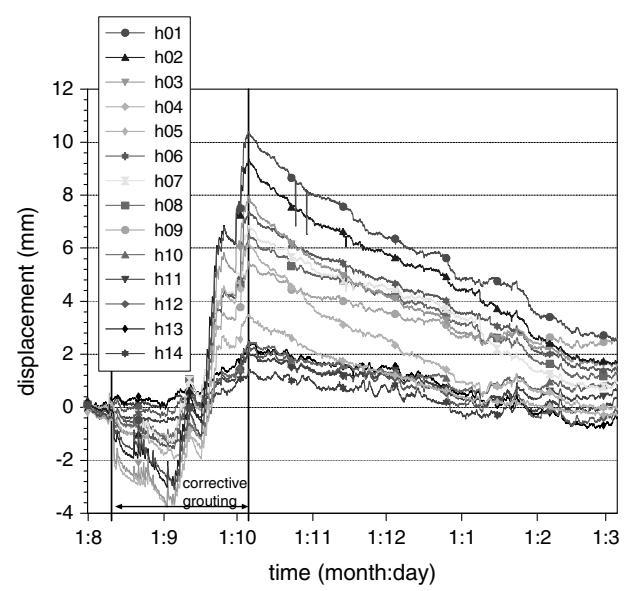
Figure 8. Heave and settlement as a function of time.

Figure 8 shows the heave and settlement measured just before, during and after the corrective grouting campaign. The vertical lines in the figure indicate the period in which grout was injected.

The figure shows that although the grout injections that start at 10-08-2008, it first only increased the settlement rate, probably due to disturbance of the 1st sand layer by the TAM installation and first injections. Most settlement was recorded at the instruments LL3 and LL4 at some distance from the leakage, see Figure 1. The injection of the first 21,000 liters of grout did not directly reduce the settlements but were needed to strengthen the soil and to reduce the progress of ongoing settlements. Grouting in September and the beginning of October of 2008, when another 62,000 litres were injected, led to heave of the buildings. In the periods between the grout injections there was still an ongoing settlement. The settlement more or less continues after grouting stops. In the few days before grouting there is a settlement rate that is comparable to what is found directly after the injections (approximately 0.05 mm/day for the instruments that settle most). In between the grouting periods a larger settlement of up to 0.2 mm/day was found.

The ongoing settlements of the buildings after finishing of the grouting process were more than expected but the settlement rate seem to decrease after 5 months (see Figure 8). A possible explanation is that during the incident the weight of the building is partly taken by the friction between the piles and the soft soil layers above the first sand layer. When the grouting stops, the soft soil layers will consolidate (these layers were disturbed by the leakage and the grouting) and will develop a negative skin friction on the piles. The pile foundation is still loaded on ultimate bearing capacity and therefore the development of negative friction will lead to extra settlement. This settlement will continue until the consolidation of the soft layers is finished and the friction piles become end bearing piles again. The construction with the stiff timber beams explains that there is hardly a correlation between the location where the grout is injected and the location where the heave is measured.
