The influence of clay wetting on geomembrane-clay interface strength L'influence de humidification d'argile sur la résistance à l'interface entre la géomembrane et l'argile

Tomislav Ivšić, Franjo Verić & Hrvoje D. Zlatoper

Department of Geotechnics, Faculty of Civil Engineering, University of Zagreb, Kaciceva 26, HR-10000 Zagreb, Croatia

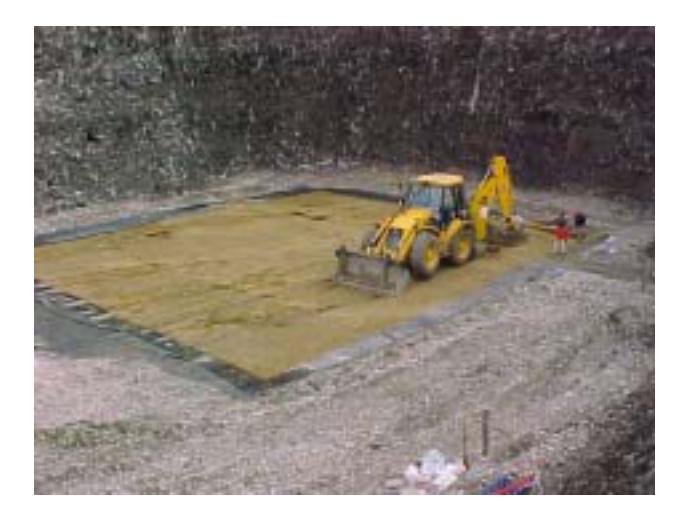
In order to reach the damaged area, the corridor in the width of 30m (expected length of damage) was excavated into the slope of waste body. The excavation of waste ended in July 2003, then the protection and drainage layers were removed and the area approx. 25x15 m was examined (Fig 1).

Figure 1. Investigation area inside the waste body

Samples of clay and geomembrane were taken for further testing. After completion of the inspection, the damaged part was remediated, the snapped cables of leak detection were repaired and pit was filled with waste to required height.

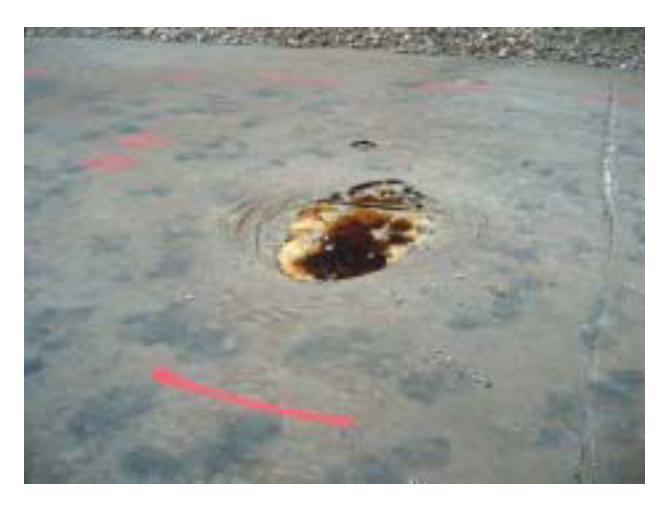
- the geomembrane was damaged in a zone of few meters wide in the direction perpendicular to the main waste slope. The damage consisted of several ruptures and cracks. Maximal crack width was about 50 cm. One of the smaller ruptures is shown on Fig. 2.

Figure 2. Smaller geomembrane rupture in damaged zone

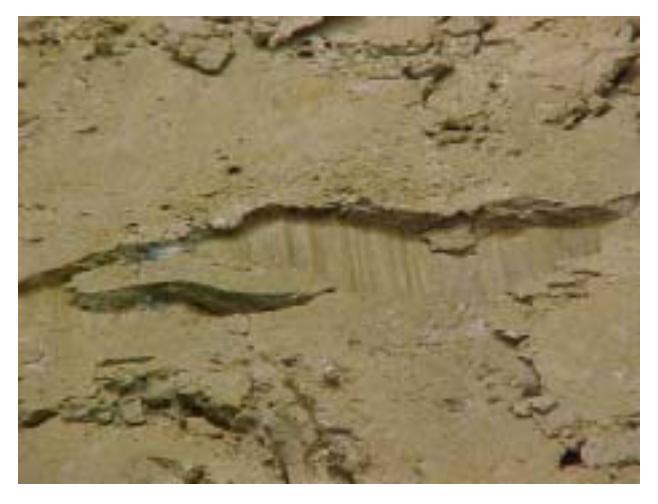
- clay underneath the geomembrane was somewhere very soft which indicates excessive water content

- the slip plane was observed in the superficial clay layer 1-3 cm under the geomembrane (Fig. 3). When the geomembrane was removed this surface layer mostly remained "stuck" to it

Figure 3. Slippage of softer clay layer over firm clay base

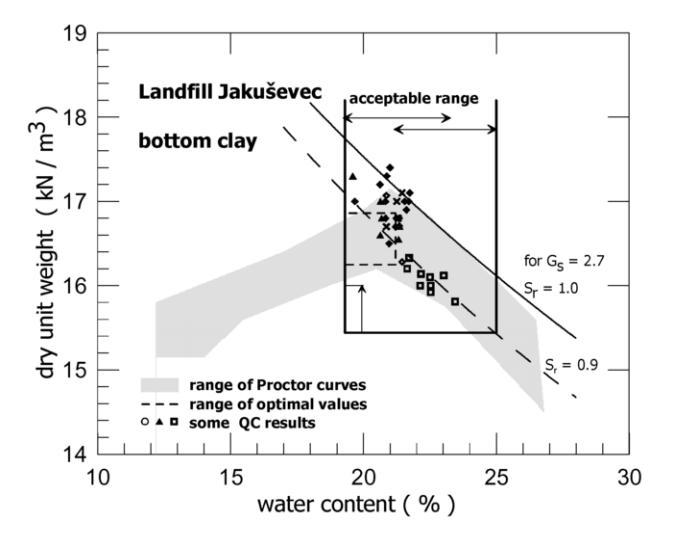
Figure 4. The range of field compaction conditions on Cell 4

The range of clay compaction conditions on site is presented on Fig. 4, using data obtained from quality control (QC) program. The design specifications defined the acceptable field range with dry unit weight greater than 95% of optimal value and field water content, w, between w_{opt} and $w_{opt} + 4\%$. The optimal values were defined individually for each part of clay borrow pit and relevant liner construction sections.

The bottom clay liner was constructed in four layers of 25 cm. Also presented are some control results for top layer of liner (beneath the geomembrane) made by nuclear probe. Other testing methods showed similar results. The results are within acceptable range, although some results show unlikely saturation over 100% when compared with theoretical curve for average clay specific gravity of 2.7.

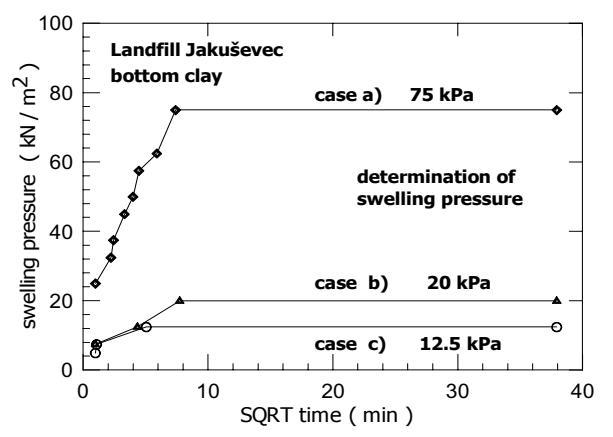
The results are presented in Fig. 6. The range of swelling pressures from 12.5 to 75 kPa means that the heave of bottom clay liner (when wetted) could be prevented by weight of 0.5m of drainage gravely layer and at least 1m of compacted waste for the loosest compaction conditions. For the densest state the heave would be totally prevented with several meters of waste overburden.

Figure 6. Determination of swelling pressures

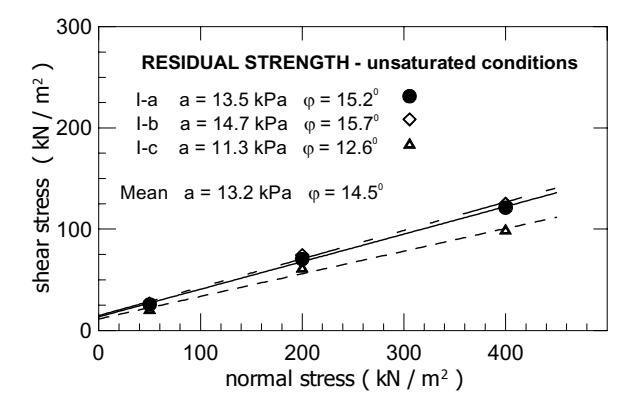
Figure 10. Residual interface strength - unsaturated specimen

For unsaturated "as compacted" specimen the differences are more pronounced in peak values than in residual. For the samples near Proctor optimum values (cases a and b) the residual strength values are virtually the same, while the looser and wetter case c consistently gives lower values.

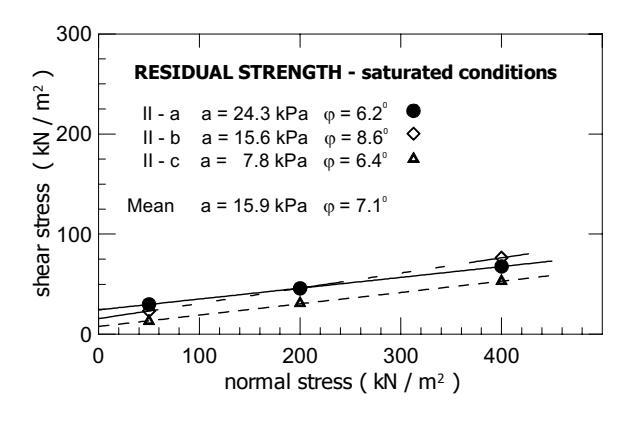
Figure 11. Residual interface strength - wetted specimen

For the specimen pre-treated by unconfined flooding and soaking of water the trend of results is similar, except that difference between peak and residual values is not large.

The pre-treatment gave significantly lower strength parameters. The difference is obvious in friction angle which for wetted specimen has value about half the value of "as compacted" specimen. Also, in the same test series the values of friction angle are about the same, while some differences could be found in values of apparent adhesion.
