Analysis of Solidification Crack in ERNiCr-3 Nickel-Base Filled Welding Metal

> Abstract. Through the observation of microstructure and crack morphology, the crack properties and causes of F92/Super304H dissimilar steel welding joint filled with ERNiCr-3 wire was analyzed. Results show the crack was distributed along the crystal and located between dendrites or subcrystals in the center or near the center of the 4th and 5th weld layers. Both dendrites with consistent direction and crystal cells formed on the free solidification surface can be observed on the crack surface. The crack can be identified as welding solidification crack because of its typical morphological characteristics of weld metal solidification crack. The reason for the crack was the weld width of the 4th and 5th layers with $16 \sim 21$ mm and one weld bead for each layer. The wide weld bead caused the weld metal to stay at high temperature for a long time, and the weld metal generated coarse and developed dendrites with consistent direction. Elements such as Ni, Nb, Si and Ti have segregated between dendrites or subcrystals to form low melting point eutectic such as Ni-Nb and Ni-Si. Cracks were generated along

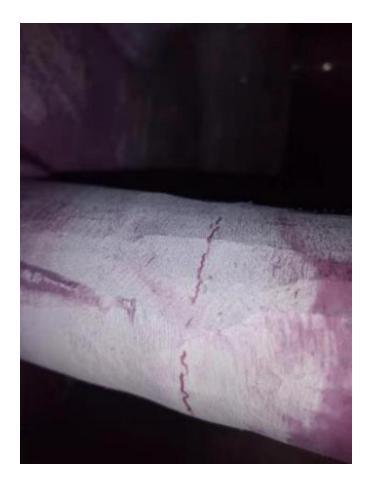
Figure 1. Crack morphology on-site superheater tube.

Macroscopically, the cracks are distributed longitudinally along the weld (figure 1), and cracks are only observed in the 4th (figure 3) or 5th welds, and some cracks are continuous or extend from the 4th to the 5th weld (figure 2), even part of the crack extending to the surface of the 5th pass (figure 1). The cracks are all located in the center or near-center area of the weld, as shown in figure 2 and figure 3. Some welds have only one crack, and some welds have multiple cracks (figure 4).

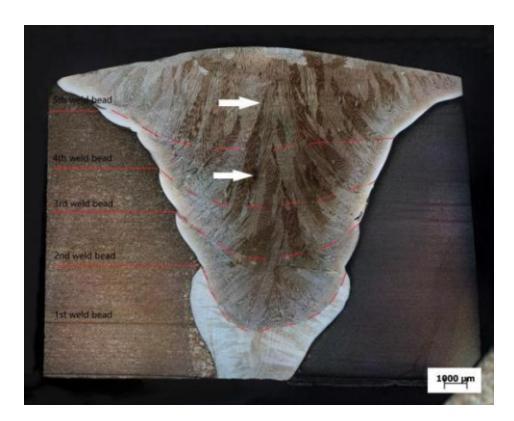
Figure 2. Weld Bead Layout and Crack Location.

As shown in figure 2, there are 5 layers of welds with one weld bead for each layer, which is consistent with the requirements of the welding procedure specification. Among the 5 layers of weld bead, the 1st, 4th and 5th layers are slightly thicker, ranging from about 2.5mm to 3.5mm, and the 2nd and 3rd layers are relatively thin, about 1.5 to 2.0mm. The bead width of the 4th and 5th layers increased significantly.

The contents of Cr and Ni in the central area of the weld shown in figure 2 were analyzed by semi-quantitative spectrometer. The Ni content from 1st to 5th layers is 21.5%, 35.8%, 46.0%, 48.0%, 50.8% sequentially, and the Cr content is 16.5% %, 18.7%, 19.0%, 19.5%, 19.5% sequentially. According to the changes of Cr and Ni content, it can be seen that the weld dilution rate is significantly reduced from 4th and 5th layer.

temperature increases, so the columnar crystals of the 4th to 5th layers are far more developed than the 1st to 3rd layers, as shown in figure 2 and figure 3. The weld width increases, the weld fusion ratio decreases, and the content of Ni, Nb, Si, Ti and other sensitive elements that promote hot cracking in the weld is higher, which can be seen from the content of Cr and Ni in each layer.

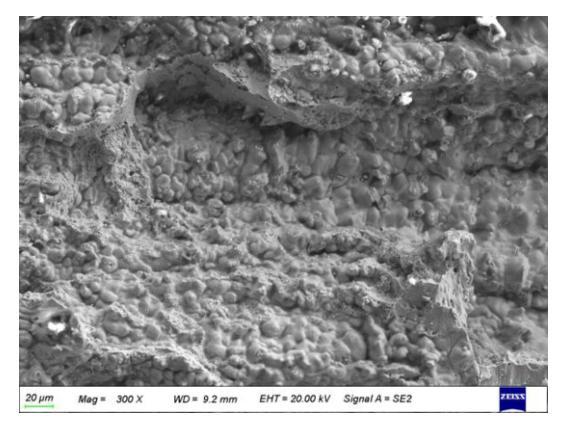
The crack section was broken and observed under SEM. It was found that the crack surface had columnar crystals with uniform orientation and free crystallizing unit cells, commonly known as "potatoes", which had the characteristics of free solidification crystal morphology, as shown in figure 5.

Figure 5. Crack section morphology.

on the crack section is the morphological feature of free solidification crystallization, indicating that no solid-state bond has formed between the crack surfaces, and the crack is the result of the separation of the local weld metal in the liquid state, which is the characteristic morphology of solidification cracks or crystallization cracks that distinguish them from other cracks. According to these characteristics, it can be determined that the ERNiCr-3 nickel-based filler weld crack of the F92/Super304H dissimilar steel joint is a welding hot crack, and it belongs to the solidification crack of the hot crack.

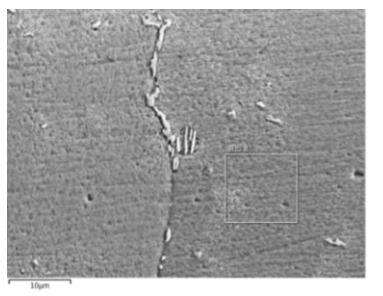
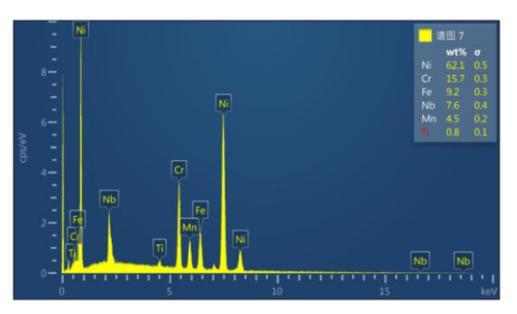
The weld metal structure is coarse developed austenite columnar grains and subgrain boundaries (figure 2-figure 4), and the growth direction of the columnar grains is consistent with the heat dissipation direction. White precipitations can be observed on the grain boundaries, as shown in figure 6. They were confirmed Ni- and Nb-rich phases by X-maxⁿ spectrometer analysis.

Figure 6. Morphology and composition of grain boundary precipitates.

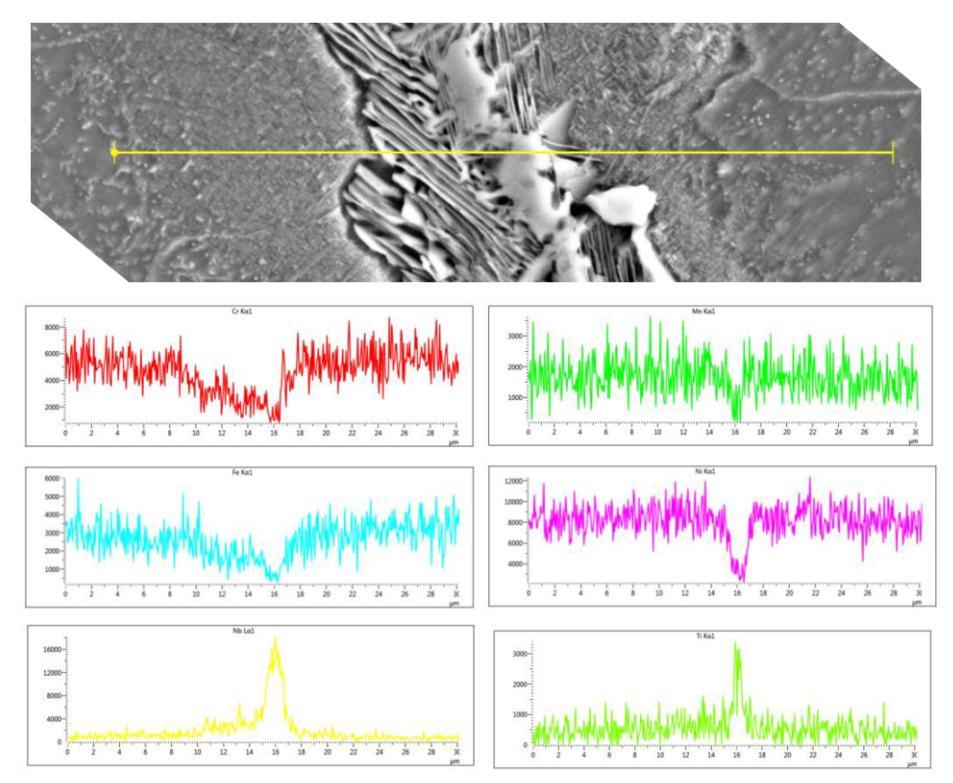
White precipitates and needle-like structures were presented near the cracks (figure 7), which was obviously different from the non crack region (figure 6).

SEM analysis shown that elements Ni, Cr, Nb, Si, Ti and Mn have obvious segregation, especially Ni, Nb, Si and Ti, as shown in figure 7. Their content in the crack area were much higher than that in other areas, for example, the highest Nb content measured is 10.9%, far exceeding the average content by 3.0%.

Figure 7. Element Distribution in Crack Area.

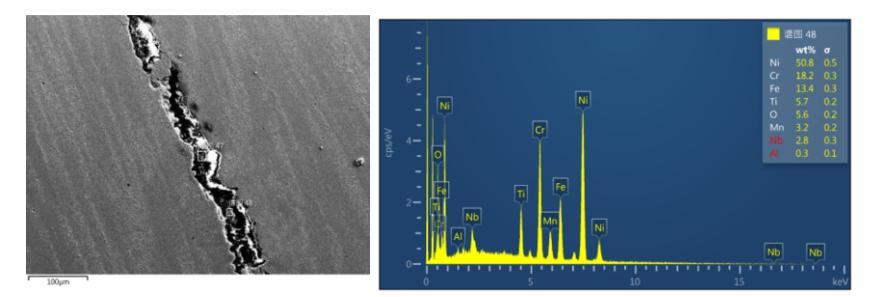
There are inclusions inside some cracks (figure 8). The energy spectrum analysis of the inclusions shows that there are relatively high contents of elements such as O, Ti, and Al, indicating that they are deoxidized products during welding. Inclusions were not observed in some cracks, which may be crack propagation segments.

Figure 8. Inclusions in Cracks.
