# Buildings serviceability restoration and reconstruction in the Kyiv urban conditions

I.V. Matveev, V.G. Milavskiy, A.I. Kisil, Yu.I. Ishchenko

*The State Enterprise Государственное предприятие «The State Research Institute of Building Construction», Kyiv, Ukraine*

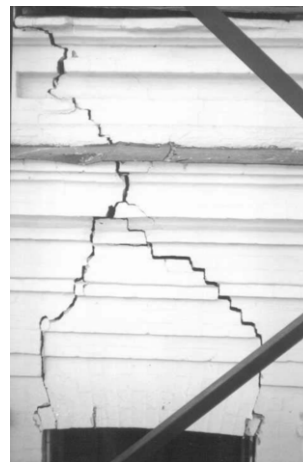
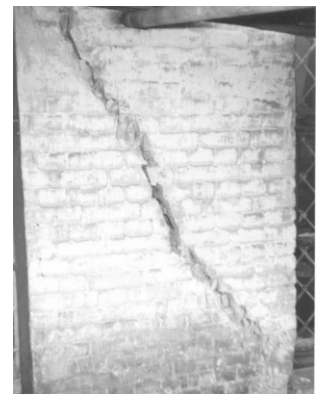
Figure 1. The failures of the MFA of Ukraine Diplomatic Academy building walls:

The annex as the first outhouse experienced much more deformations. Its facing wall had several fractures dividing it into separate blocks. The two of blocks were inclined from the wall surface up to 25 cm along the parapet. The outer wall of the corner insertion between the building and annex had sizable cracks and an inclination of the same degree towards the square. The building was in an emergency condition. The deformation examples are given in Fig. 1.

a - an arch fracture of the brick beam; b - a wall fracture in the ground floor piers level

For the purpose of the building serviceability restoration the works were performed as follows:

- Establishment of the strain joint between the annex and building central part;
- Strengthening of the existing strip foundations by piles pressed in from under the existing foundations base;

- Improvement of the spatial position of bearing wall blocks by means of the AVK 200-33 automated detilting plant;
- Replacement of the timber overlapping by the concrete one and arrangement of the basement under the whole annex;
- Strengthening with bands and cement mortar injecting into the wall fractures and cracks;
- Replacement of the timber roof by the metallic trusses and carrying out of repair works.

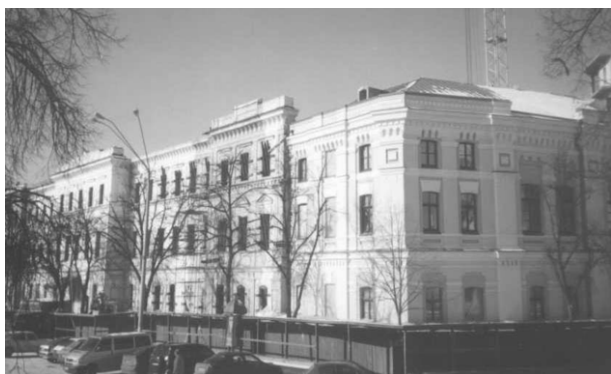
Fig. 2 gives a general view of the building after its spatial position detilting.

Figure 2 The MFA Diplomatic Academy building after detilting its position in a space.

For the analysis of parameters and procedures for structures spatial position improvement the building calculation model was elaborated with the building structures strains, fractures and cracks arisen during the building use period taken into account. The improvement of the bearing walls spatial position using the AVK 200-33 automated detilting plant featured the works executed to elevate the Diplomatic Academy building structures. The maximum lifting of the building central part walls reached 15 cm, of the annex – 26 cm. The fractures and cracks in the walls elevated into the vertical position were closed, and the overall inclinations were put into the permissible limits.
