# Strengthening and underpinning the foundations of the Ministry of Employment and the Economy of Finland at Alexander Street No. 4 and 6

Kari Avellan

*KAREG Consulting Engineers, Helsinki, Finland*

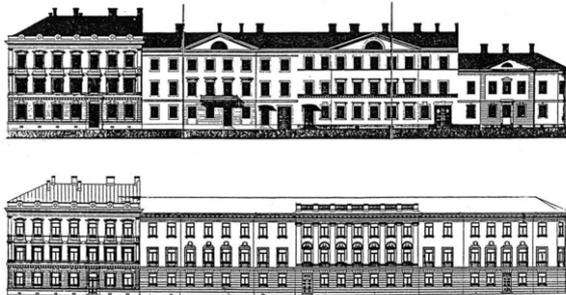
Figure 3. Original facades of Alexander Street and remodelling of 1915 unifying No. 6, 8 and 10.

Renovations in 1913 expanded the premises of Alexander Street No. 6, and in 1915 the facades of the 3 contiguous state addresses were redesigned as a whole, in a uniform Neoclassical style (figure 1 and 3). The current aspect of the ensemble dates from the 1930's when buildings opposite to Alexander Street 4 and 6 were torn down. Around the two courtyards additional functions were grouped in an effective plan. Some of the halls and rooms of the old merchant homes were preserved on the street sides, and parts of the original basements also were kept.

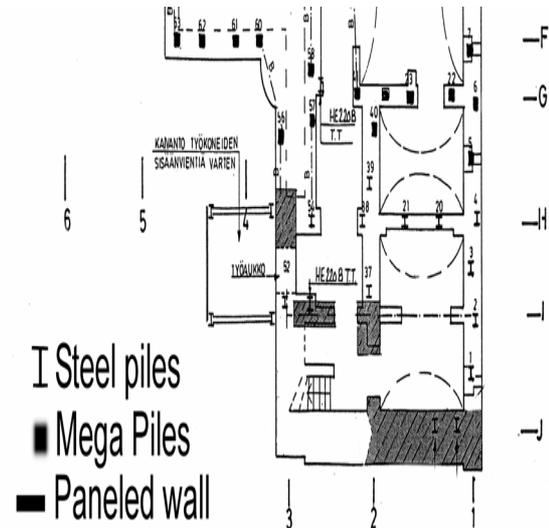
Figure 4. Underpinning plan for the building at Alexander Street 4.

The most important area of the building at Alexander Street 4 was founded on silty sand layer under which is a significant layer of silty clay. The vibration cause by the surrounding traffic was measured in different parts of the structure at a maximum velocity of 10 mm / sec. It was on the basis of this study that the decision to strengthen the foundations was taken. For the part of the building which was resting on a smooth area, walls were underpinned with jacked steel piles and concrete Mega Piles comprising of a section of 30 x 30 cm (figure 4). As for the wall parts of the building which were resting over a hard area, they were paneled (cast in place concrete). The piles situated under the facade walls where the particule velocity was highest (most important traffic vibrations), were jetted. In fact these were the first Mega Piles to be jetted in Finland. Every pile was subsequently tested for characteristic load (serviceability limit state) and the results proved more than satisfactory.

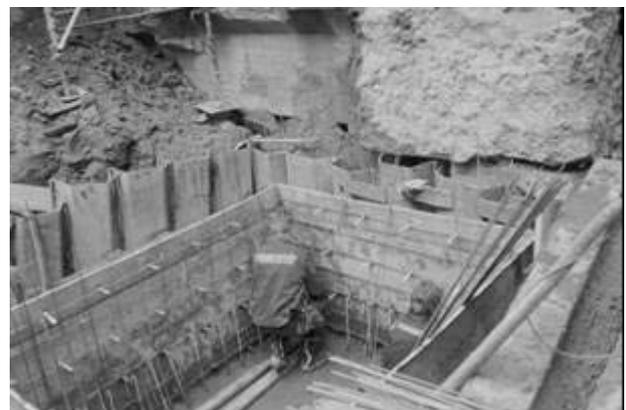
Figure 5. Elevator shaft with exposed underpinned foundation behind.

On the side of the common courtyard of Alexander Street 4 and 6, part of the wall was underpinned with Mega Piles. The reason for this was the opening of a back wall to make way for a newly planned connecting corridor as well as a service elevator shaft (figure 5). The base slab of the elevator being lower than the floor slab, the pile depth had to be extended accordingly. The additional bearing capacity needed from the piles was compensated by the injecting of the pile tips with a stiffening gel obtained by mixing sodium silicate with calcium chloride.

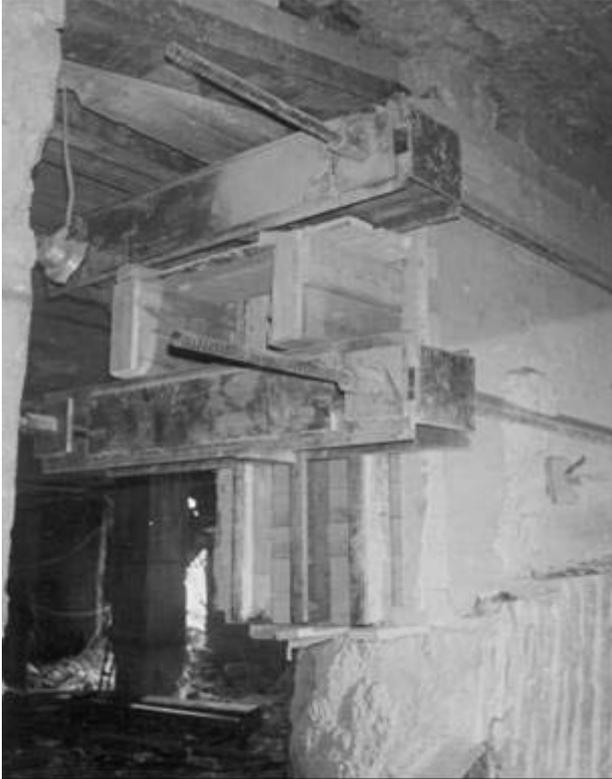
Figure 6. View of pretensioning device.

between 1 and 2 meters of bedrock had to be blasted. In one instance, to avoid structural collapse, a special procedure was devised. This consisted of pretensioning on its whole length a supporting wall with anchored tension bars, as well as pretensioning laterally the rock beneath it (figure 6 and 7). Removal of the old concrete wall proceeded incrementally with a diamond boring machine. This was realised in alternation with casting concrete for the new concrete columns.

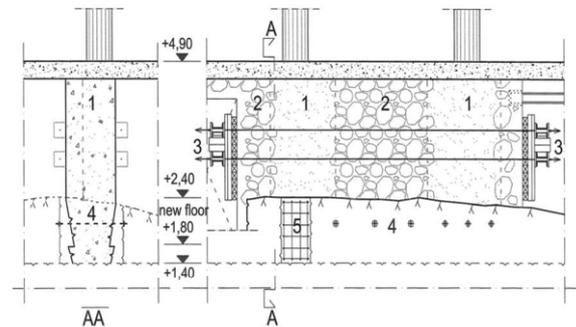
Figure 7. Pretensioned wall during work: 1-Old concrete pilaster 2-Bolder fill 3-Pretensioning device 4- Tensile rods in rock 5- New column section.
