Stability of underwater slopes realized by means of a suction dredger

In Flanders (Belgium) large amounts of sands, to be used in the construction and glass industry, are excavated by means of suction dredgers. It showed that for deep excavations the dredging process cannot be modelled by conventional methods. In order to comprehend the process of breaching a laboratory test set up was elaborated and a full scale breaching test was performed.

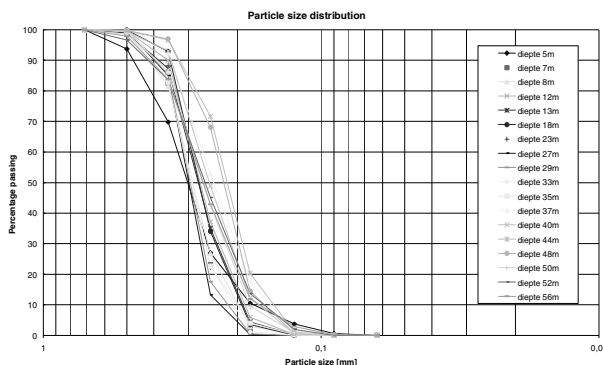
Figure 6: Particle size distribution.

Typical particle size distribution curves of extracted sands (after washing) are given on figure 6.

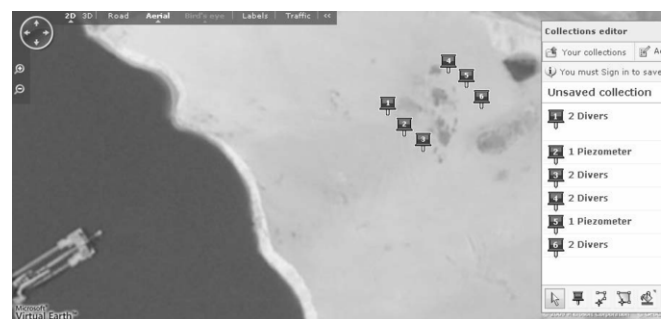
Figure 9. Emplacement of piezometers

The emplacement of the piezometers is also shown on the aerial view figure 9.

Piezometers and water pressure cells were placed at a safe distance beyond the expected reach of breaching instability, i.e. resp. at 50m and 80m from the crest of the existing slope. (figure 8)

The piezometers have a filter element of 2m, placed of depths of resp. 3m and 15m and are equipped with divers (ceramic pressure sensors in stainless steel housing with a memory capacity of 24000 measurements)

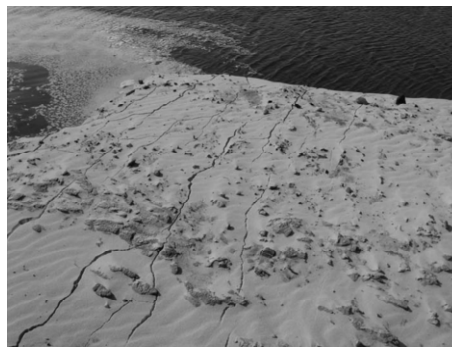
Figure 12: Fissuring at surface level.

Figure 12 shows a picture of fissuring observed at surface level.

The video recordings confirm these findings, and show a steadily progressing instability front during breaching. With regular time intervals soil layers with a thickness of some decimeter come apart and then gently slide away.

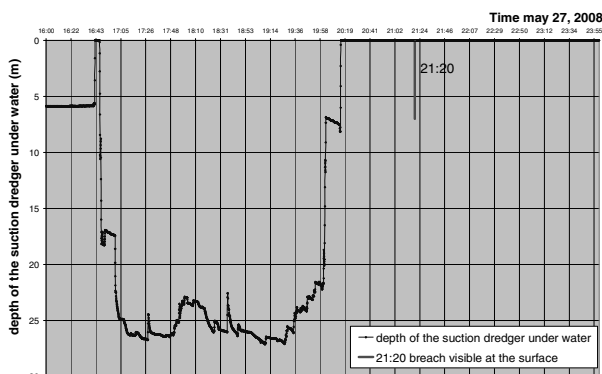
Figure 11: Pressures measured at suction mouth

Water pressures measured at the suction mouth are a measure for the depth of the tube below water level. Figure 11 shows that the tube was lifted (probably due to pit production exceeding suction capacity) at 20h05, where instabilities at surface level were visually observed at 21h20. This shows clearly time dependency of breaching.
