# Settlement of an art relic church caused by the construction of the Metro line

J. Farkas & D. Turi

*Budapest University of Technology and Economics, Department of Geotechnics*

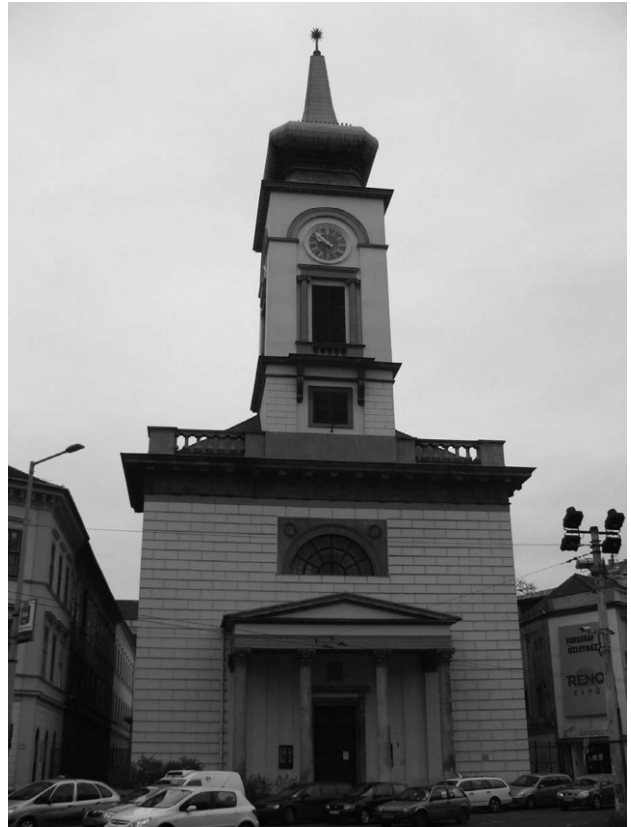
Photo 2.

The longitudinal ground plan church, which was built between 1816 and 1830 in neoclassical style (Photo 1.) was made of craved stone and brick wall, in front and at the rear with annular vault and cupola on pendentives (18m span). The construction of the metro station is a danger for the entrance portal (Photo 2).

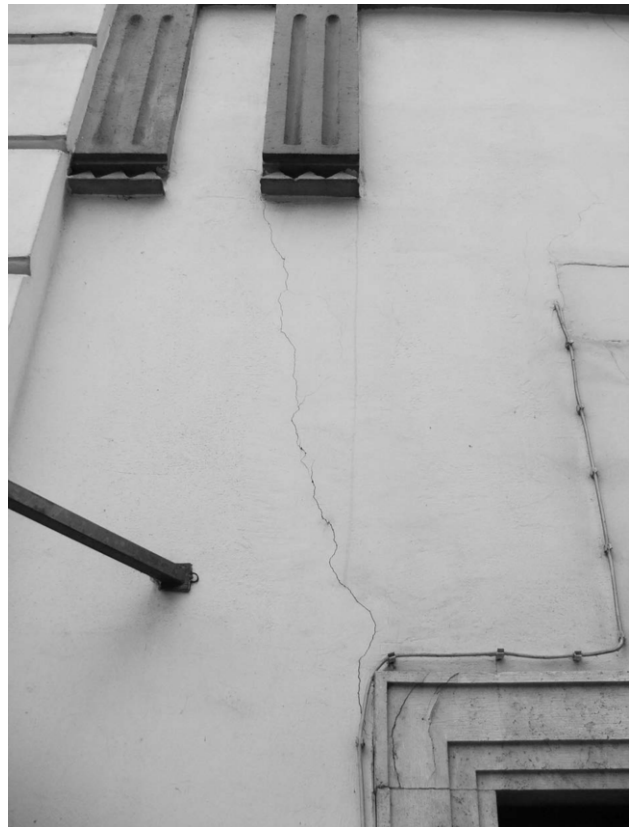
Photo 3.

The monument building with a shallow foundation and no cellar was damaged during the II. World War. Later the construction of the pedestrian subway in front of the church caused significant horizontal and vertical displacement and cracks on the building (Photo 3).
