# Soil matric suction as an indicator of the mud flow occurrence

A. Petkovšek & M. Maček  
*FGG, University of Ljubljana, Slovenia*

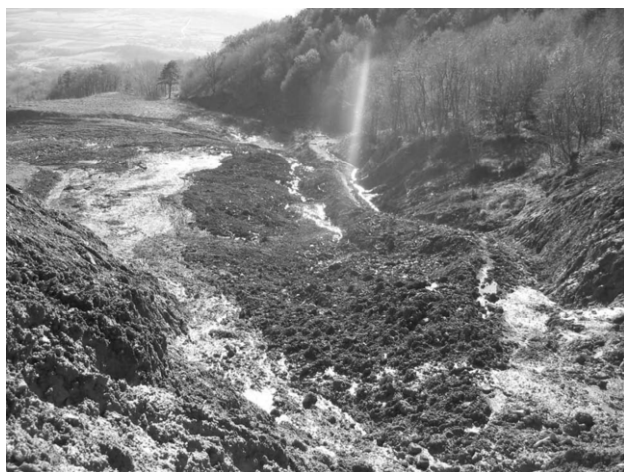
Figure 2. The viscous mud flow

The Slano blato landslide is one of the largest and the most active landslides in Slovenia with a volume of more than one million m<sup>3</sup> of moving mass. It is situated in the west of Slovenia above the village of Lokavec (Figure 1). Its name “Slano blato” in the Slovene language means salty mud. In dry periods the landslide behaves as a group of several slow moving landslides, while in wet periods it moves mainly as a viscous earth flow with the occurrences of rapid mudflows (Figure 2).

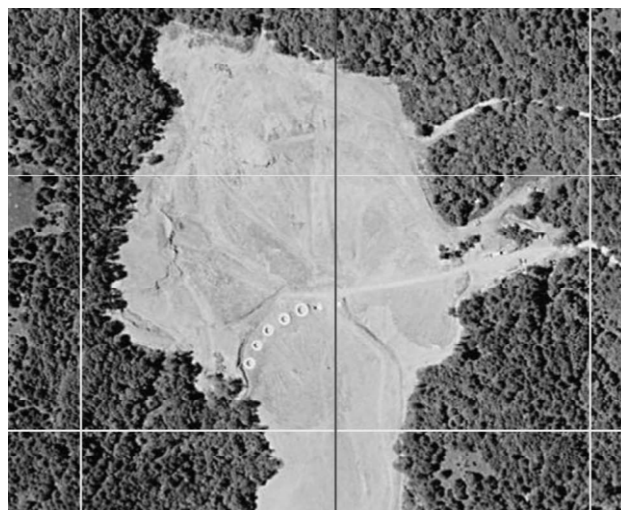
Figure 3. Aerial view of the upper part of the Slano blato landslide in 2005 with the first shafts

Intensive rainfalls in 2008 triggered again a large number of smaller earth and mud flows of about several thousand m<sup>3</sup> of moving mass, all above the concrete shafts (Figure 3), where the slopes were steeper than 23°, while the central part of the landslide, below the shafts, where the slope was reshaped to 12 – 15°, remained in the mode of very slowly moving landslide and no mud flow occurred, although the soil suction was reduced to zero.
