Risk Evolution during the Design of the Adaptation of a Railway Bridge Foundation

Abstract. During a design process the risk profile of a project continuously evolves. Often a project progresses through a diamond shaped risk envelope. The initial concept is simple, but during the engineering process several risks are defined and mitigated, making the design increasingly complex. With additional investigations and calculations, some of the identified risks can be better defined. As a result, the design should evolve into a matured design in which only a few risks remain. These risks should be manageable. If uncontrollable risks remain, even though the chance of occurrence may be small, this could render the project unfeasible. This paper will show how the risk profile of a bridge foundation adaptation has evolved.

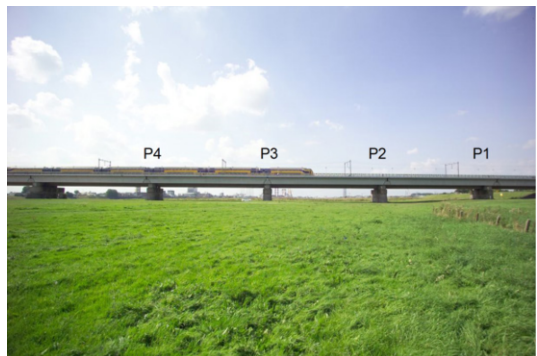
Figure 4. Flood plain before adaptation

As can be seen in figure 4, pillars 1 to 4 are located in the flood plain. Only pillars 1 to 3 need adaptation. The current summer levee including the part of the flood plain with pillar 4 will be included in a future island between the main and side channels of the river.

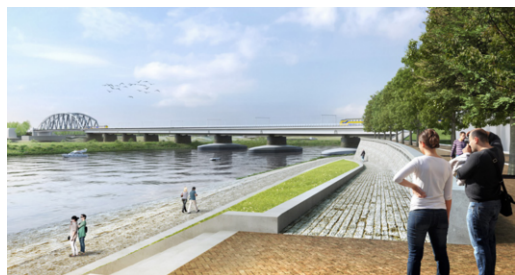
Figure 5. Side channel after adaptation

Figure 5 illustrates the future view from the north bank of the side channel, looking towards the south-west. The three adapted pillars can be seen in the water, pillar 4 can be perceived on the island, just left from the center of the frame.

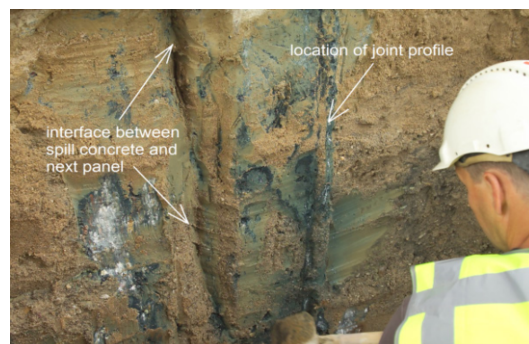
During excavation to 6 m below surface level, the wall could be inspected. The suspected joints showed a typical 'double joint' caused by spill concrete that was not successfully removed before concrete casting of the next panel (left panel in figure 8).

The core of the joint (where the joint profile had been extracted), between spill concrete and previous panel, was still filled with bentonite. Without CSL this anomaly would not have been noticed.

Figure 8. Typical double joint caused by spill concrete

To check the soil tightness of the wall, all joints between the diaphragm wall panels were tested with the Cross-hole Sonic Logging (CSL) technique (Spruit et al. 2014). The CSL technique has been developed for application in diaphragm walls under Geo-Impuls, the Dutch joint industry programme aiming at reducing the occurrence of geotechnical failure in Dutch civil engineering. Based upon the CSL graphs, some joints needed inspection.
