# Concrete Flow in Diaphragm Wall Panels: A Full-Scale In-Situ Test

**Abstract.** Flow processes, taking place during the concreting of diaphragm wall panels (D-wall panels), are of great importance for the quality of the wall. During this phase, the bentonite, present in the excavated trench, should be completely replaced by concrete in a controlled way. In literature several cases are described in which this process resulted in bentonite inclusions in the panel. These inclusions often lead to severe problems, like leakages, for the building pit to be excavated within the diaphragm wall panels. Beside the risks for the building pit, leakages caused by bentonite inclusions can also have large consequences for nearby constructions. In this article, set up and results of a full-scale diaphragm wall test are described. Conclusions are drawn with regard to the influence of several parameters on the flow process and subsequently on the quality of the wall and the risk on bentonite inclusions.

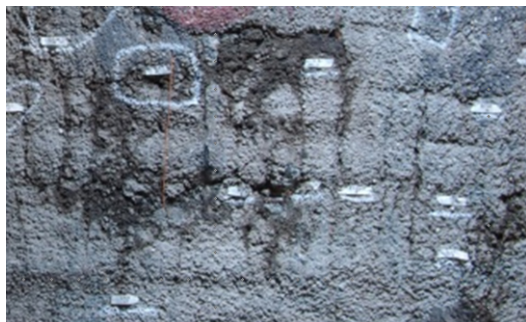
In Panel 2 at several locations (totally about 50% of the panel) an effect as shown in Figure 6

is observed. Clearly visible at the surface is the location of reinforcement bars. This indicates that those bars influence the horizontal flow of concrete perpendicular to the net of bars. Also it indicates that on those locations, in the space between reinforcement bars and surrounding soil no flow of importance parallel to the plane through the reinforcement net takes place.

**Figure 6.** Location of reinforcement bars visible in Panel 2

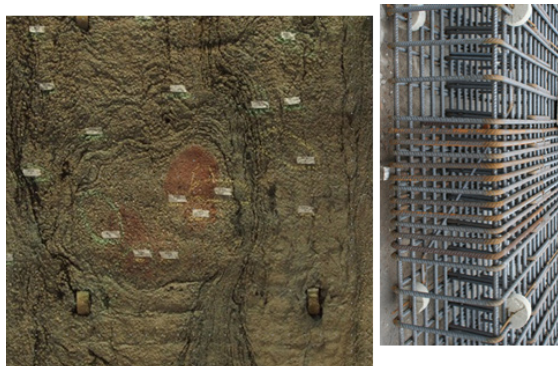
Another pattern is observed in locations with an extreme amount of reinforcement, see Figure 7. The red concrete, visible in the middle area originates from the last truckload, the grey concrete surrounding it from the first truckload. During the first truckload the level of the tremie pipe was 3.5 m deeper than this location, during part of the last truckload this level was 0.5 m under the reinforcement concentration.

**Figure 7.** Pattern visible at locations with a strong reinforcement concentration

A plausible explanation for what is seen here, might be the fact that during the first truckloads, this area was not completely filled with concrete,

due to the reinforcement concentration. From simulations this was also expected. During the last truckload, however the pressure in the concrete near the outlet of the tremie pipe must have reached much higher values, since the overall concrete level in the trench was higher. Probably with that pressure, the gap in the concrete was filled from underneath, suppressing the (grey) concrete present at the edges of the formerly non filled area. The latter would explain the circular lines of grey concrete which are alternated with lines of dark grey bentonite, surrounding the circular red area. Area's similar to this one are found at 3 different locations in the panel, all where concentrations of reinforcement are present.
