# Design and instrumentation aspects of a 40m high nailed slope

Alberto S.F.J. Sayão, André P. Lima & Fernanda O. Springer

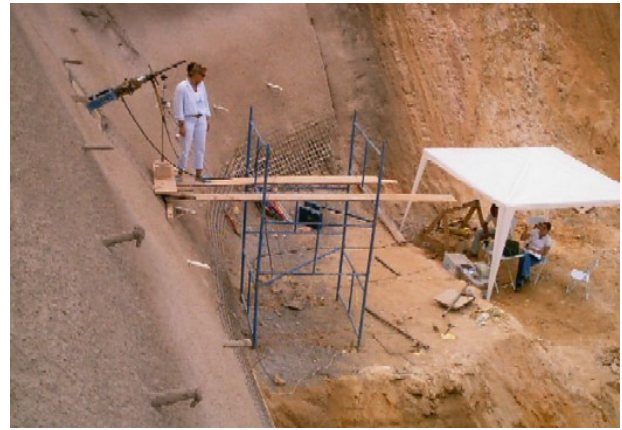
Figure 3 - Nail pullout testing on a platform during excavation.

In the field, several nails were instrumented and subjected to pullout tests under different conditions of curing time, grouting procedures and confining stress. The pullout tests were conducted by controlled loading increments in a site next to the excavation front. All tested nails were 4m long and were not used in the final configuration of the nailed structure. An average value for the interface strength  $q_s$  may be taken as 200 kPa. Fig. 3 shows a pullout test being carried out. As the excavation progressed rapidly downwards, a test on a nail with 7 days curing time had to be performed on a temporary platform.

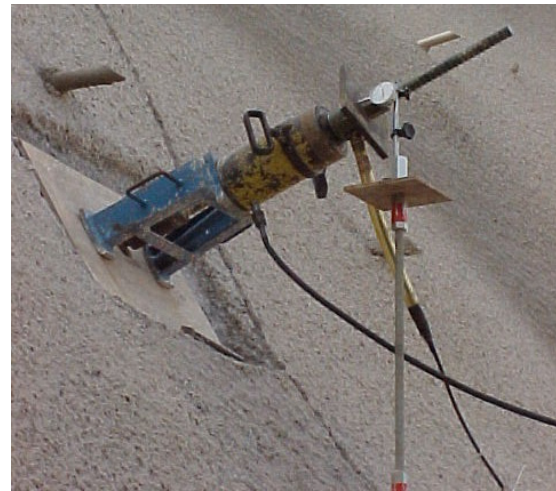
Figure 4 - Pullout test set-up.

Pullout loads were imposed with a hydraulic jack and monitored with a load cell at the nail head. Strain gauges glued to the steel bar provided information about the load distribution along the nail. Electronic readings were recorded with a data logger and a laptop computer. A dial gauge was used for monitoring the nail extension during the test, with reference to a stable point. Fig. 4 shows a closer view of the test set-up.

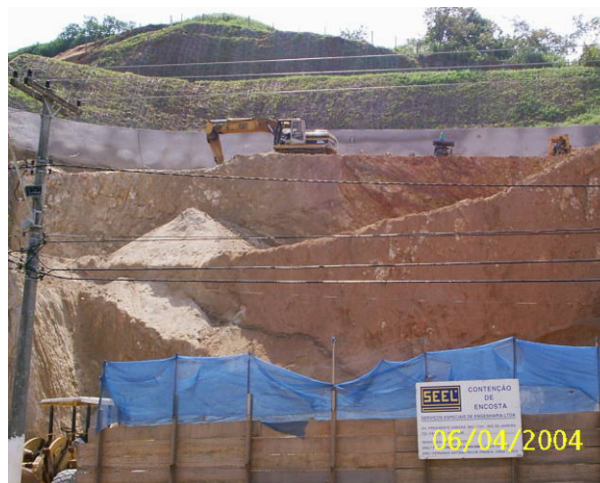
Figure 6 – First stages of nailed excavation.

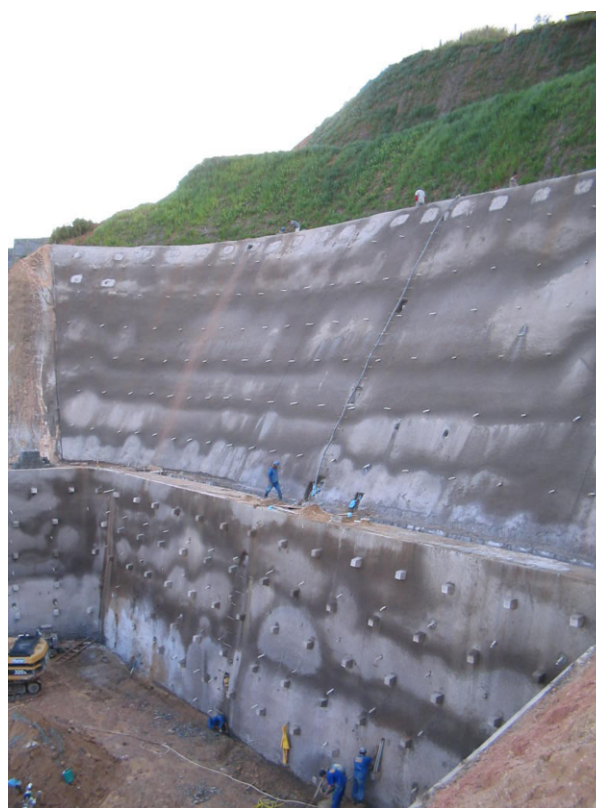
Figure 7 – Last stages of 40m high nailed excavation.
