# The Stability Analysis of Heituwan Tailings Pond Based on Strength Reduction Method

**Abstract.** To analyze the stability of Heituwan tailings pond after vacuum well point dewatering treatment, a unit thickness numerical 3D model was built based on field survey data and physical mechanical properties tests; and the model was analyzed by FEM numerical software according to strength reduction method. The properties of stress and strain, the plastic region, and the deformation properties are acquired by numerical stimulation, and the simulation result was compared with the in-situ monitoring data. The results show that the safety factor does not meet the requirements of the standard; and most of the landfill made of manganese tailing has developed into plastic status; the deformation is more obvious where the tailing store is higher and closer to roller compacted rockfill dam; the manganese tailing landfill near the roller compacted rockfill dam should be grouted by cement to meet the requirements of continued use.

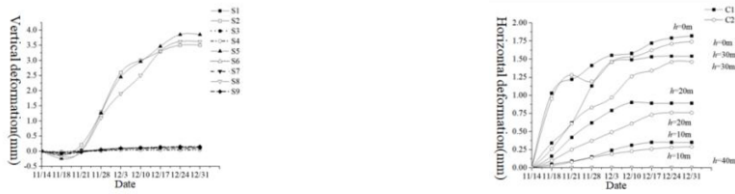
**Figure 9.** Monitoring result.

To verified the numerical analysis result, a field monitoring scheme was conducted on the Heituwan tailings pond after the tailings pond was treated with Vacuum well point dewatering method as it shown in figure 8. There are 9 subsidence monitoring point numbered with S1 to S1 and 2 horizontal monitoring point numbered with C1 to C2 set on the tailings pond. Figure 9 shown the data of the subsidence monitoring and horizontal deformation monitoring during Nov. 14, 2019 to Dec. 31, 2019. The subsidence of the points 53.1m away from the axis of the tailings dam which were very close to the point D in the model were bigger than others points. Compared the horizontal deformation in different depth, the order of the value size of different depth is 0m>30m>20m>10m>40m.

(a) Variation of vertical deformation with time.

(b) Variation of horizontal deformation with time.

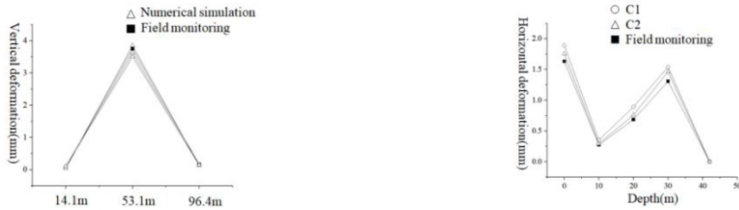
**Figure 10.** Difference of deformation between numerical simulation and field monitoring.

(a) Difference in vertical deformation.

(b) Difference in horizontal deformation.

As it shown in figure 10, compare the subsidence and horizontal deformation of numerical analysis result and monitoring result, it was found that the difference between the numerical simulation and field monitoring was small enough to meet the demand of engineering, and the horizontal deformation in monitoring result was slightly bigger than in the numerical simulation due to the difference of the tailings pond along the axis of the tailings dam was not considered in numerical simulation.
