Void Detection Behind a Hydraulic Tunnel Lining Containing Complex Reinforcement Using Combined Non-Destructive Testing Methods

Abstract. The existence of voids behind the lining has always been a "pain point" in tunnels. In recent years, prestressed concrete linings have been so densely reinforced that voids cannot be accurately detected using a single non-destructive testing method. A standard model of Voids behind the lining with reinforcement parameters, concrete mix ratio, thickness and material inside the void consistent with the actual project was produced. Based on this model, ground-penetrating radar, impact echo and ultrasonic laminar imaging detection tests were carried out and typical mapping of the various methods was obtained. Combined with the applicability of the practical operation in engineering, combined non-destructive testing methods is proposed and verified in actual engineering. The results show that the combined non-destructive testing methods can accurately detect voids of lining, and can take into account the detection efficiency to meet the detection requirements of complex reinforced linings.

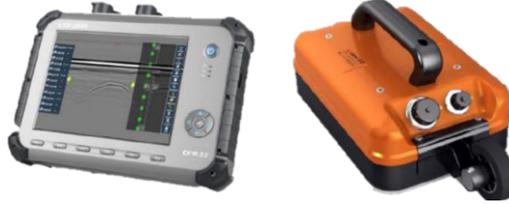
Figure 2. Ground Penetrating Radar (GPR) equipment.

This test uses the LTD-2600 radar mainframe and CG900MHz shielded antenna produced (figure 2) by the China Institute of Radio Wave Propagation to carry out the relevant tests.

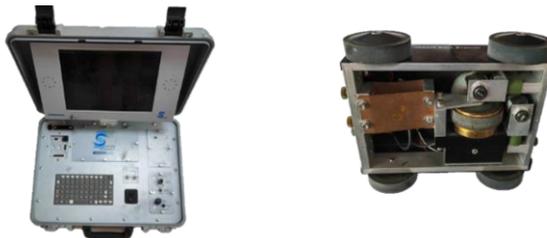
Figure 3. Impact Echo Scanner (IES).

The Impact Echo Scanner (IES) (figure 3) was selected for the test, which uses a rolling receiver and a distance measurement system that allows automatic testing along the line of measurement, and the speed of the rolling does not affect the distance of the test interval.

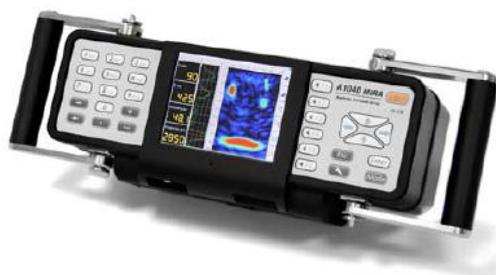
Figure 4. A1040 MIRA low frequency ultrasound section imager.

The A1040 MIRA low frequency ultrasound section imager was used to carry out the pilot study, as shown in figure 4.

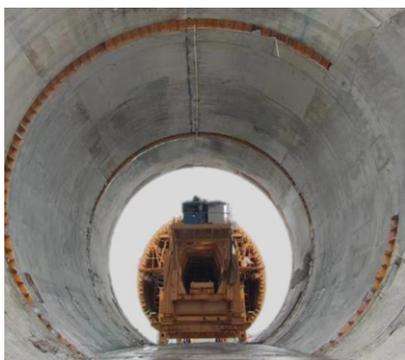
Figure 10. Hydraulic tunnels.

A hydraulic tunnel with a diameter of 6.4m uses 0.4m thick prefabricated pipe sheets for the initial lining and 0.55m thick prestressed concrete for the inner lining. The lining is equipped with a double layer of reinforcement mesh and a double layer of double-ring unbonded prestressing strands. An actual photograph of the tunnel is shown in figure 10.
