Failure Analysis of a Soft Broken Roadway and a New Bolt-Grouting Support Technology

Abstract: In this paper, taking a typical roadway in broken and soft rock strata in No.10 Mine of Pingdingshan coal field as an example, the deformation and failure mechanism of rock mass was deeply analyzed based on field testing. Then the technology of high-strength prestressed bolt-grouting support, such as the new combined high-strength grouting bolt, high-strength hollow grouting anchor cable, were developed. Based on this, a repair support scheme using the new technology was designed for on-site roadway, and was successfully implemented in the field. The monitoring results after the repair of field roadway show that the maximum of roadway surface convergence deformation is 56mm. The maximum force of the grouting bolt is 122kN, the grouting anchor cable is 256kN. The new technology can fill the cracks of rock mass and the borehole interstice at the free part by using grouting materials. It can effectively enhance the self-bearing performance of soft broken rock mass on the premise of ensuring the diffusion of prestressed active supporting effect in rock mass, and then suppress the deformation

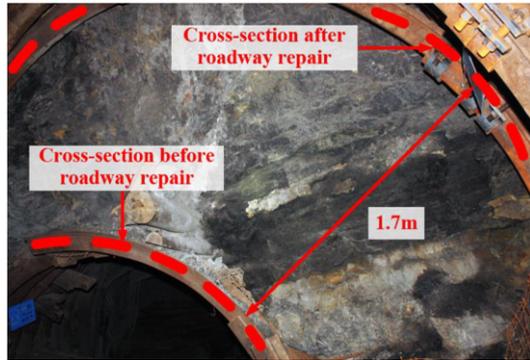
Figure 3. Cross-sections before and after roadway repair

The roof of coal seam E 8 is arranged along the lower hill of track group E in the central area of No.10 coal mine. The original driving section is 14.4m² and the length is 970 meters. The original design adopts bolt-mesh support, which is partially supported by U36 steel arch support after many repairs. The original roof of the roadway is sandy mudstone, the two sides are mudstone, coal seam and sandy mudstone from bottom to top, and then the upper side is thick fine-grained sandstone. The floor of the roadway is mudstone, and some sections pass through the E 8 coal seam. The track is seriously damaged by dynamic pressure when going downhill. After many repairs, the longest stability period of the roadway after repair is less than a year. The coal seam has been exposed in the 600-meter section of track to the drop-off yard after many times of bottom pulling construction. At present, the track downhill roadway is seriously damaged, which has endangered the safety of pedestrians and transportation. The roadway section changes from semi-circular arch to sharp roof shape, which shows that the roof is seriously sunk and the two sides move into the roadway as a whole. Moreover, the roadway deformation has not stopped, and the roadway is facing the danger of complete destruction. Fig. 3 lists the sections before and after the expansion of typical parts of the downhill roadway of group E track in the central area. Compare initial design cross-section, the transformation convergence of the rock mass of the site roadway exceeds 1.7m.

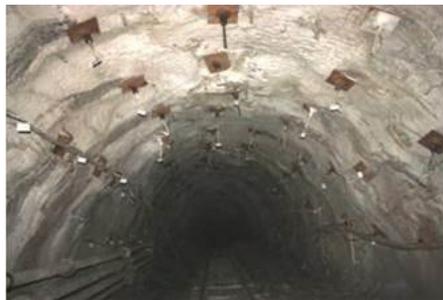
Figure 13. Repair effect of the field roadway

Fig. 13 lists the field roadway expansion and repair treatment effect after adopting the high-strength prestressed bolt-grouting and expansion support scheme. According to Fig. 13 and the above monitoring data, it can be seen that the roadway in the field has a good effect after expanding and repairing with this technology, and the spray layer is basically intact without obvious cracking and damage. Compared with the conventional bolt-mesh support and U-shaped steel arch support, the new technology can effectively enhance the self-bearing performance of weak broken rock mass and effectively limit the deformation and failure of rock mass, which has obvious advantages and effectiveness.
