Stress-strain and stability analysis of tailing dam Toranica – Kriva Palanka

Lj. Dimitrievski
Department of Geotechnics Faculty of Civil Engineering, Skopje, Republic of Macedonia
D. Ilievski, D. Dimitrievski & V. Kolevski
GEING Krebs und Kiefer International and others ltd. Skopje, Republic of Macedonia

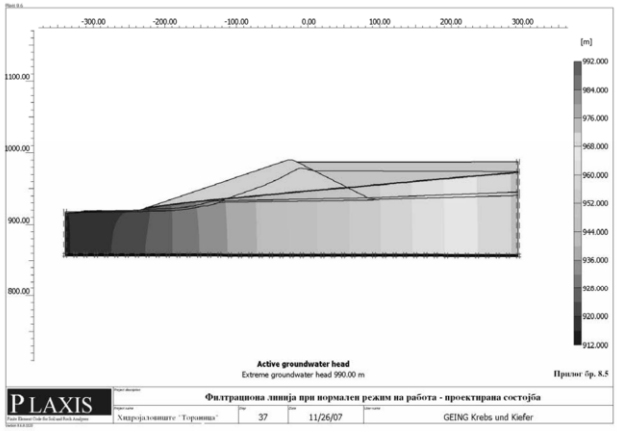
The analyze made for the designed conditions without drainage, presents that if the tailing dam works with full capacity, the water level inside will form a filtration line for stationary regime of work in the embankment sandy dam (appearance of water near the downstream too–Figure 2). Conducted filtration flows and piezometric line will appear at the slope which could cause washing of the tiny material from the slope close to the too of the embankment with local instability which can cause disturbing of the global stability of the sandy dam on longer period of time (Figure 4).

Figure 2. Filtration line during normal regime of work without drainage

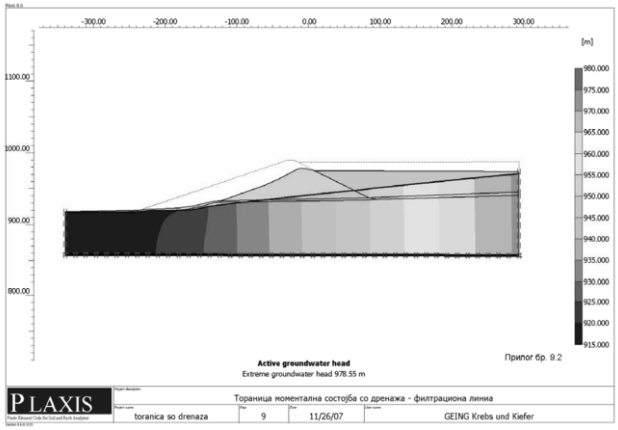
Two cases were analyzed for the condition of the hydro tailing dam with drainage in the middle lowest part (the part of the former river bed of Kriva reka). First case is during normal work of the tailing dam and the second case is if the collector is not in function, which will rise of the level up to the peak elevation 987.5 m asl. In both cases the drainage is in function, it decreases the piezometric line under the slope of the sandy dam for a distance that will disable the capillar raising and freezing of the water (Figure 3). The factors of safety of the global stability is higher than 1.5.

Figure 3. Filtration line during normal regime of work with drainage

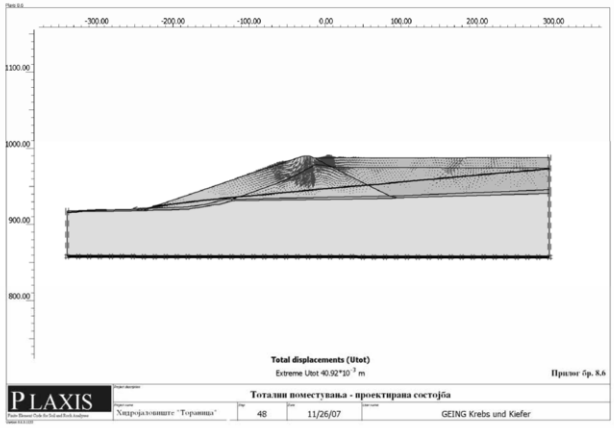
Figure 4. Total displacements - designed condition without drainage

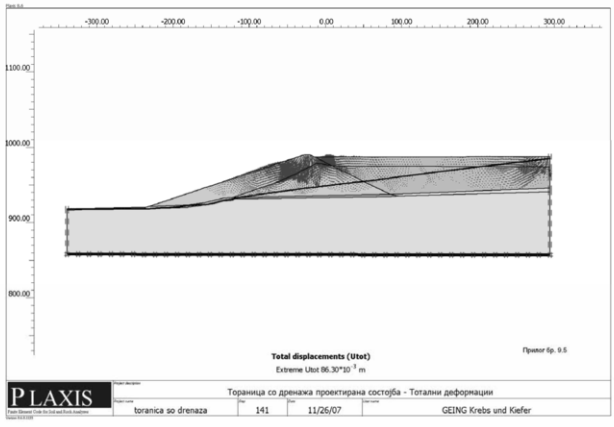
Figure 5. Total displacements - designed condition with drainage

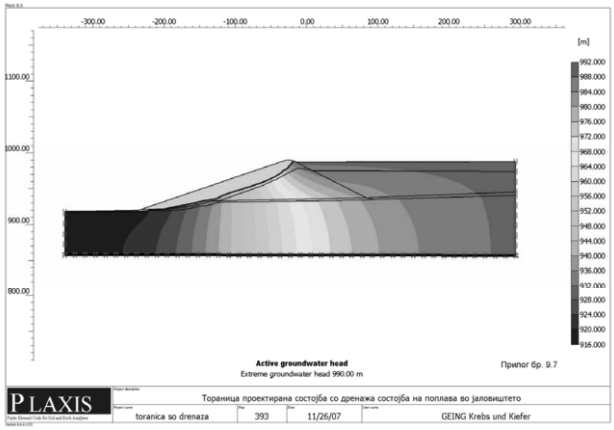
The analyze made for the level of the water up to the peak elevation 987.5 m asl without drainage (case of termination of the collector work or appearance of upstream flooding wave) shows that the filtration line is appearing on the downstream slope of sandy dam (Figure 6), which could cause some instability problems as mentioned before for the case without drainage.

Figure 6. Designed condition with drainage for flooding of the tailing dam

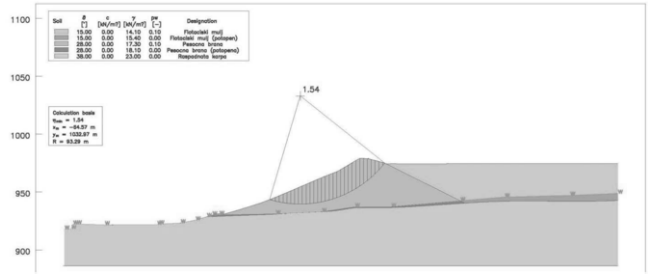
With the slope stability analysis performed for the actual condition of the tailing dam with piezometric line adopted according to piezometers monitoring, the factor of global stability is Fs=1.54 (Figure 7), which is higher then the minimal allowed according to the regulations for this kind of slopes Fmin=1.3. It points out that the sandy dam in these conditions is stabile. It should be pointed out that during the analysis local shallow sliding surfaces are appearing on the slope of the sandy dam because of the variable inclination of the downstream slope, which could affect the global instability on long term.

Figure 7. Global stability - present condition

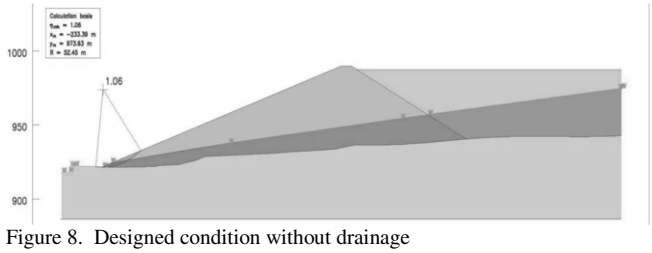
Figure 8. Designed condition without drainage

⇒ The results of the slope stability analysis for the designed case for the level of 990m asl without drainage show that the piezometric line is appearing on the downstream slope close to the too which could cause slope erosion and long term instability;

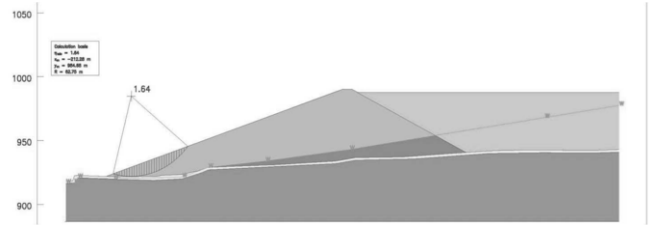
Figure 9 Designed condition with drainage

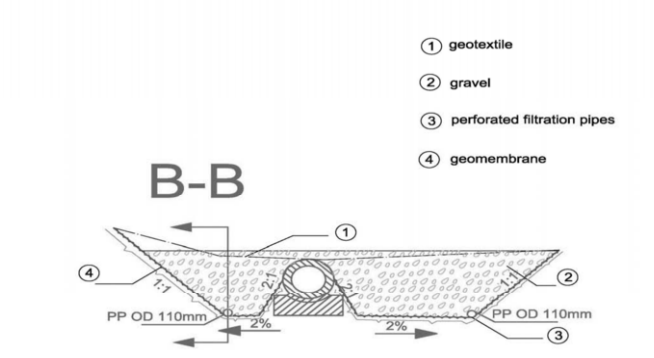
Figure 10. Detail of drainage blanket

⇒ For long term and active use of the hydro tailing dam, it is strongly recommended performance of drainage blanket (Figure 10);
