Importance of Shear Stress Anisotropy and bottom drainage on Tailings Dam Stability: a Case History

A slope failure occurred in February 2007 at one of the tailings ponds operated by Solvay in Bernburg, Germany, about 70km North-West of Leipzig. The failure involved about 150,000 m³ of tailings material which flowed through a breach in the dam slope. A detailed investigation was carried out to determine the causes of the failure, so that suitable changes could be made for the future safe operation of the facility.

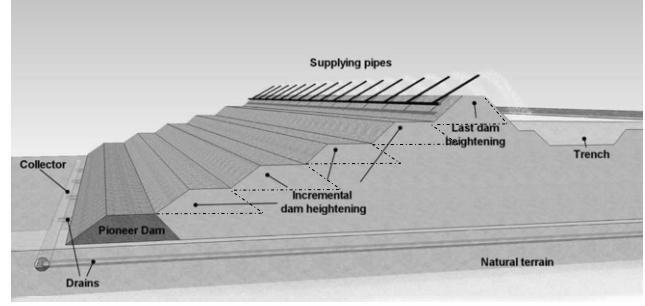
Figure 1 - Dam profile

<u>1</u> Installation of base drainage layer

A series of drainage pipes is buried about 1m deep in the natural foundation soil of about 1m of fine-grained soils overlying silty sands. The purpose of these drains is to collect leachate that permeates downward from the tailings impoundment, and to transport it to a collector drain at the dam toe.

After consolidation, the dam is raised for the next phase of usage by building a new embankment with the coarser tailings material deposited close to the dam periphery. This material is excavated from a trench located close to the dam crest. The dams are raised in stages of 1.5m height.
