Evaluation of Full Scale Levee Stability Tests at Booneschans and Corresponding Centrifuge Tests

M. A. Van

Expertise Manager, Deltares, P.O. Box 177, 2600 MH Delft, The Netherlands, meindert.van@deltares.nl

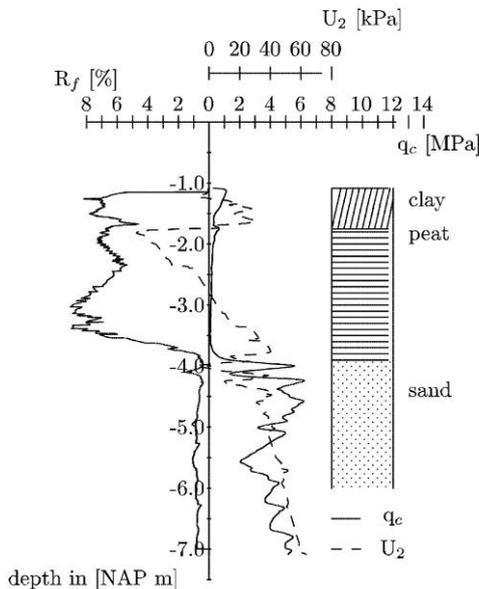
Figure 1. Typical CPT at test embankment

In total 33 Cone Penetration Tests, CPT's and 22 continuous Begemann borings were conducted. An interpretation of the CPT's and borings is used to construct a geotechnical profile along the test field. Figure 1 shows a typical CPT and its interpretation found at the middle cross-section of the test embankment. The depth shown by Figure 1 on the vertical axis is related to the reference datum NAP, which is approximately mean sea level. The subsoil consists of a thin, 0.5 to 1.0 m thick clay layer followed by a 1 to 2 m thick peat layer and a Pleistocene sand layer. The CPT's conducted at the site, some up

to a depth of 20 metres, did not reach the bottom of the Pleistocene sand layer. The peat has a volume weight of 9.8 to 10.8 kN/m³ and a water content ranging from 2.0 at the top to 3.0 to 4.8 at the bottom. The volume weight of the top clay is 16.6 kN/m³ with a water-content of 0.3 to 0.6.
