Building damage examples due to leakage at a deep excavation in Amsterdam

Mandy Korff^{1,2}, Robert J. Mair², A.Frits van Tol^{1,3}

¹ Deltares, ² Cambridge University, ³ Delft University of Technology

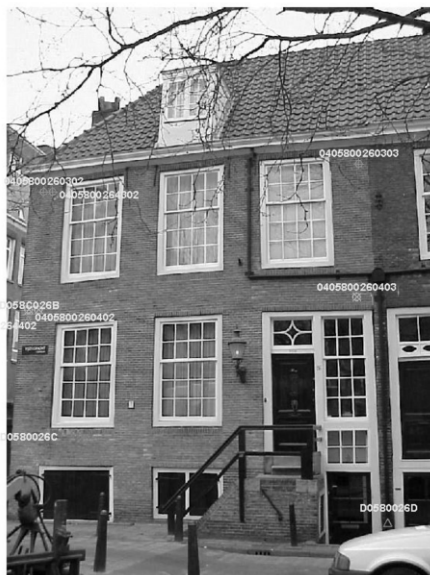
Figure 2 Weaverbuilding Vijzelgracht 26 with prism locations (picture Projectbureau NoordZuidlijn)

The buildings all have a semi-basement, a raised ground floor, and a first floor with vaulted roof. The rear of the house includes a kitchen addition. Each block of houses has a continuous ridge beam. A foundation consisting of 52 timber piles per house is expected to extend to the first sand layer. Before construction of the North South Line these buildings were equipped with monitoring instruments (Figure 2).
