Engineering assessment of jet-grouted structures Valoration technique des structures en sol traitées par jet grouting

M. Arroyo & A. Gens

Department of Geotechnical Engineering & Geosciences, UPC, Barcelona, Spain

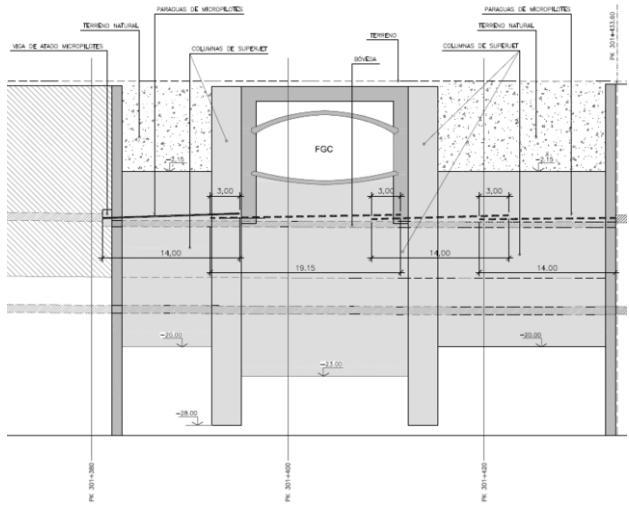
Site B was located at less than 2 km from site A, but the geotechnical setting was very different. A tunnel linking two cut and cover excavations had to cross underneath an existing railway tunnel. The new tunnel countervault was at about 23 m below ground (Figure 3). The soil profile at site B comprised 2 m of made ground, 3 m of medium clay, 8 m of medium sand,

15 m of fine sand and silts and 1 m of gravels, overbearing the same stiff clays treated at site A. The water table was at the countervault level of the existing tunnel. The newer tunnel had to be excavated through the water bearing fine sands and silts.

Figure 3. Designed treatment at site B: section

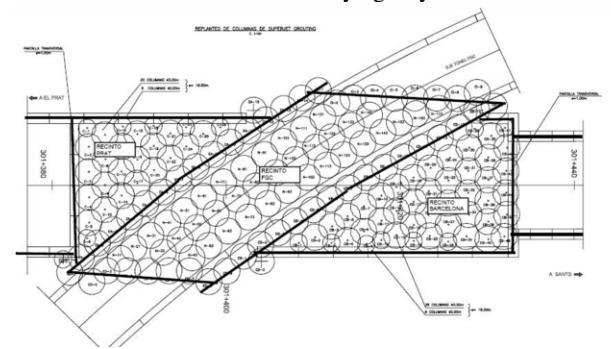
Apart from other protective measures the new tunnel design was heavily reliant on a jet-grouted treatment. The treatment was organized according to two main ideas: a sealing barrier around the excavation, and a generalized reinforcement inside the excavated area. The sealing barrier was partly formed by long jet-grout columns and, outside the older tunnel shadow, partly by diaphragm walls. Thus three independent enclosures were theoretically formed, one at each side of the older tunnel, and another just below it (Figure 4). Sealing was to be achieved by reaching into the clay substrate.

Figure 4. Designed treatment at site B: plan view. Black lines indicate sealing barriers: either diaphragm walls or long jet-grout columns

To materialize the soil treatment a bi-fluid jet-grout technique, commercialized under the name "superjet" was proposed by the specialist contractor. Two different types of columns were proposed, with 2 and 3 m estimated diameter. The plan arrangement of the columns is shown in Figure 4. The known basic treatment parameters are collected in Table 1. As indicated, some of these parameters were verified by monitoring of the injection process.
