Ground improvement under historical buildings: a case history

R. Passalacqua

Dep.t of Civil, Environmental & Architectural Eng.g (DICAT) – University of Genoa -Italy

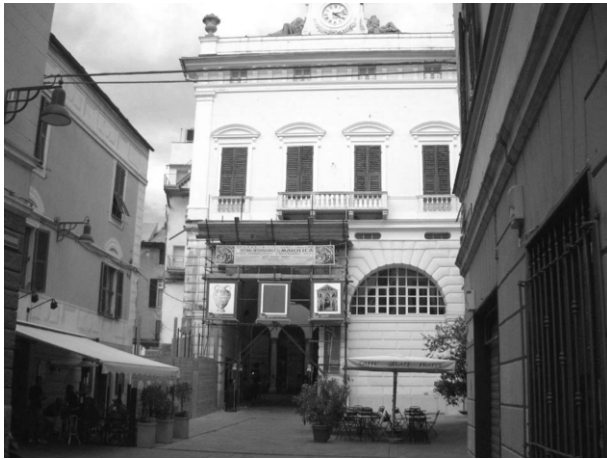
But, as the piles' execution approached the Gavotti Palace's masonry wall, this begun to settle markedly, rousing up safety issues.

Figure 1. Main façade of the Gavotti Palace, with the exit of its arcaded walkway and, at left, the neighboring erecting yard.

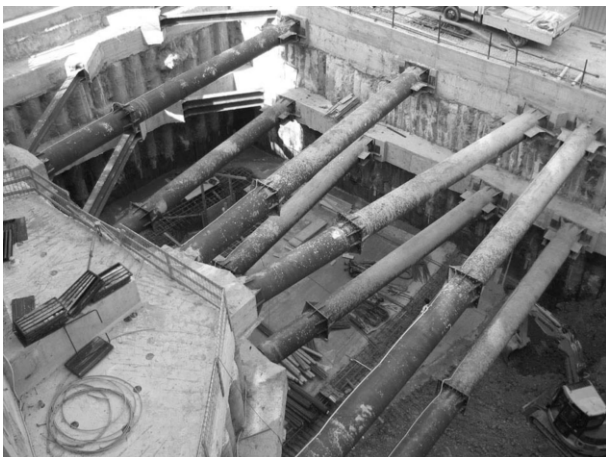
Figure 4. The two levels of struts and the excavation at full depth.

It musty be finally observed that the full-front excavation, down to 9 meters below GL, caused a settlement of no more than 6 millimeters and, on the contrary, with the suspended first tentative of grouting alone 7 millimeters where surmounted.

FEM analyses allowed to identify and correct some issues, among whose the most relevant had been: the depth at which the first stage of excavation must stop and the struts' pre-stressing values, to be applied at both the planned levels, before of the deepening restarts.
