The influence of clay wetting on geomembrane-clay interface strength L'influence de humidification d'argile sur la résistance à l'interface entre la géomembrane et l'argile

Tomislav Ivšić, Franjo Verić & Hrvoje D. Zlatoper

Department of Geotechnics, Faculty of Civil Engineering, University of Zagreb, Kaciceva 26, HR-10000 Zagreb, Croatia

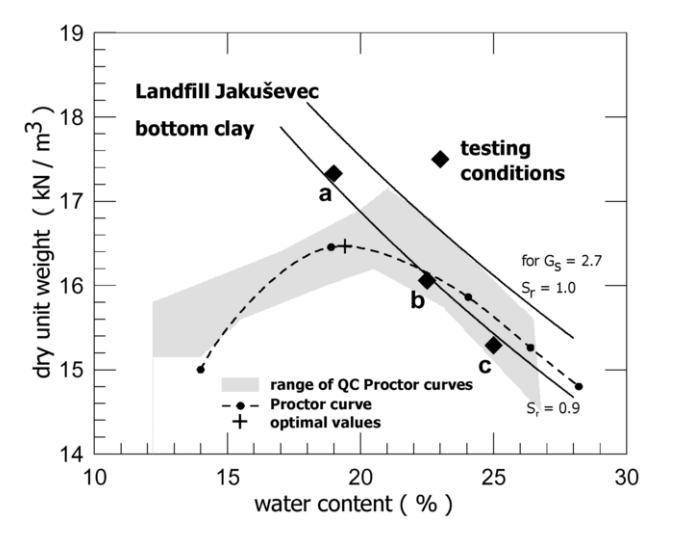
Case a)	water content:	19%	dry unit weight: 17.3 kN / m ³
Case b)	water content:	22.5%	dry unit weight: 16.1 kN / m ³
Case c)	water content:	25%	dry unit weight: 15.3 kN / m ³

These cases are presented in Fig.5 with laboratory Proctor curve for particular clay samples, taken for laboratory testing.

Figure 5. Compaction properties of tested clay $(w_{opt} = 19.42\%; \gamma_{dry} = 16.47 \text{ kN} / \text{m}^3)$

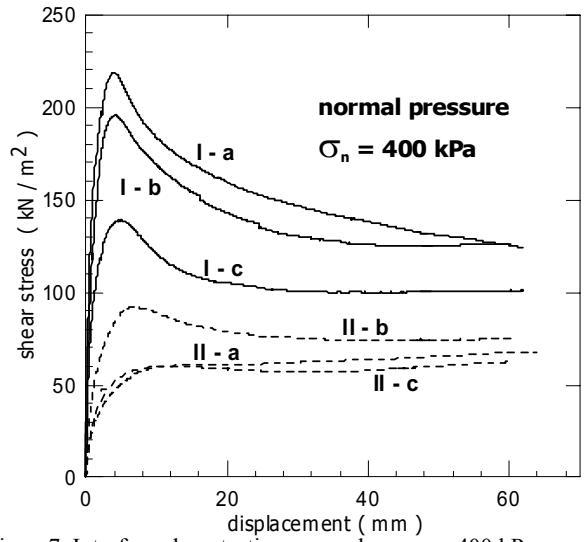
Figure7. Interface shear testing-normal pressure 400 kPa

The presented test results show that the interface claygeomembrane strength is significantly affected by moisture and density conditions of clay before testing.

For unsaturated "as compacted" specimen the differences are more pronounced in peak values than in residual. For the samples near Proctor optimum values (cases a and b) the residual strength values are virtually the same, while the looser and wetter case c consistently gives lower values.

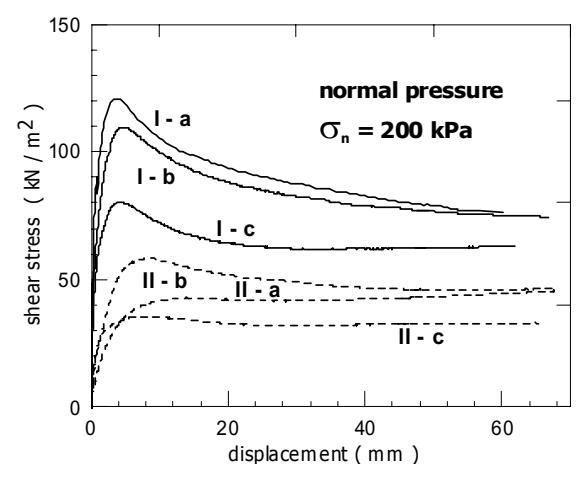
Figure 8. Interface shear testing-normal pressure 200 kPa

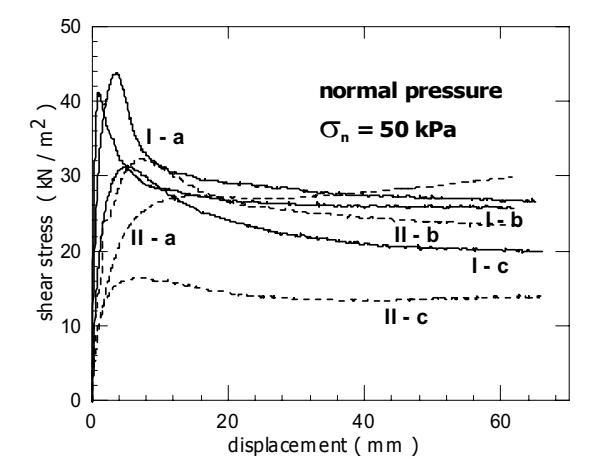
Figure 9. Interface shear testing-normal pressure 50 kPa
