Restoration of foundation of northern library of Bayon temple, Angkor

Y. Iwasaki
 Geo-Research Institute, Japan

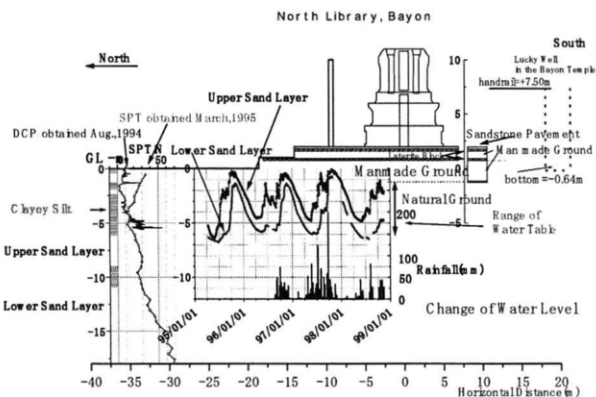
Figure.3 Ground Condition at Bayon, Angkor Thom

The ground condition of the nearby Bayon temple is shown in Fig.3. The foundation ground for northern library is about 2m higher level than the surrounding one outside of Bayon temple where the boring was performed. SPT(standard penetration test) value increases with depth down to 20m. The ground water level was monitored for several years and found at ground surface at the end of the rainy season and reaches at the lowest depth of 5 to 6meters. SPT value in dry season is larger than those in rainy season at the ground surface due to wet and dry effect on the surface soil.

Based upon archaeological excavation, we found a pavement layer of laterite blocks below the foundation and another one at 2m below the surface pavement. The foundation of the library was found well compacted sandy soil that shows cone penetration resistance of $q_c=2.0\text{MPa}$. The estimated STP value is about $N=20$.

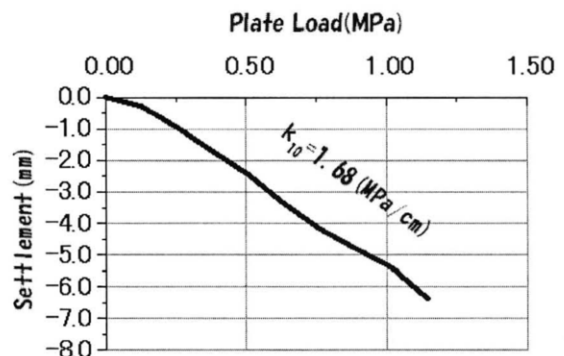
Figure 6. Result of plate loading test

ay be major reason for the open gaps. Sag at the roof may be due to local settlement at the top surface of the foundation fill. Plate loading test was performed on the dismantled surface of the manmade fill foundation with a circular plate with a diameter of 10cm as shown in Fig.6. The Young's modulus of the compacted fill was estimated as $E=15.1\text{MPa}$ assuming $\nu=0.3$.

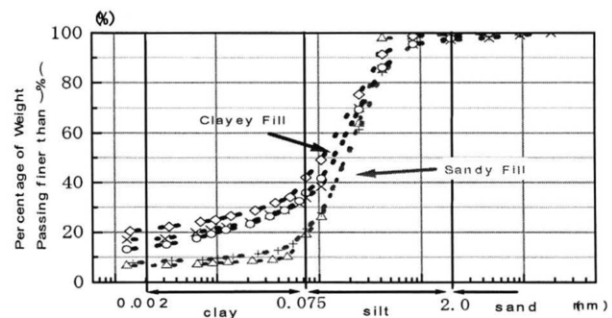
Figure 7. Grain size distribution of dismantled fill

Fig.7 shows grain size distribution of the fill material. The fill was mainly sandy soil with clayey soil was found mainly at the boundary between fill and laterite blocks. Fig.8 shows compaction characteristics by Proctor's standard method. The dry density measured at the site was $\rho_d=1.797$ that is about 95% of the maximum dry density and evaluated as highly compacted state.

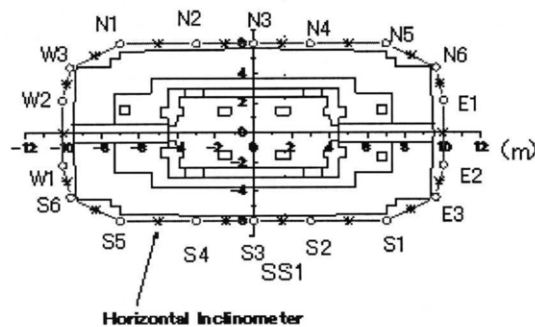
Figure 9. Setting horizontal inclinometer surrounding Library

Differential heave during dismantling was measured by horizontal inclinometers (Fig.9). A reference level point was damaged and the absolute settlement was not known. The results were shown in Fig.10. Relatively larger heave was measured at southeast side compared to northwest side. The differential heave was about $d=2\text{mm}$. The unload due to dismantle was estimated as 370kN. Assuming the Young's modulus of 15.1MPa, the heave may be estimated as the following equation.

The estimated heave is $\delta=1.4\text{mm}$, which is less than the measured differential heave. Since one sided heave was caused by more or less even unloading, the base ground beneath the foundation may not be uniform. The southeast side is weaker than the northwest side. However, there is no specialized heave near at both ends where the upper structure had deformed. Also the difference in heave is considered small and does not affect upon the reconstruction of the monument.

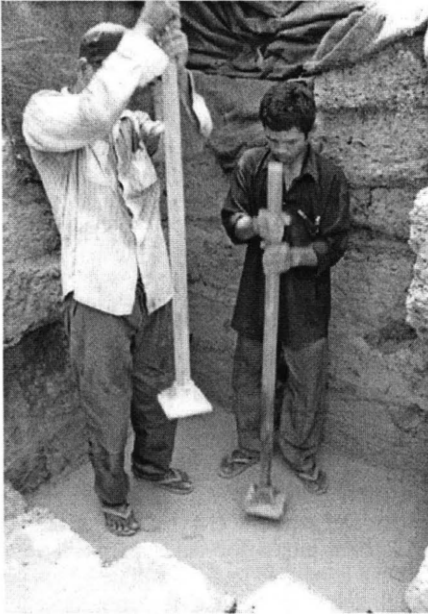
Photo 1
Elephant foot
for ground
compaction

The slacked lime mixed soil increases its strength gradually with time because of the slow chemical process of carbonation. The fill material was mixed with water contents for mixing in Tab-1. After mixing, the fill material was left over for curing. The cured fill material is spread over with about 10cm. The elephant foot is used to compact the fill with 5 to 10times of tamping until no more compaction is realized.

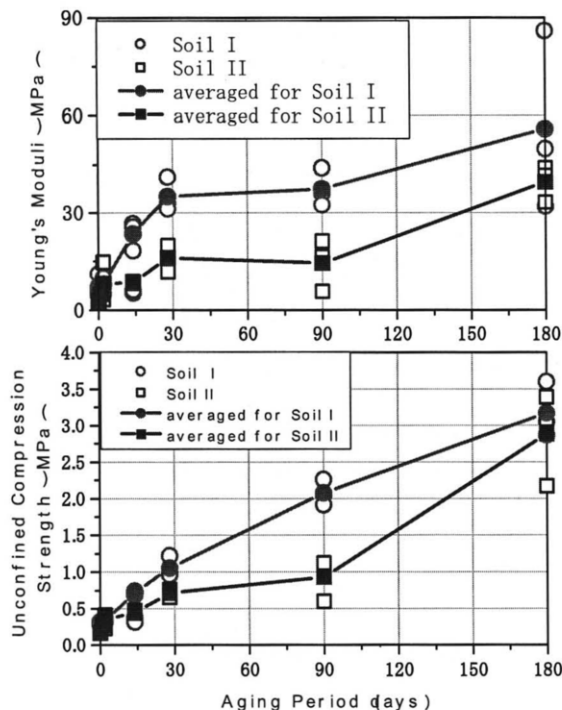
Figure 12. Increase of strength and Young's modulus with time

1MPa after 30days for Soil type I. After six months, the strength reached about 3MPa that gives safety factor of S.F.=3. The Young's modulus also increases to about 40MPa after six months that we have set for the quality of the foundation fill.

The effects of aging after compaction were studied to perform unconfined compression test after compaction at several different period of aging up to 180days as shown in Fig.12 It was found that the strength is only 0.3MPa just after compaction but increases linearly with time and reach the required strength of
