# Feedback Analysis and Prevention & Control Strategy of the Real Causes of the Gallery Cracks in Super-High Arch Dam

**Abstract.** Gallery cracks occur commonly in concrete dams, but their cracking mechanism has yet to be effectively revealed. In this paper, the actual temperature, stress change history and cracking process of a gallery area were uncovered, based on the safety monitoring data of cracks in a super-high arch dam. In addition, the basic development and change laws, as well as the corresponding cracking mechanism, were analyzed, and the real causes and influential factors of cracks at the site were revealed, which will provide a reference for the prevention of cracks in similar projects in the future.

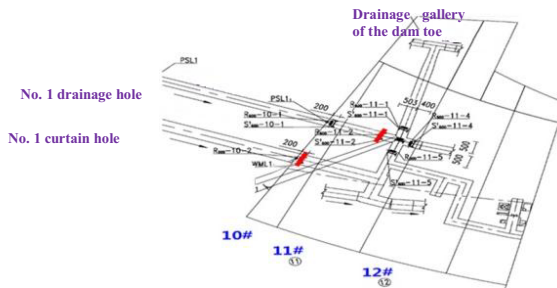
Figure 4. Layout of monitoring instruments for the top arch area of the dam block in the gallery area.

bars. The actual crack direction is shown in figure 6. It is not difficult to see that the situation observed by the monitoring instrument is able to accurately reflect the development and change of stress and strain in the gallery area of the dam.

From a theoretical analysis perspective, when the tensile stress of the concrete on the roof arch of the gallery gradually approaches the tensile strength of the concrete, then the steel bars will gradually share greater tensile stress. In addition, when the surface stress of the gallery exceeds the tensile strength of the concrete, then the cracks are formed on the surface of the gallery. At that time, the stress in the gallery area will be redistributed, the steel bars in the gallery area will share more tensile stress, and the stress of the steel bars will suddenly increase. According to the monitoring data of the on-site steel bars shown in figure 5, the actual situation is highly consistent with the theoretical analysis results.

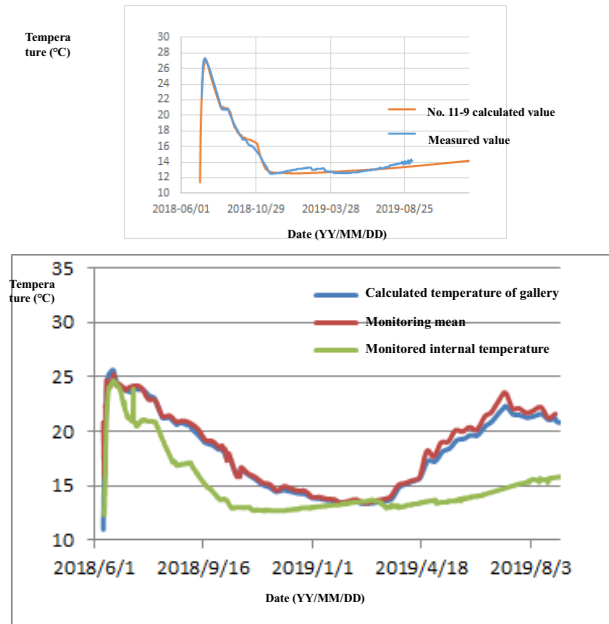
**Figure 9.** Comparison of measured temperature, stress and feedback simulation value of typical parts of the gallery.

Figure 9 shows the comparison curve of the temperature, stress and strength curves of the gallery roof of No. 11 dam block. It can be seen that, since September 25, 2018, the stress exceeded the allowed stress which means the safety coefficient of the concrete on the surface of the gallery roof had fallen below 1.5; as required in the Code, the safety coefficient must be over 1.5. At this time, the internal temperature of the gallery area was 14.5°C, which has not reached the design arch sealing temperature of 13°C, and the temperature on the surface of the gallery roof was still approximately 18.7°C. After this, as the overall temperature of the dam dropped to the arch sealing temperature, the stress reached the first highest point. Next, the later stress continued to increase with the further drop of the temperature on the surface of the gallery. In late February of 2019, the temperature reached its lowest point, and the stress reached another peak.

to about 1.5, then the risk of cracking becomes very high. This is basically the same as the time when cracks are observed on-site. The change process of stress and safety coefficient is consistent with the change trend reflected by the monitoring value of on-site surface strainmeters and gallery reinforcement stress meter, thus indicating that the feedback simulation results can basically reflect the change law of the overall stress and safety status of the gallery area of the No. 11 dam block. Among them, the tensile stress generated by the overall and local temperature drop in the dam forms a concentration effect in gallery roof, which is the main cause of gallery cracks.

(3) In order to reduce the risk of gallery cracking, in addition to lowering the highest temperature in the gallery area as a whole, the entrance and exit of the gallery must be closed as much as possible, so as to reduce the influence of outside temperature on the gallery. Meanwhile, the necessary maintenance is also beneficial to preventing shallow dry shrinkage cracks.
