Geotechnical Risks in a Deep Building Pit in The Hague's Old City Centre – Project Veenkade Case Study of the Restoration of an Old Canal and a New Underground Parking Garage

Abstract. In The Hague, a 2 storey parking garage was built beneath a reinstated canal at the Veenkade with 160 parking places. The canal and the parking garage were installed at minimum 3 - 6 m distance from old houses with a shallow foundation by means of a 10 m deep building pit. A risk analysis was undertaken and major risks were identified, resulting in mitigating measures, e.g. compensation grouting in combination with very accurate monitoring. The structure was completed in 2014.

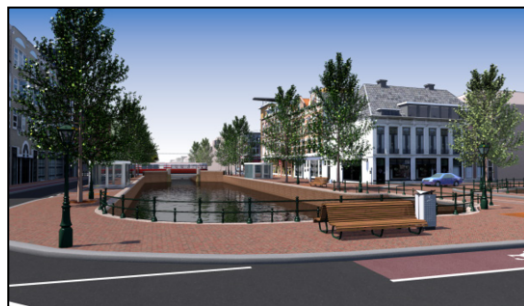
Figure 1. Artist impression of the new Canal

The concrete structure of the canal and the parking garage were completed in 2014 (see figure 1). Presently the fully automatic parking facilities are being installed.

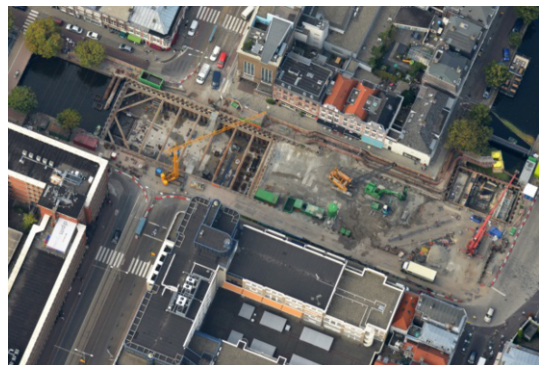
Figure 5. Excavation in 2 compartments

First of all, the building pit was divided into two compartments (see figure 5). This was part of a strategy to allow traffic to use the new bridge over the canal in an earlier stage. The first compartment to be constructed, however, was surrounded by relatively new buildings on piled foundations, which were less sensitive to possible soil deformations. By measuring the soil deformations by means of inclinometers, an excellent insight in the deformations at the more critical second compartment was obtained.
