Prediction versus performance of Land Reclamation Bund

C.F. Leung, S.A. Tan & R.F. Shen

Centre for Soft Ground Engineering, Department of Civil Engineering, National University of Singapore

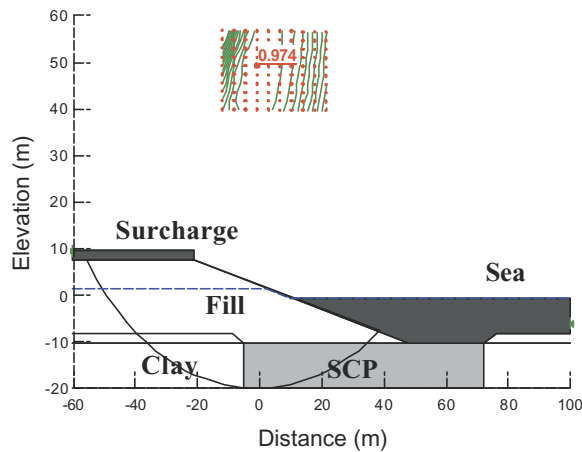
Figure 2 Failure of bund slope under a combination of adverse conditions

It should be noted that none of the single factors alone listed in Table 1 can trigger the bund failure. However, when several adverse conditions happen simultaneously at the same location, bund slope failure may become imminent. For example, if factors 2, 3 and 5 in Table 1 occur simultaneously at the same location, namely the underlying soft marine clay is weaker than typical value, the bund alignment deviates landward for say 13 m relative to the SCP, and the bund has been overfilled too fast to +7.5 m ACD without proper control, the bund slope will fail with the factor of safety dropping below unity, as shown in figure 2. It is likely that localized concurrence of several adverse conditions will trigger local failure of the bund slope and propagates progressively to larger areas leading to catastrophic effects.

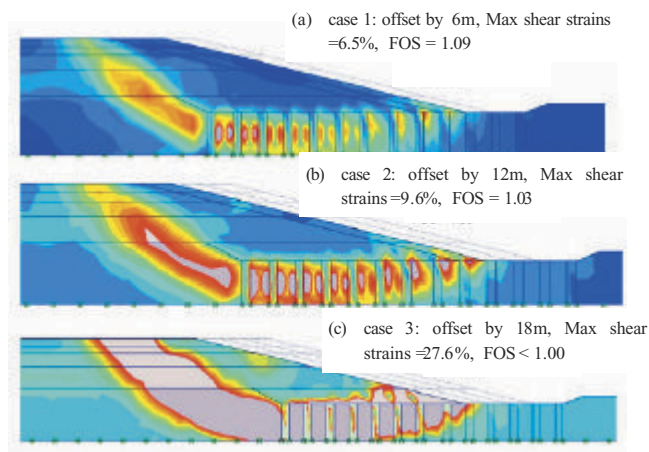
Figure 3 Shear strains for 7.5m bund with bund alignment offsets by (a) 6m (b) 12m and (c) 18m

clearly shows the significant impact of the offset of bund alignment on the slope stability. As shown in Fig. 3, with the bund offset increases from 6m (case 1) to 12m (case 2), the FOS reduces from 1.09 to 1.03. When the offset reaches 18m (case 3), the FOS drops below unity, indicating a slope failure. The maximum shear strains also increase from 6.6% to 27.6% from case 1 to case 3 as shown in the figure.
