# Study on Rail Short-Wave Irregularity of Speed Increased Tracks

**Abstract.** The data obtained from a field test of irregularity of rail surface in Hu-Kun line, a CWR track, is processed by statistical analysis of maximum amplitude and one-third octave analysis. The result shows that the regularities of rail surface in joint areas of CWR track are worse in common. In general, the amplitudes of rail surface irregularities can get beyond 0.5mm/m, which exceed standard values in every wave length ranges, and the maximum of them can reach 15dB. The conditions of rail surface regularities in non-joint areas are better, and the rail surface irregularities from most of the test points are lower than 0.15mm/m, which do not exceed standard values.

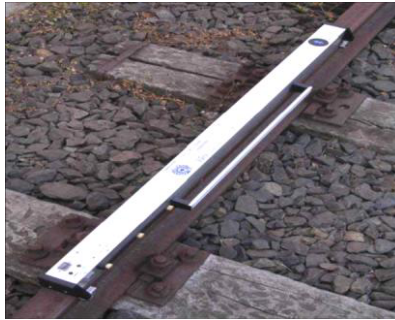
SEC-RC rail electric flatness gauge, produced by Schmidt rail technology Co., LTD and whose sampling interval was 200 testing point per meter, was used. The test instrument is shown in Figure 1.

Figure 1. Rail electric flatness gauge.

In order to analyze rail surface regularities from different parts of the rail, rail surface regularities data mainly obtained from middle-rail (1/2 standard rail length apart from rail welding joint) and side-rail (1/4 and 3/4 standard rail length apart from welding joint) was collected. There were 4 testing points (1 point in joint, 1 point in middle-rail, 2 points in side-rail) in every rail, and 104 samples. The situation of the field test is shown in Figure1.

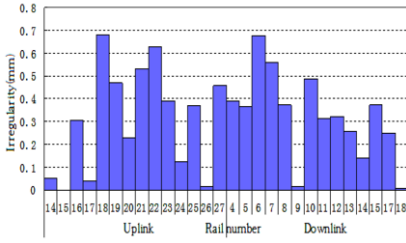
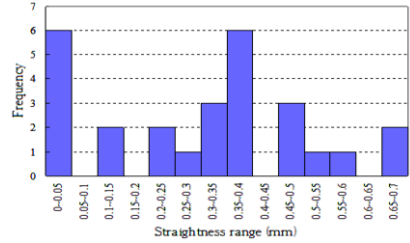
(a) scattergram along the line.

(b) frequency column diagram.

Figure 5. Scattergram of max convex irregularities in joint areas.

Figure 5(a) shows the max convex irregularities of rail surface in joint areas, and Figure 5(b) the frequency of max irregularities. As can be seen in Figure 5, the max convex irregularities of rail surface is 0.68mm, which allocates mainly in 0-0.05mm and 0.3-0.4mm, and the mean value is 0.314mm.

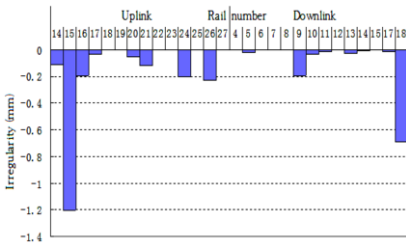
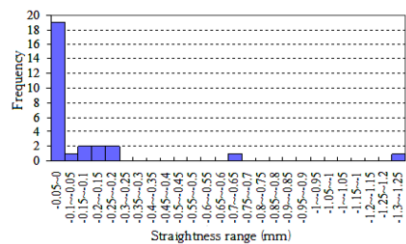
(a) scattergram along the line.

(b) frequency column gram.

Figure 6. Scattergram of max spill irregularities in joint areas.

Figure 6(a) shows the max spill irregularities of rail surface in joint areas, and Figure 6(b) the frequency of max irregularities. In Figure 7, the max spill irregularities is -1.2mm, which allocates mainly in -0.05-0mm, greater than max convex irregularities(0.68mm), and the mean value is -0.1mm.

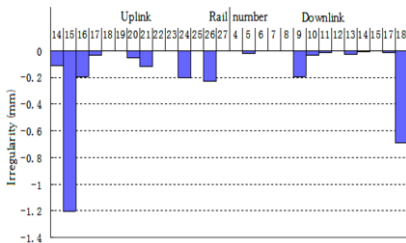
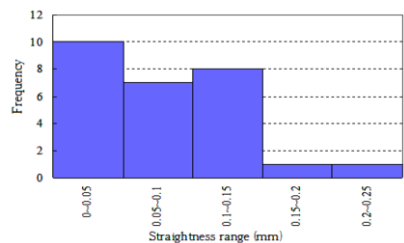
(a) scattergram along the line.

(b) frequency column gram.

Figure 7. Scattergram of the max convex irregularities at side-rail 1.

Figure 7(a) shows max convex irregularities at side-rail 1, Figure 7(b) max frequency irregularities. In Figure8, the max convex irregularity of rail surface at side-rail is 0.28mm, most of which is less than 0.15mm, and the mean value is 0.074mm. It means that the convex irregularities of rail surface at side-rail 1 are good.

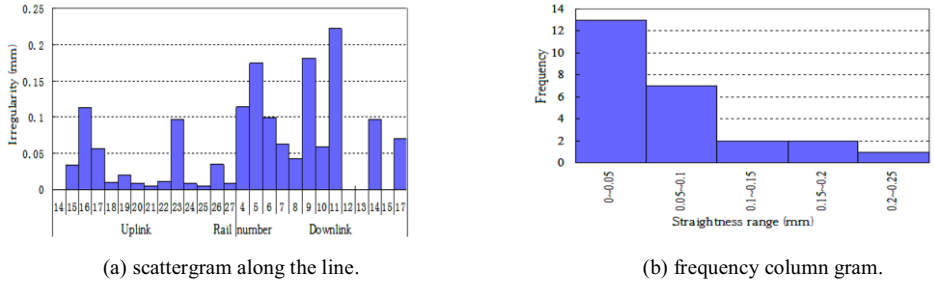
Figure 11. Scattergram of the max convex irregularities at middle-rail.

Figure 11(a) shows the max convex irregularities of rail surface at middle-rail, Figure 11(b) the max frequency irregularities. In Figure11, the max convex irregularity of rail surface at middle-rail is 0.23mm, most of which is less than 0.1mm, and the mean value is 0.061mm.

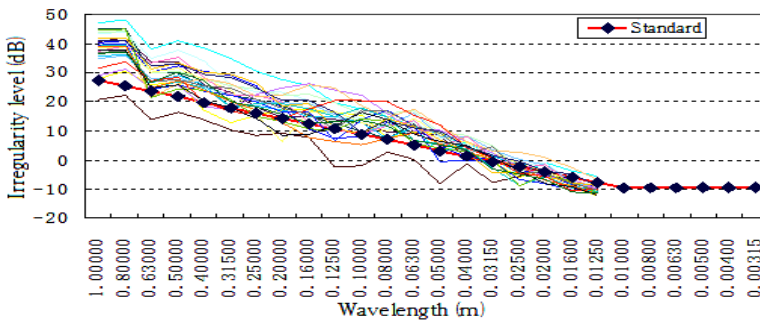
Figure 13. 1/3 octave spectrum of rail surface irregularities in joints.

Figure 13 is 1/3 octave spectrum of rail surface irregularities in joints. It shows that the irregularities of the rail joints are higher than standard limit values, the max difference of which is 18dB, and the regularity of the rail surface is low. Moreover, in different range of frequency, irregularities of rail surface are different. In the wavelength range of 0.05-1m, the irregularities of the rail surface are high, and increase as the wavelength increases. In the wavelength range of less than 0.05m, the irregularities are low and close to standard values, and decrease to standard values as the wavelength decreases.

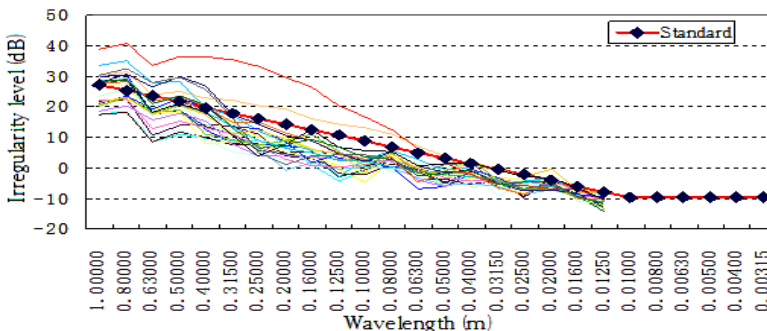
Figure 14. 1/3 octave spectrum of rail surface irregularities at side-rail 1.

Figure 14 and Figure 15 are 1/3 octave spectrums of rail surface irregularities at side-rails. They show that, except several points, regularities at side-rail 1 and at side-rail 2 are almost the same. Irregularities are mainly lower than standard spectrum, and the regularities of the track are well. In the range of 0.4-1.0m, some of them exceed the standard values. But overall, the regularities of rail surface at side-rail are well.

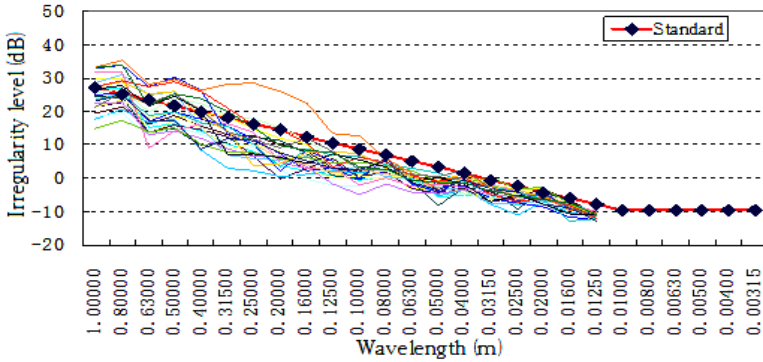
Figure 15. 1/3 octave spectrum of rail surface irregularities at side-rail 2.

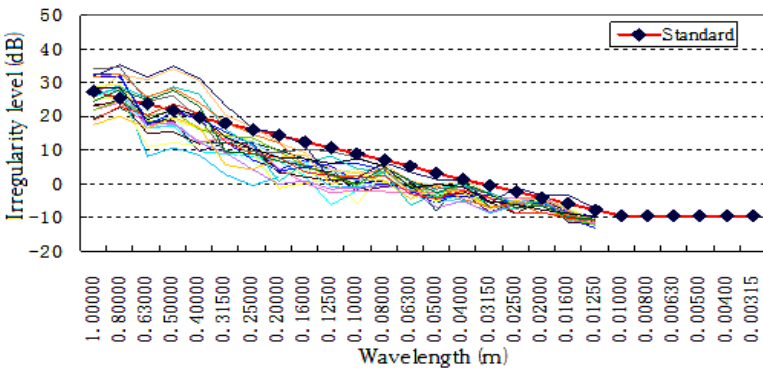
Figure 16. 1/3 octave spectrum of rail surface at middle-rail.

Figure 16 is 1/3 octave spectrum of rail surface at middle-rail. It shows that irregularities of the track are lower than standard values in all the analysis wavelength ranges. In the range of 0.315-1.0m, some of them are higher than standard. But overall, the regularities of rail surface at side-rail are well.
